Maywood Chemical Company Superfund Site

Results of Radon and Gamma Radiation Measurements at 19 Commercial and Governmental Properties of the Maywood Site

Maywood, New Jersey

August 1994

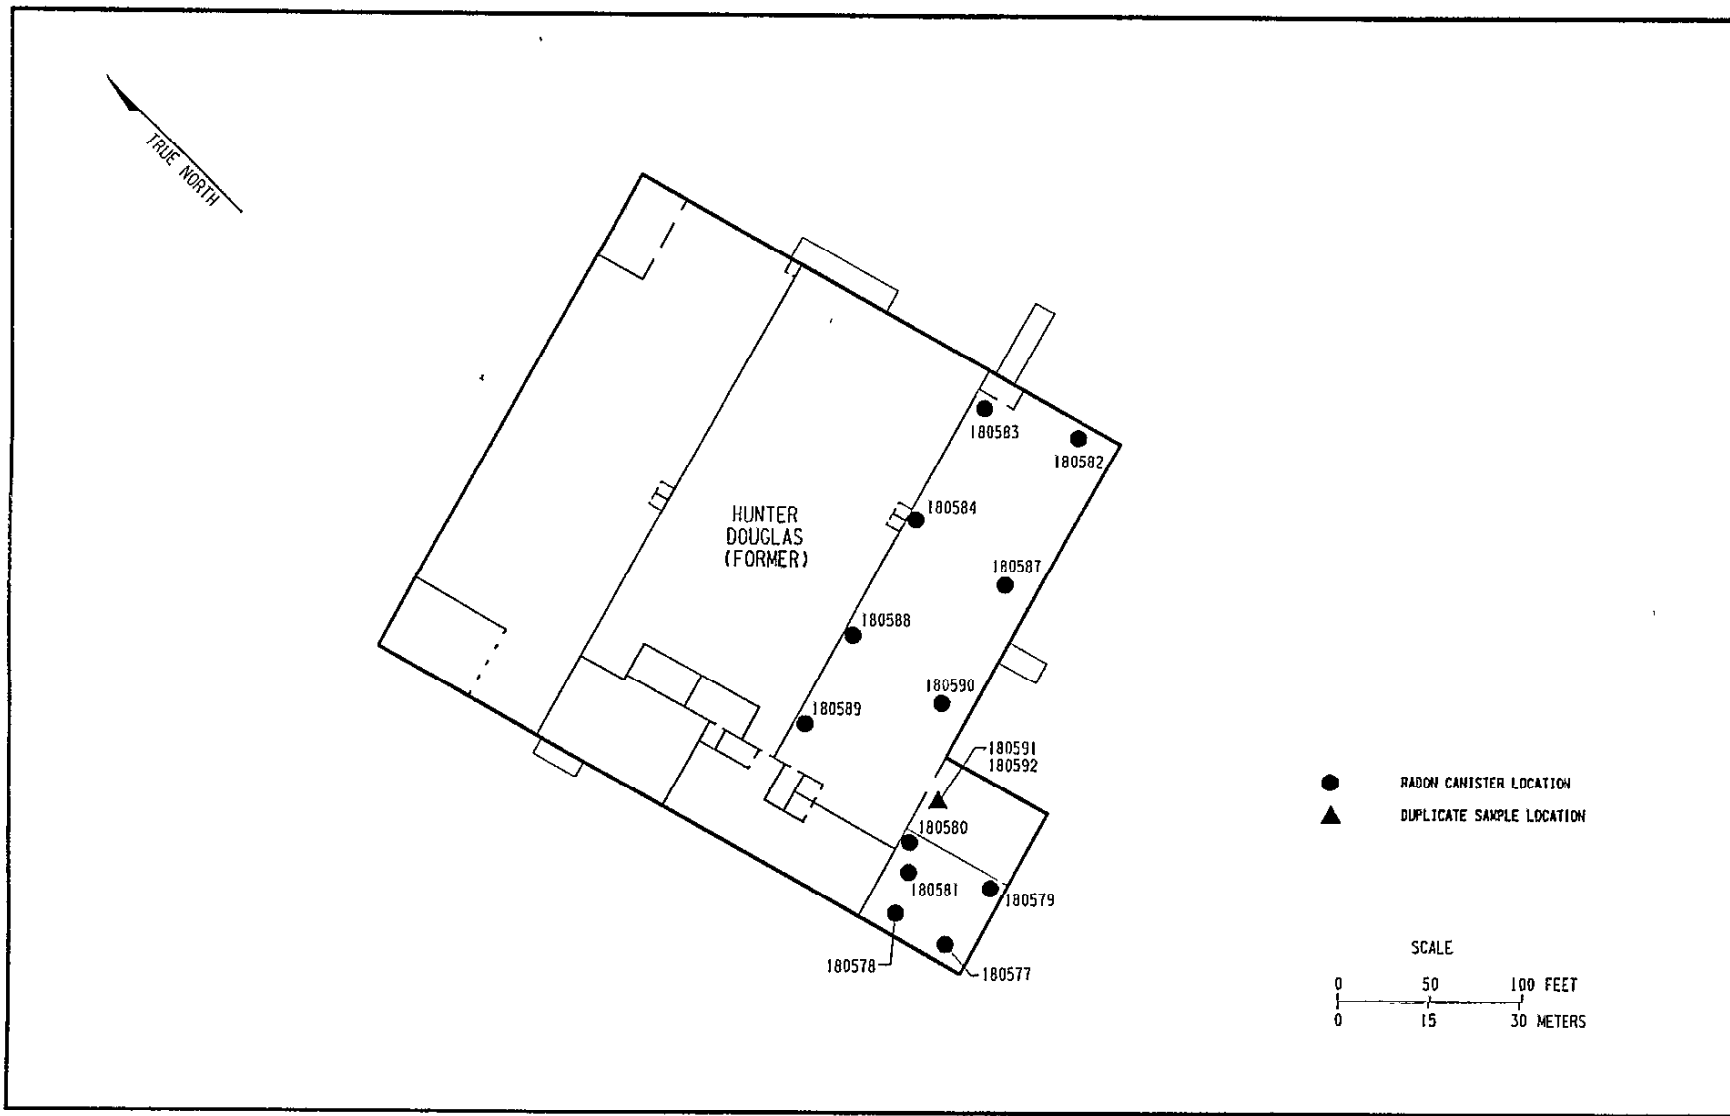
Figure 4-7
Locations of Radon Canisters at Meta-Lite
(Portion of Former Hunter Douglas Property)
85-99 Route 17 North

Deployment of 14 activated charcoal canisters was performed during a normal work day to measure concentrations of radon. The locations of the canisters are shown in Figure 4-7, and the data are presented in Table 4-3. Canisters were placed in locations where the greatest number of employees were located and in areas where "closed house" conditions could be approximated as closely as possible to ensure collection of a

representative sample. "Closed" or "closed house" conditions refers to the building being closed, that is, the windows and doors are kept closed and no heating or cooling systems such as attic fans are in operation for at least 12 hours before the radon canisters are deployed. Radon concentrations ranged from less than 0.2 to less than 0.3 pCi/L, all within background. These concentrations are well below background for the Maywood site, which is 1.0 pCi/L, and are also significantly below DOE's guideline of 3.0 pCi/L above background.
