Maywood Chemical Company Superfund Site

ORNL/RASA-88/51

**RESULTS OF THE RADIOLOGICAL SURVEY
AT THE NATIONAL COMMUNITY BANK, 113 ESSEX STREET,
MAYWOOD, NEW JERSEY (MJ021)**

Date Published – September 1989

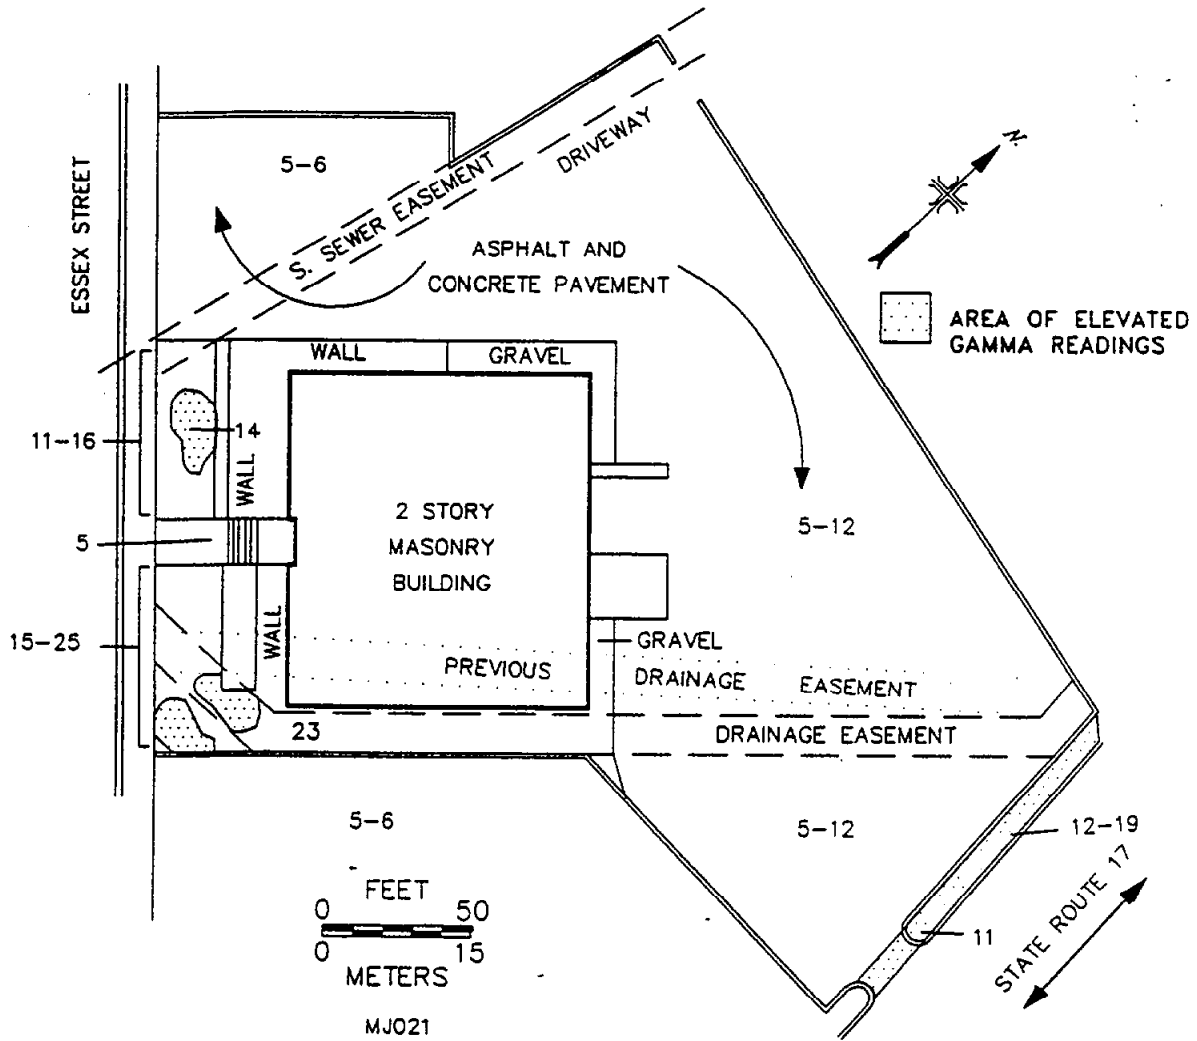
Fig. 1. Gamma radiation levels ($\mu\text{R/h}$) measured on the surface at the National Community Bank, 113 Essex Street, Maywood, New Jersey (MJ021).

Before the bank was built in the mid-1960s, the contaminated Lodi Brook crossed the property in four 24-inch concrete pipes underground (Fig. 1). Presently, it crosses the bank property in a new concrete box culvert a few feet southeast of the original easement. From the original point of entry to the property at State Route 17, the new easement parallels the southeast wall of the building until it reaches the front lawn, where it angles back to the original easement and goes under Essex Street.

Gamma radiation levels measured during a gamma scan of the property surface are given in Fig. 1. Gamma exposure rates over the major portion of the property ranged from 5 to 12 μ R/h. The highest measurements ranged from 11 to 25 μ R/h and were found in front of the building on either side of the steps. Soil samples B1 and B2 were taken from this area. Elevated gamma levels were also evident along the eastern boundary of the

property, measuring from 11 to 19 $\mu\text{R/h}$. Soil samples B3 and B4 were taken in this area.

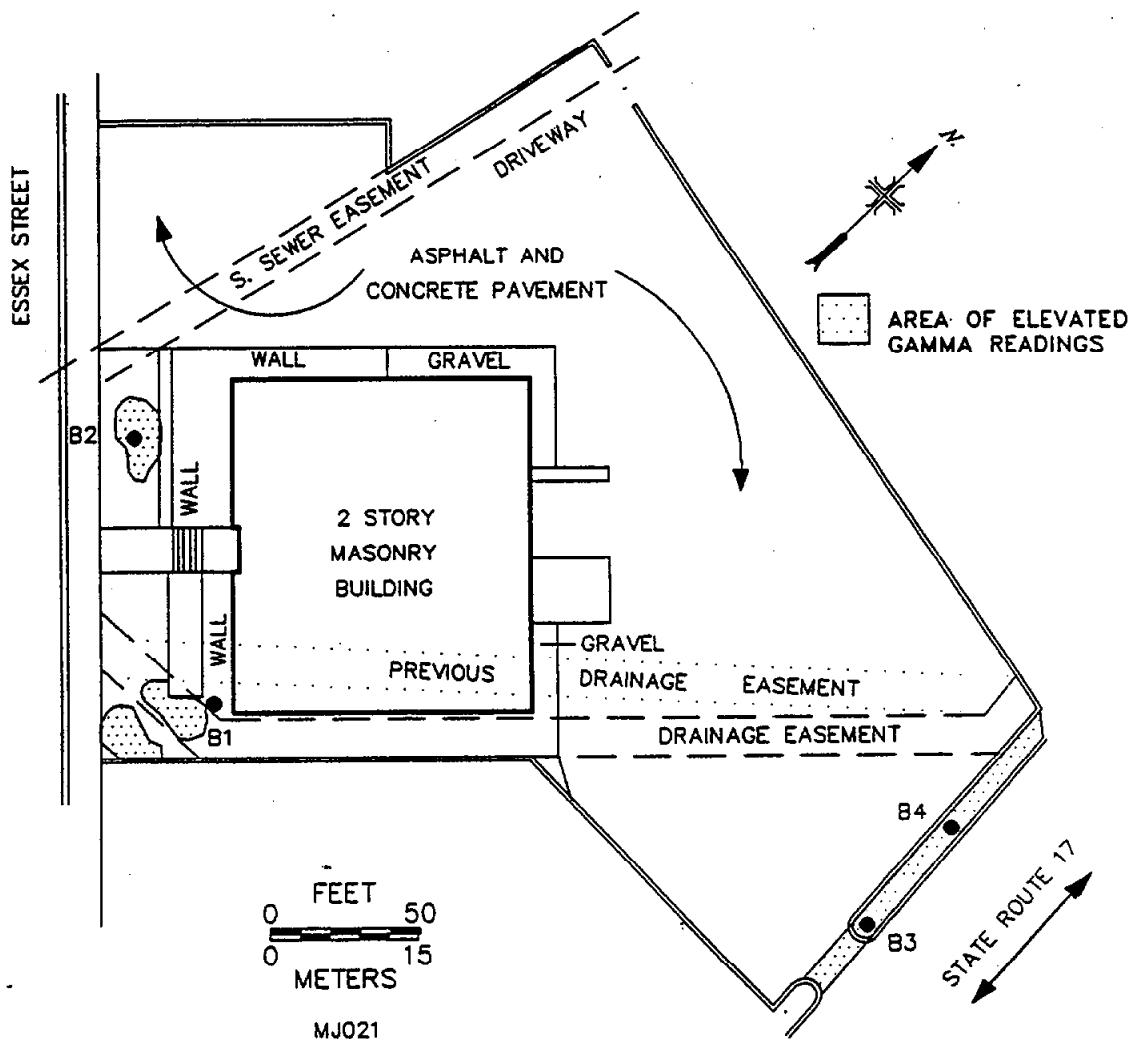
Fig. 2. Diagram showing locations of soil samples taken at the National Community Bank, 113 Essex Street, Maywood, New Jersey (MJ021).

Biased soil samples were taken from various locations on the property for radionuclide analyses. Locations of these samples (B) are shown in Fig. 2, with results of laboratory analyses provided in Table 3. Concentrations of radium, thorium, and uranium in these samples ranged from 1.0 to 2.0 pCi/g, 1.5 to 8.5 pCi/g, and 0.98 to 3.1 pCi/g, respectively. All samples were near or above background levels for the northern New Jersey area (Table 2). Thorium levels in biased soil samples B1A and B2A were 8.5 pCi/g and 6.5 pCi/g, respectively; both of these concentrations were in excess of DOE criteria (Table 1).

Measurements and results of soil sample analyses taken at the National Community Bank indicate that the property contained radioactive contamination primarily from the ^{232}Th decay chain, with slight contamination from both ^{226}Ra and ^{238}U . These radionuclide distributions are typical of the type of material originating from the processing operations at the MCW site. The concentration and extent of ^{232}Th on this property is in excess of the applicable DOE criteria (Table 1). This material was found at sample locations B1 and B2, as shown in Fig. 2. Based on the results of this radiological assessment, it is recommended that this site be considered for inclusion in the DOE remedial action program.
