Maywood Chemical Company Superfund Site

RADIOLOGICAL CHARACTERIZATION REPORT
FOR THE DeSAUSSURE PROPERTY
MAYWOOD, NEW JERSEY

SEPTEMBER 1989

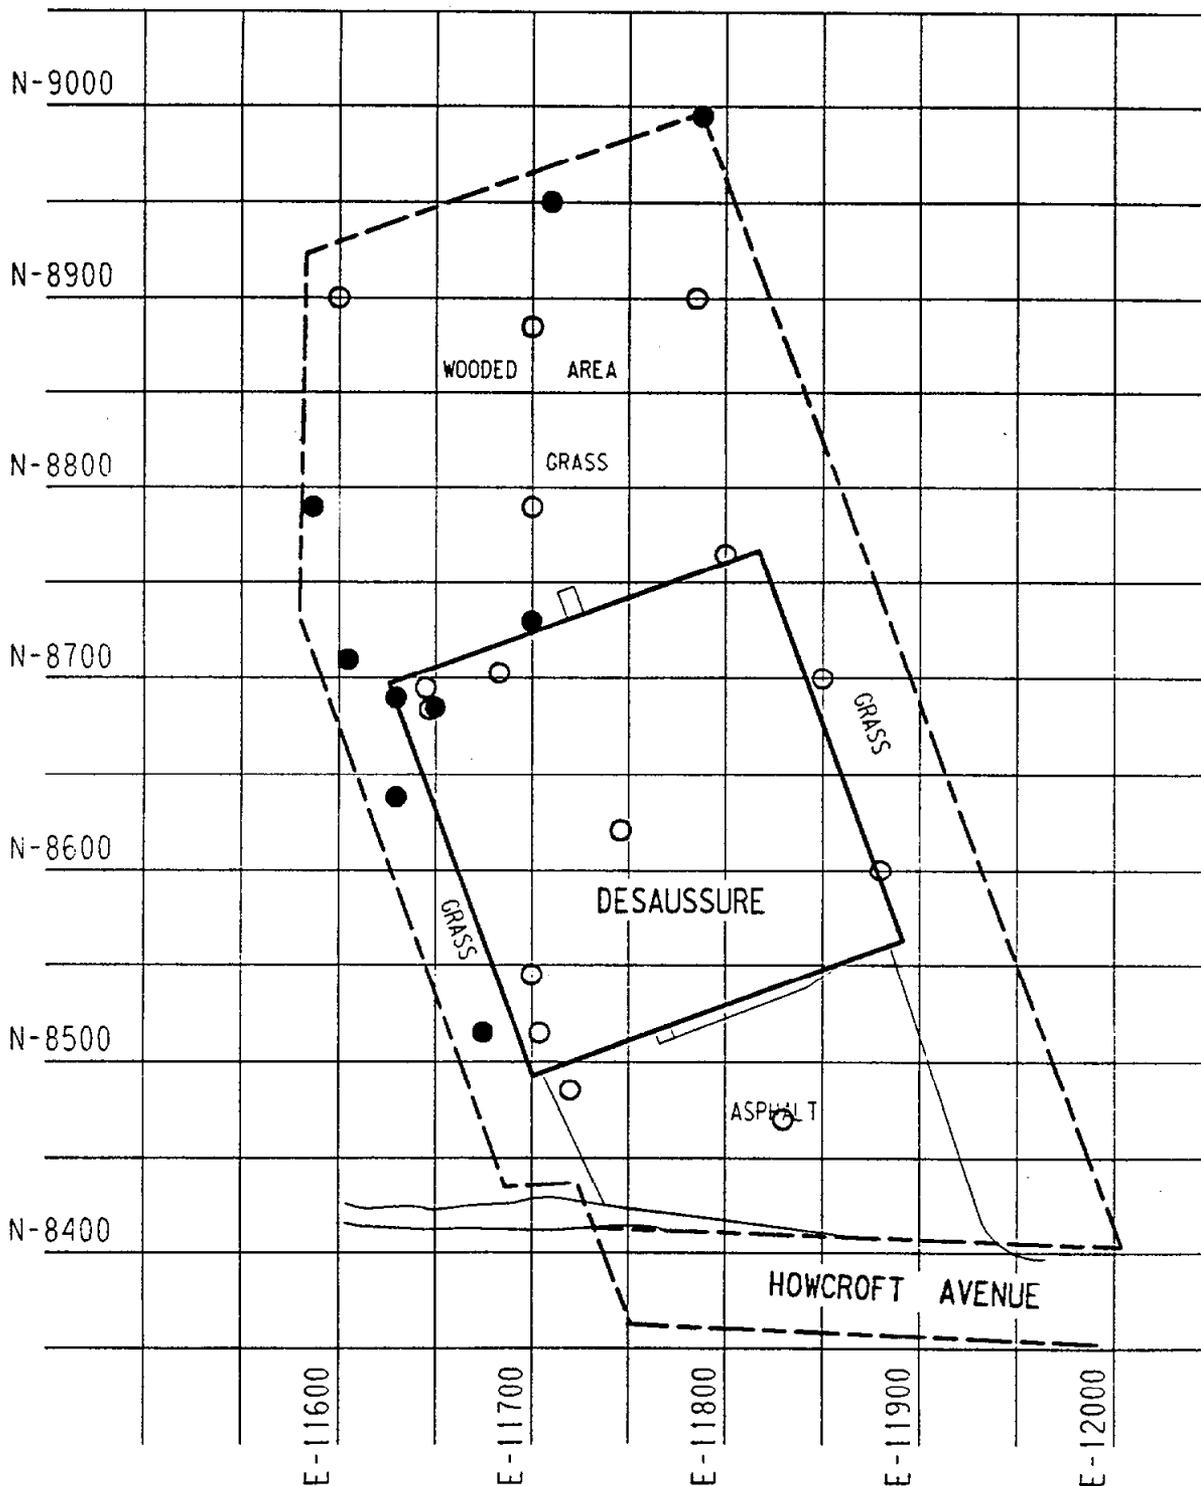
FIGURE 4-1 BOREHOLE LOCATIONS AT DESAUSSURE

Soil analysis data for this property did not indicate surface contamination on the property. However, near-surface measurements indicated the potential for surface contamination along the north and west property boundaries, adjacent to the west side and a portion of the north side of the building, and an isolated area near the east property boundary. Soil analysis of surface soil samples along the drainage ditch adjacent to the southwest corner of the property indicated surface contamination in that area. Subsurface investigation by gamma logging indicated contamination to a depth of 1.83 m (6.0 ft).

Analytical results for subsurface soil samples are given in Table 5-1, and gamma logging data are given in Table 5-2. The results in Table 5-2 showed a range from 2,000 cpm to 382,000 cpm. A measurement of 40,000 cpm is approximately equal to the DOE guideline for subsurface contamination of 15 pCi/g. Analyses of subsurface soil samples indicated uranium-238 concentrations of 5.0 pCi/g, thorium-232 concentrations ranging from 0.9 to 1.3 pCi/g, and radium-226 concentrations ranging from 0.4 to 1.9 pCi/g.

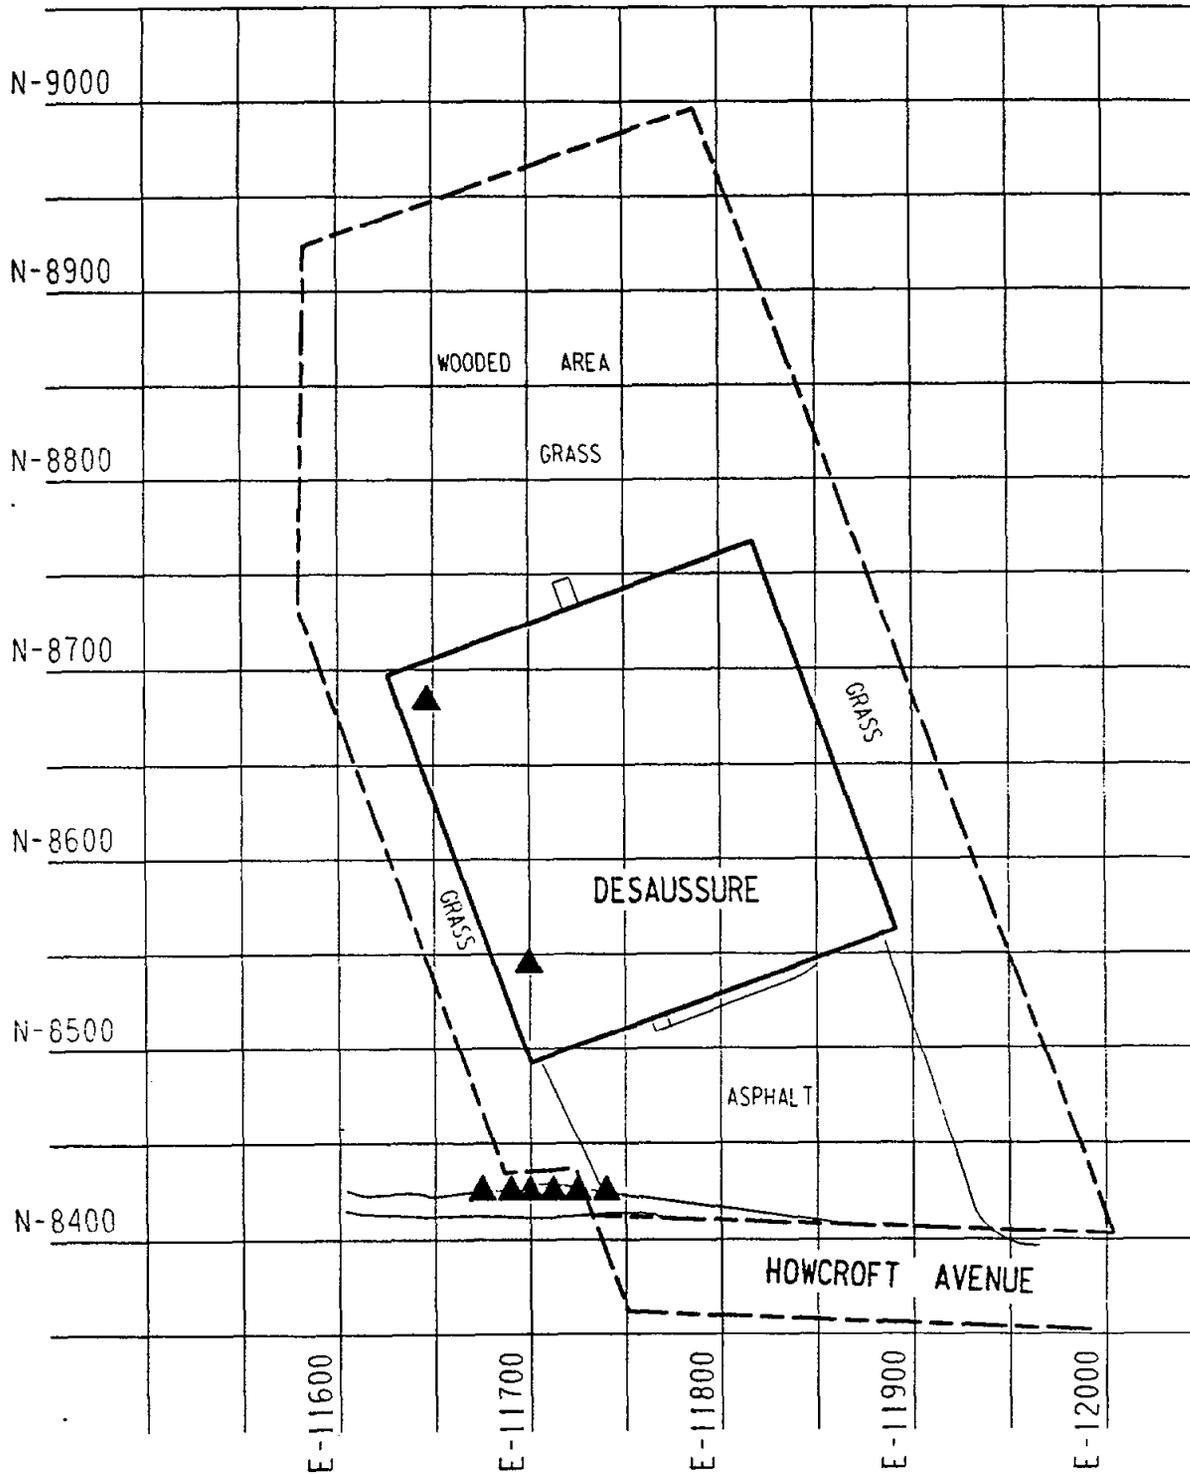
FIGURE 4-2 SURFACE AND SUBSURFACE SOIL SAMPLING LOCATIONS AT DESAUSSURE

Subsurface soil samples were collected from two locations (Figure 4-2) using the side-wall sampling method and were analyzed to compare laboratory soil sample results to downhole gamma radiation measurements. A cup or can attached to a steel pipe or wooden stake was inserted into the borehole and used to scrape samples off the side of the borehole at a specified depth. The subsurface soil samples were analyzed for radium-226, uranium-238, and thorium-232 in the same manner as the surface soil samples.

Surface soil samples [depths from 0.0 to 15.2 cm (6.0 in.)] were taken at six locations along an open drainage ditch in the Borough right-of-way adjacent to the property (Figure 4-2). These samples were analyzed for thorium-232, uranium-238, and radium-226. The concentrations in these samples ranged from less than 8.0 to 80.2 pCi/g for uranium-238, from 59.1 to 124.3 pCi/g for thorium-232, and from 5.3 to 12.9 pCi/g for radium-226. Analytical results for surface soils are provided in Table 5-1; these data showed that concentrations of thorium-232 and radium-226 exceeded DOE guidelines (5 pCi/g plus background of 1 pCi/g for surface soils) with a maximum concentrations of 124.3 and 12.9 pCi/g, respectively. Use of the "less than" (<) notation in reporting results indicates that the radionuclide was not present in concentrations that are quantitative with

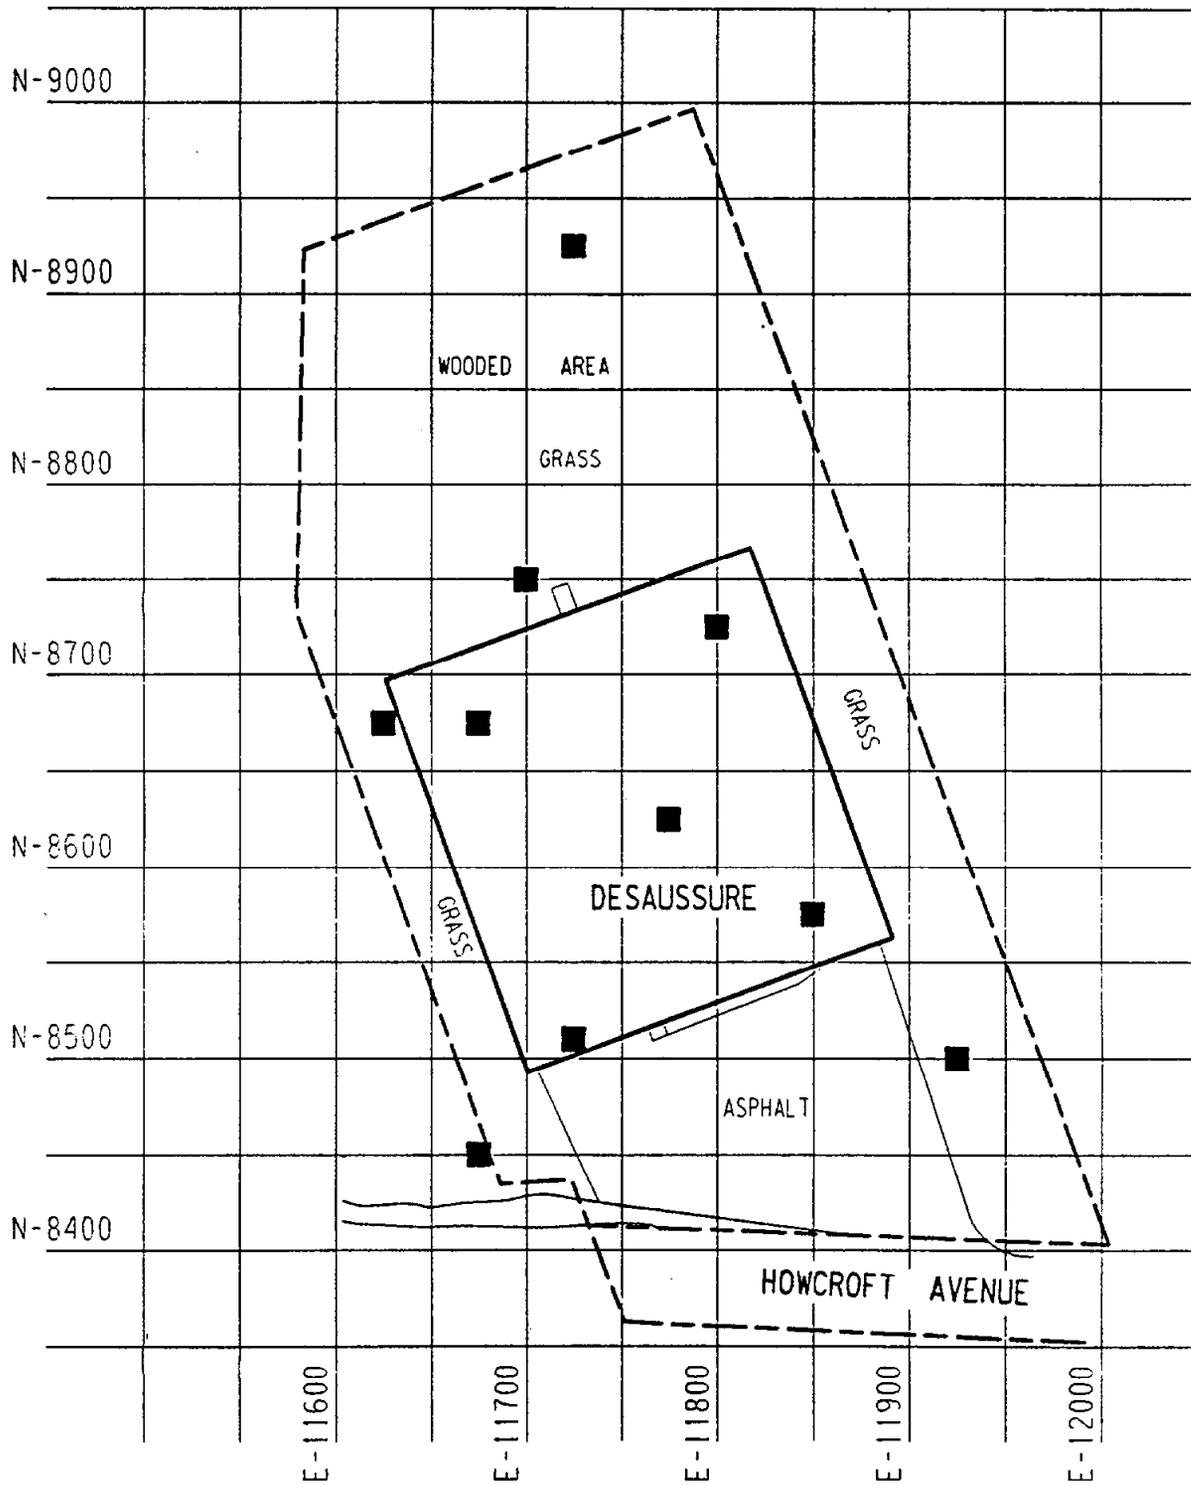
FIGURE 4-3 GAMMA EXPOSURE RATE MEASUREMENT LOCATIONS AT DESAUSSURE

Exterior gamma exposure rate measurements were made at five locations throughout the property grid system and at five location inside the building. To obtain these measurements, either a 5.0- by 5.0-cm (2- by 2-in.) thallium-activated sodium iodide gamma scintillation detector designed to detect gamma radiation only or a pressurized ionization chamber (PIC) was used. Measurement locations are shown in Figure 4-3. The PIC instrument has a response to gamma

Exterior gamma radiation exposure rate measurements ranged from 10 to 146 $\mu\text{R}/\text{h}$, including background. The indoor exposure rate measurements ranged from 8 to 13 $\mu\text{R}/\text{h}$, including background. These results can be found in Table 5-3. Assuming an employee spends 40 hours per week for 50 weeks per year (2,000 hours or 8 hours per day for 5 days per week) inside the building (at an average exposure rate of 10 $\mu\text{R}/\text{h}$) and 5 hours per week for 50 weeks per year (250 hours or 1 hour per day for 5 days per week), outside

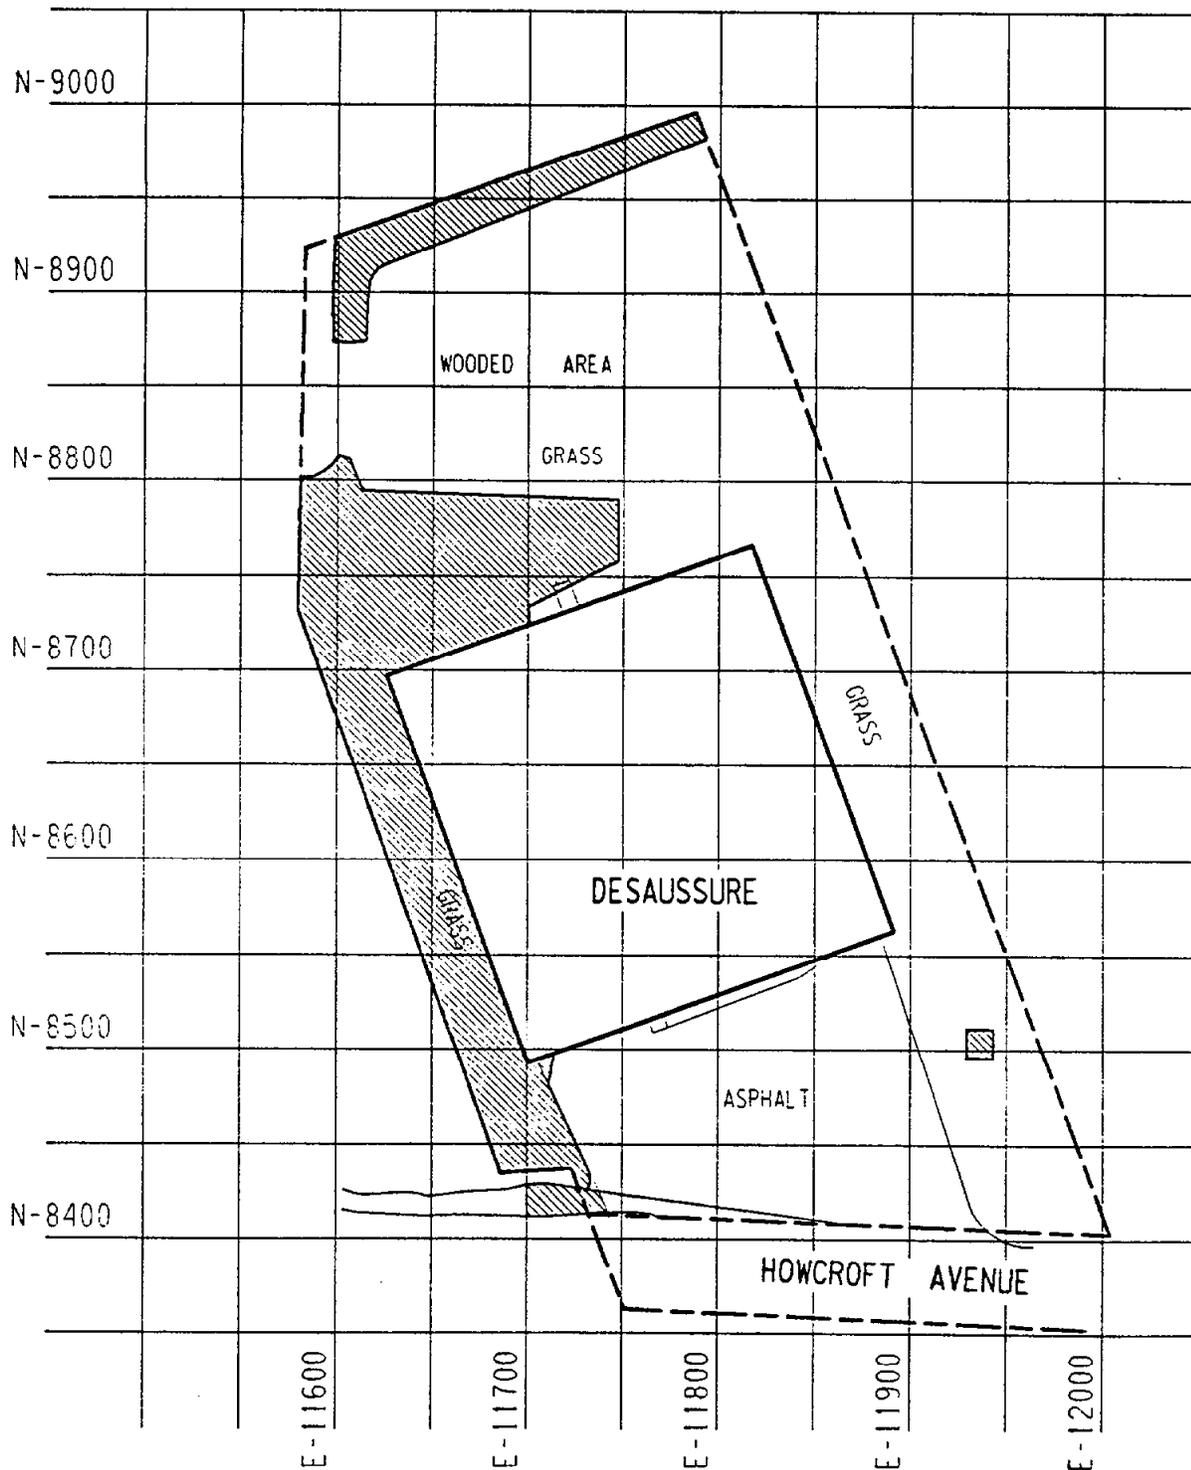
FIGURE 5-1 AREAS OF SURFACE CONTAMINATION AT DESAUSSURE

Near-surface gamma radiation measurements on the property ranged from 5,000 cpm to approximately 161,000 cpm. The average background level for this area is 5,000 cpm. A measurement of 11,000 cpm is approximately equal to the DOE guideline for thorium-232 of 5 pCi/g above background for surface soil contamination. Using this correlation, the near-surface gamma measurements were used to determine the extent of surface contamination and the basis for selecting the locations of soil samples. Areas of surface contamination are shown in Figure 5-1.

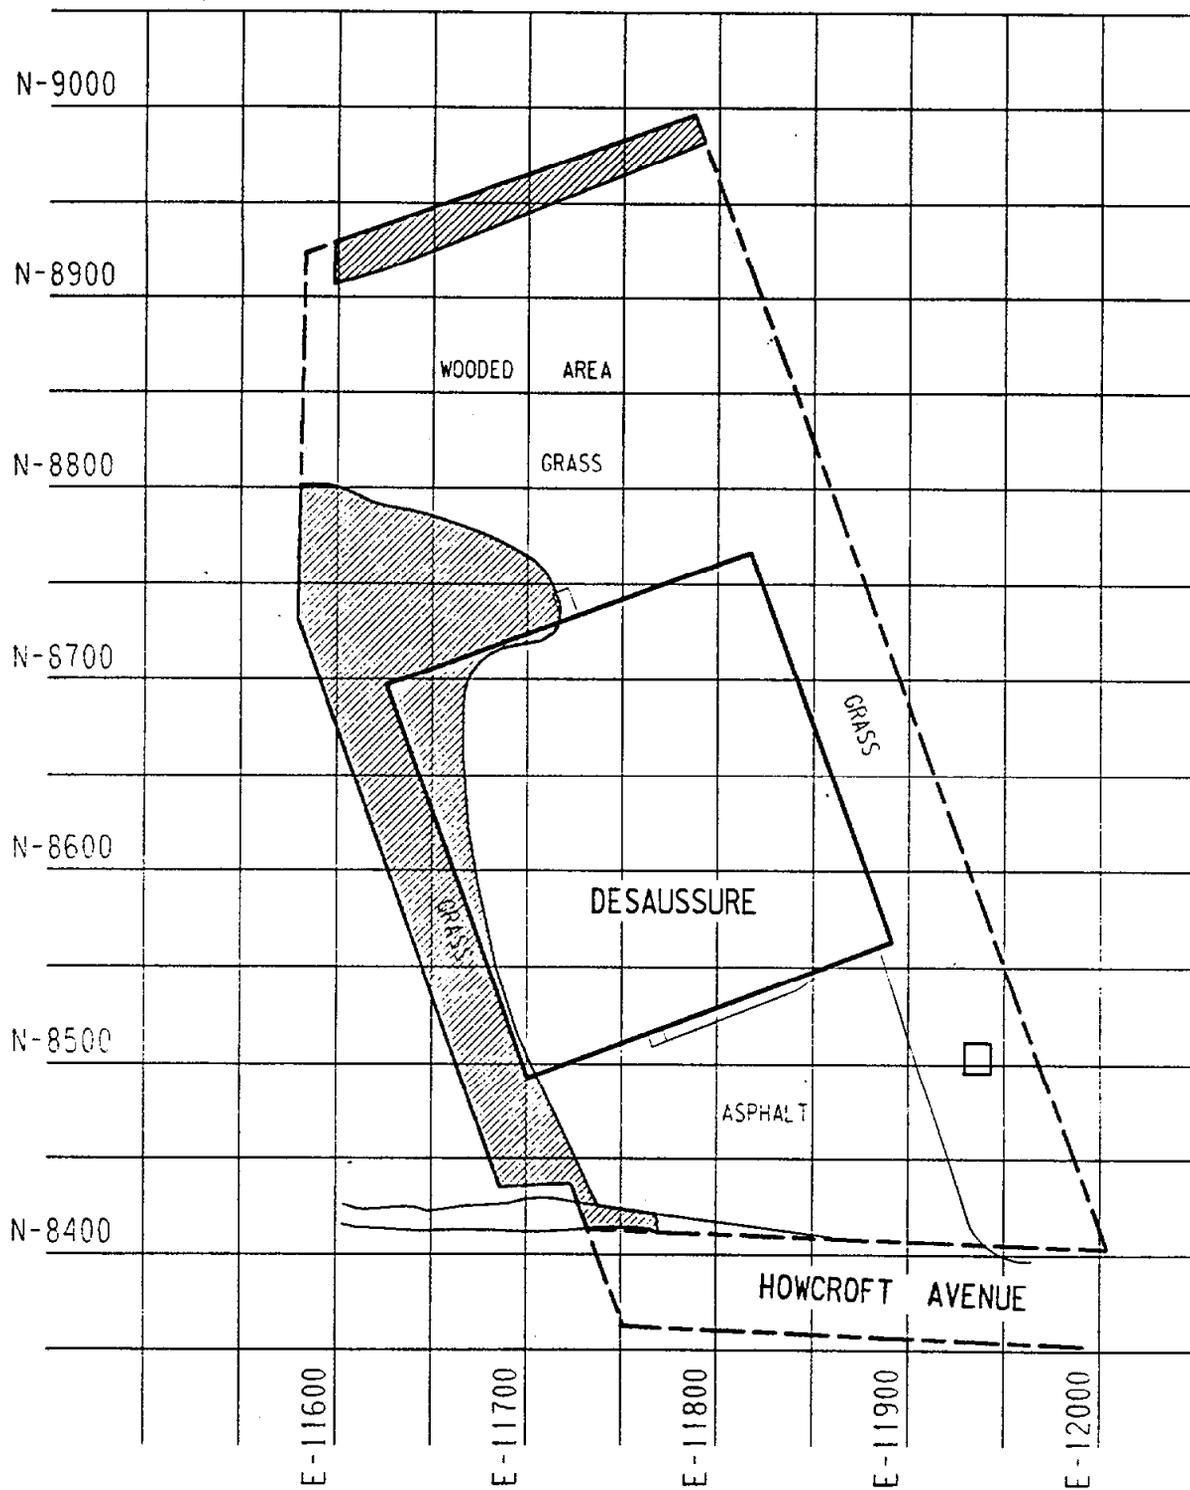
FIGURE 5-2 AREAS OF SUBSURFACE CONTAMINATION AT DESAUSSURE

resulted from concrete pads buried beneath the western third of the building. Historical information obtained from aerial photographs of the property prior to its development indicate that concrete evaporating ponds were present in this location on the property. The recent addition to the building is in the area above these buried ponds; therefore, their presence offers the most logical explanation for refusal during drilling attempts. Fill material between the building floor/slab and the underlying concrete was not found to be radiologically contaminated. It could not be determined if disturbed soil or fill material beneath the buried concrete pads is contaminated because of drill refusal. There is a high probability that subsurface contamination extends beneath the building and the buried concrete pads in this location.

The presence of subsurface contamination was also indicated along the north property boundary extending westward from the east property boundary to within approximately 4.6 m (15 ft) of the west boundary. This area of the property is forested and adjoins a grassy lawn area that surrounds the immediate foundation of the DeSaussure building on three sides (the south side of the building is adjacent to an asphalt parking/loading area). The total affected area is estimated to be approximately 35 percent of the property. These conclusions are supported by documentation that establishes the presence of the former channel of Lodi Brook in this area. This channel is the suspected transport mechanism for the radiological contamination.

On the basis of near-surface gamma radiation measurements, surface and subsurface soil sample analyses, and downhole gamma logging, contamination on this property is believed to consist primarily of subsurface contamination at depths ranging from 15.2 cm (6.0 in.) to 1.83 m (6.0 ft). The areas of subsurface contamination are shown in Figure 5-2. The subsurface contamination appears to extend beneath the building as well as onto adjacent commercial property.
