Formerly Utilized Sites Remedial Action Program (FUSRAP)

for Maywood, New Jersey

Subject: Bechtel Job No. 14501, FUSRAP Project
DOE Contract No. DE-AC05-81OR20722
Radiological Characterization Report for the
New York Susquehanna & Western Railroad Property
In the Vicinity of the Maywood Interim Storage Site
Code: 7310/File: 138

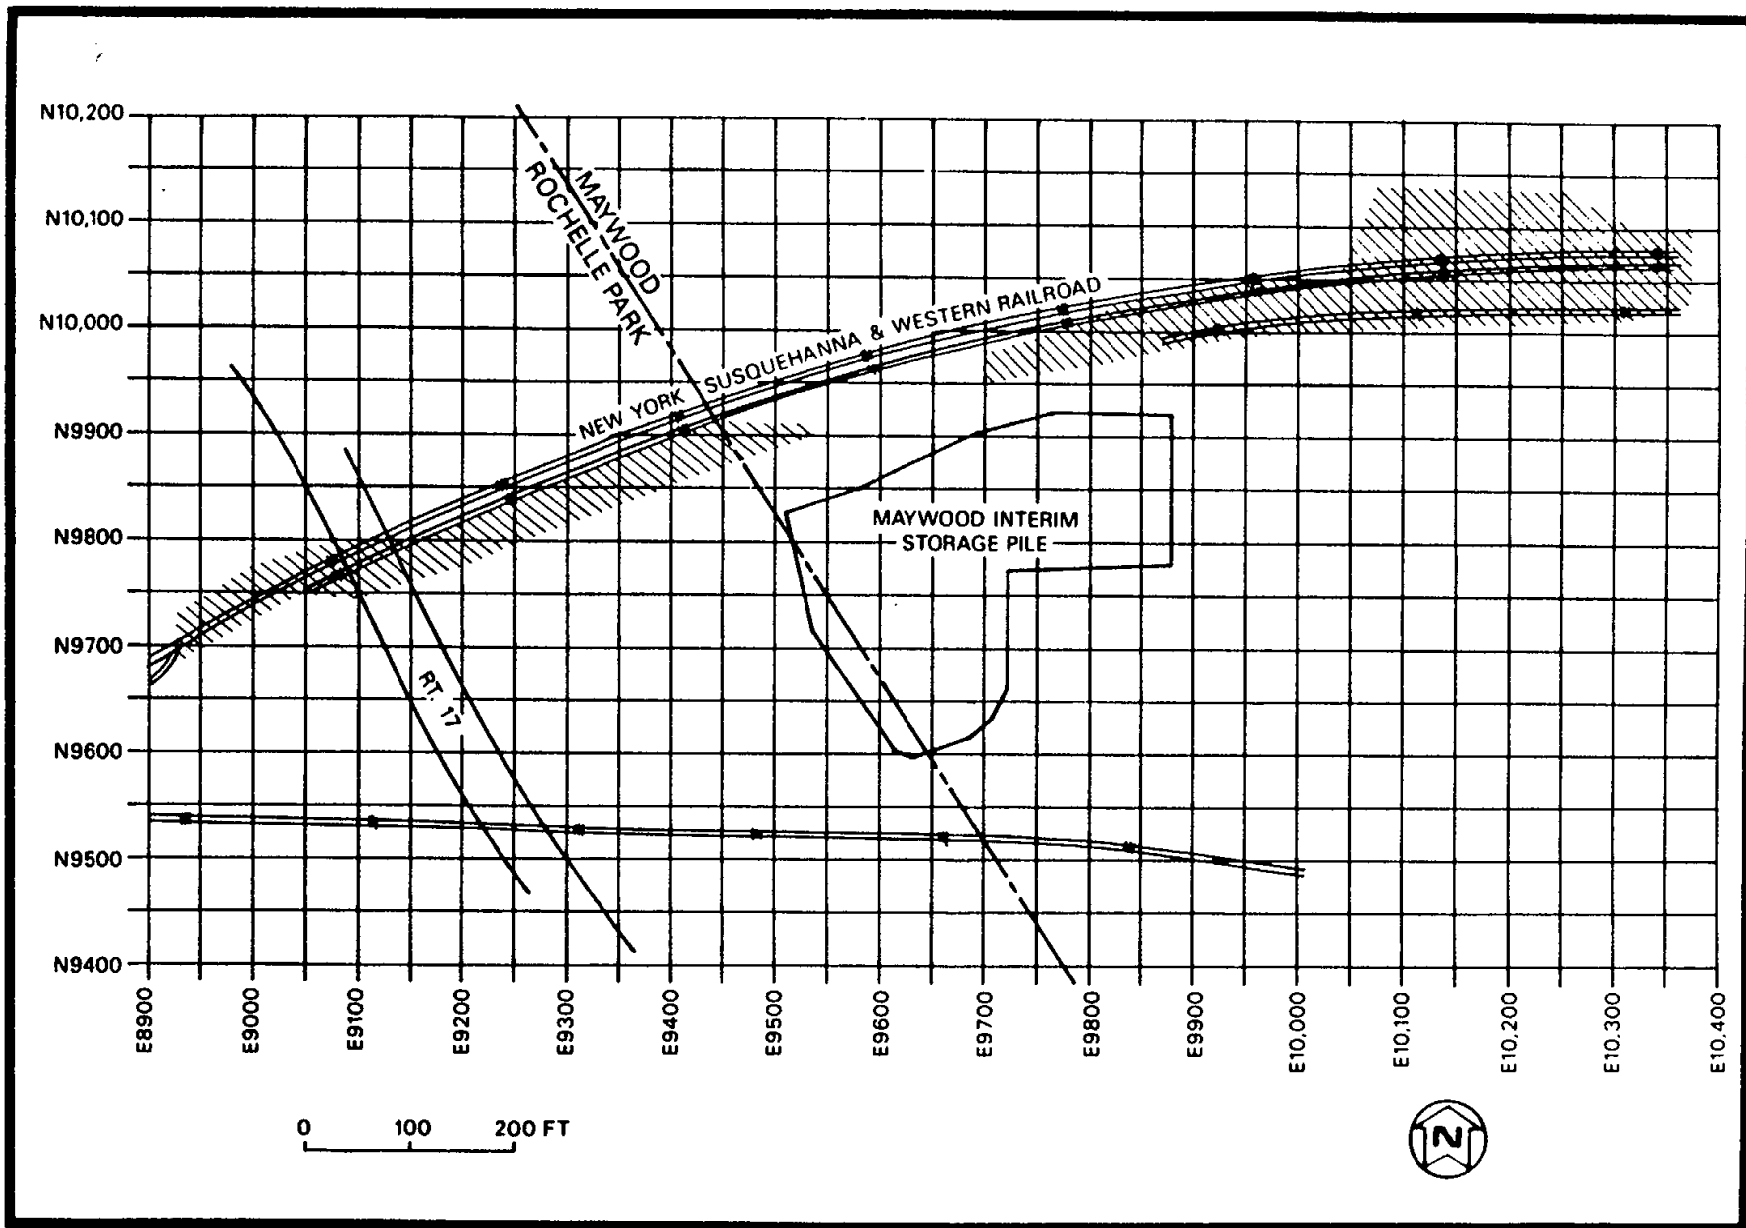
FIGURE 1 BOUNDARIES OF SURFACE CONTAMINATION ON THE NYS&W RAILROAD PROPERTY IN THE VICINITY OF THE MISS

Gamma levels measured on the property ranged from the background level of 5,000 cpm to 918,000 cpm, or approximately 1.5 pCi/g to 379 pCi/g. To identify surface areas where the level of contamination exceeds the DOE guideline for thorium-232, areas where readings exceeded 11,000 cpm were plotted on a grid. Plotting these areas showed that an area equal to approximately 118,425 ft² is contaminated. Figure 1 shows the areas of the surface contamination. In addition, near-surface gamma measurements showed that contamination extended onto two residential properties north of the railroad property. These properties (130 and 136 West Central) had been identified during the 1985 ad hoc survey program. Oak Ridge National Laboratory will conduct radiological characterizations of these properties for designation purposes.

- o A surface area equal to approximately 118,425 ft² is contaminated above the DOE guideline of 5 pCi/g.
- o An estimated 9600 yd³ of contaminated material will require excavation. The contamination ranges from surface deposition to a depth of 13 ft in the area along the railroad spur.
- o Contamination extends onto two residential properties north of the railroad property (130 and 136 West Central).

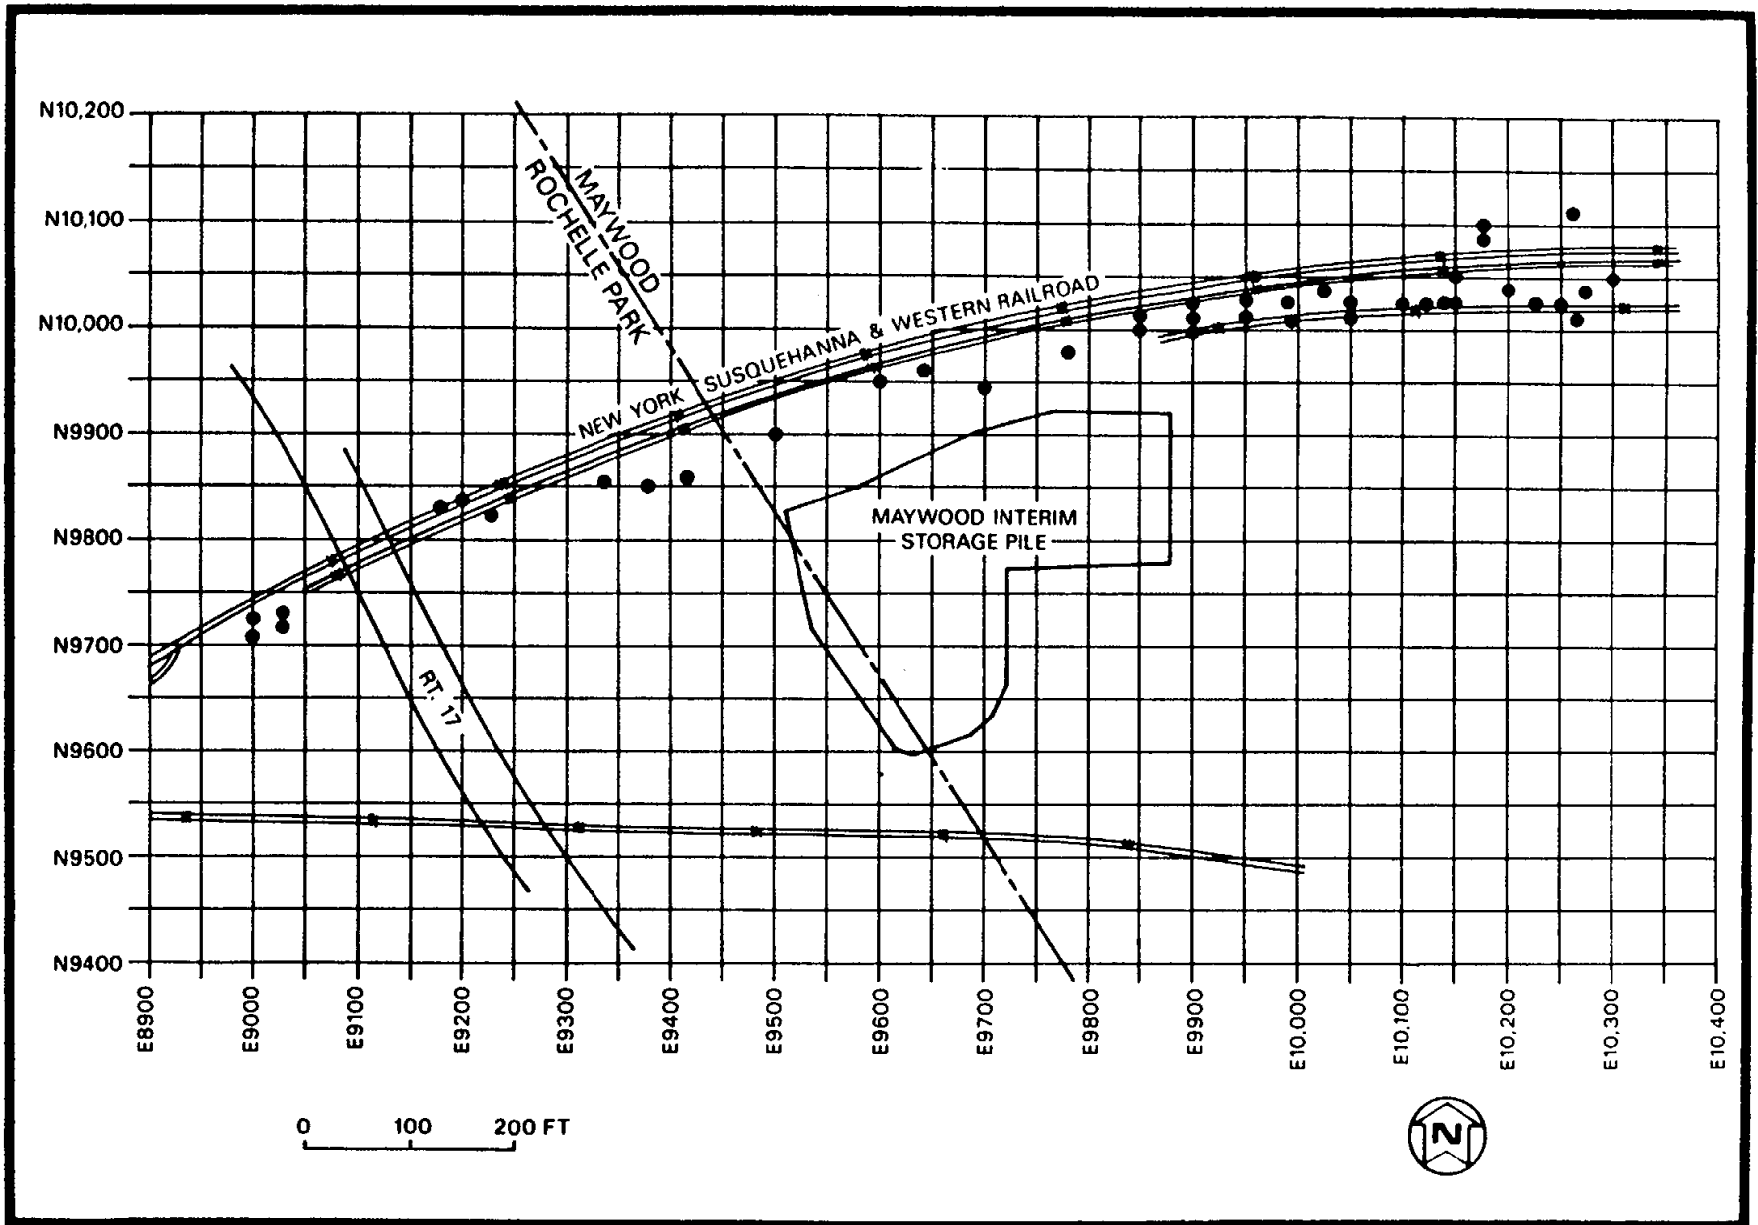
FIGURE 2 BOREHOLE LOCATIONS ON THE NYS&W RAILROAD PROPERTY IN THE VICINITY OF THE MISS

During the course of the subsurface investigation, 41 radiological boreholes were drilled and gamma logged to determine the depths and concentrations of radioactive contamination. The borehole logs were reviewed to identify trends, regardless of whether concentrations exceeded the DOE guideline. Borehole locations are shown in Figure 2. Detailed gamma logging data are presented in Table 1.

As shown in the Table 1 data, subsurface contamination was found under the southern most railroad spur, i.e., the one nearest to the site boundary. These data support the conclusion reached during a review of existing information that indicated subsurface contamination on the railroad property. Old photographs showed the spur was built over a previously low-lying area that had been filled in with contaminated material from the Maywood Chemical Works.
