Formerly Utilized Sites Remedial Action Program (FUSRAP)

Transmittal of Radiological Survey Results for 441 Central Avenue, Hackensack, New Jersey

RADIOLOGICAL SURVEY RESULTS AT 441 CENTRAL AVENUE, HACKENSACK, NEW JERSEY (MJ053)*

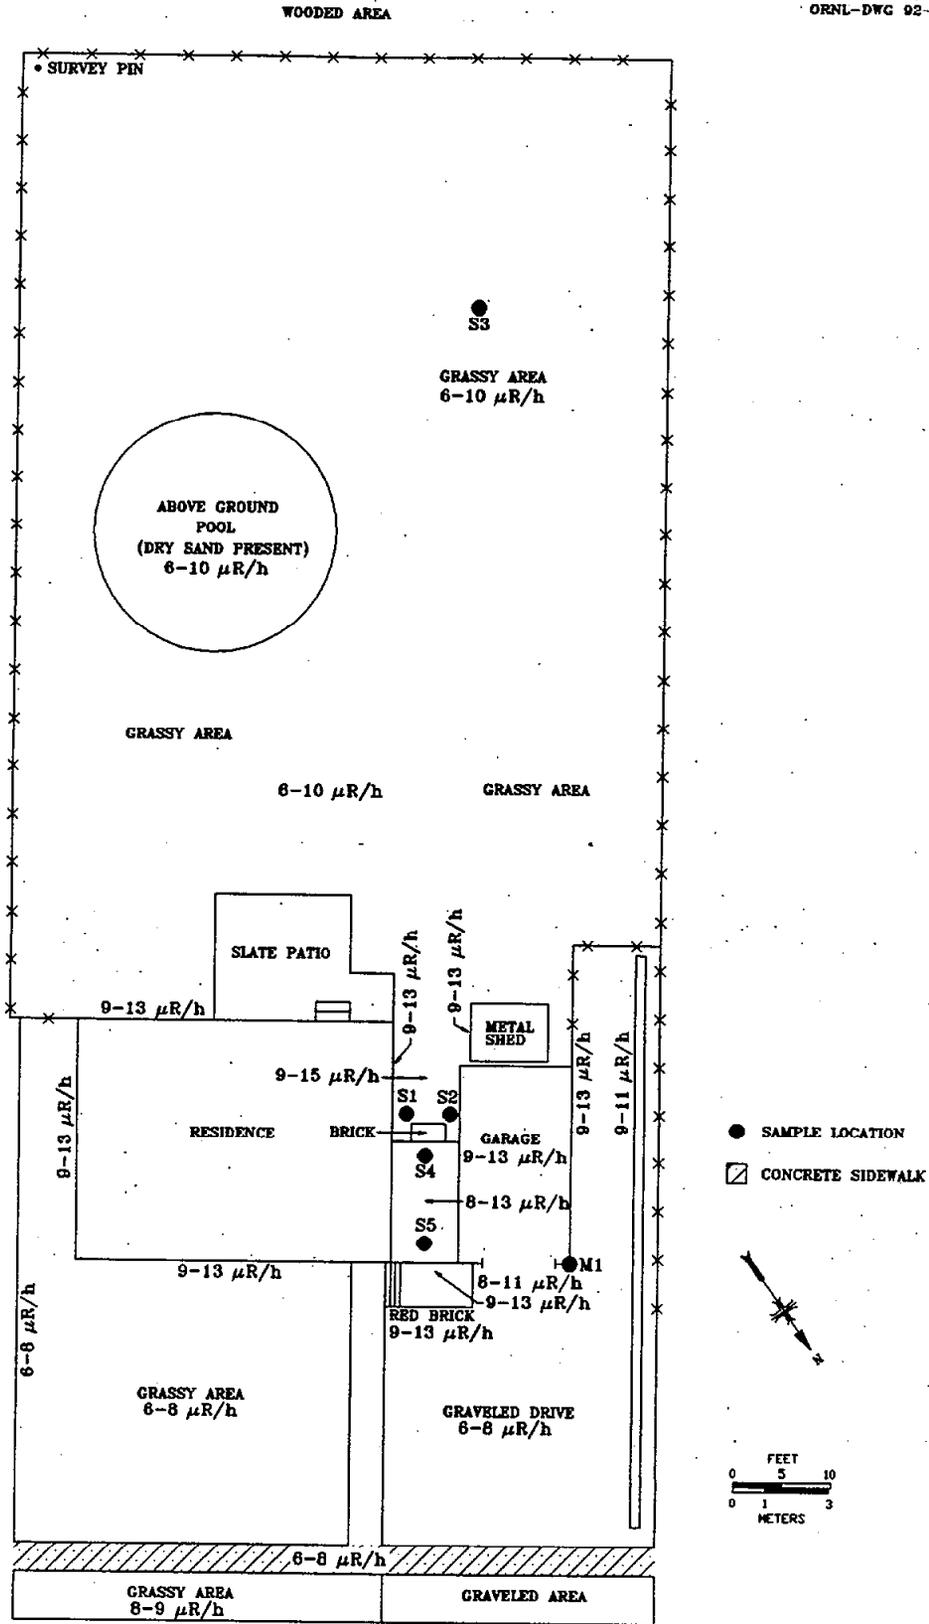
Fig. 1. Diagram of the property at 441 Central Ave., Hackensack, New Jersey (MJ053).

A field survey drawing indicating areas of elevated radiation measurements and radiological results is included in this report as Fig. 1.

Results of the surface gamma scan over the property are shown in Fig 1. Gamma measurements outside generally ranged from 6-10 $\mu\text{R/h}$ in both the front and back yards, and up to 11 $\mu\text{R/h}$ on contact with the slate walks. Ranges were from 9-13 $\mu\text{R/h}$ around the foundations and inside the sun porch and garage. Indoor gamma radiation limits set by DOE are 20 $\mu\text{R/h}$ above background. A maximum of 15 $\mu\text{R/h}$ was measured in the area outside the sun porch near the back entrance. This elevated gamma reading may be due to the natural activity in the cinder block foundation and the geometric effects of the small area.

Beta gamma dose rates taken around the foundations of the house and garage ranged from 0.01 to a maximum of 0.03 mrad/h. The maximum was measured on the front porch and on the gravel around the front of the garage. DOE guidelines limit the exposure to 0.2 mrad/h/m².

Surface and subsurface soil samples were collected from five areas on the property, two of which were samples obtained by drilling through the floor of the sun porch to the fill material below (S4 and S5). A sample of concrete chips was taken from the northwest corner of the garage just above the garage door.
