Maywood Chemical Company Superfund Site

Subject: Bechtel Job No. 14501, FUSRAP Project
DOE Contract No. DE-AC05-81OR20722
Radiological Characterization Report for New Jersey Route 17 in Rochelle Park, New Jersey
Code: 7310/WBS: 138

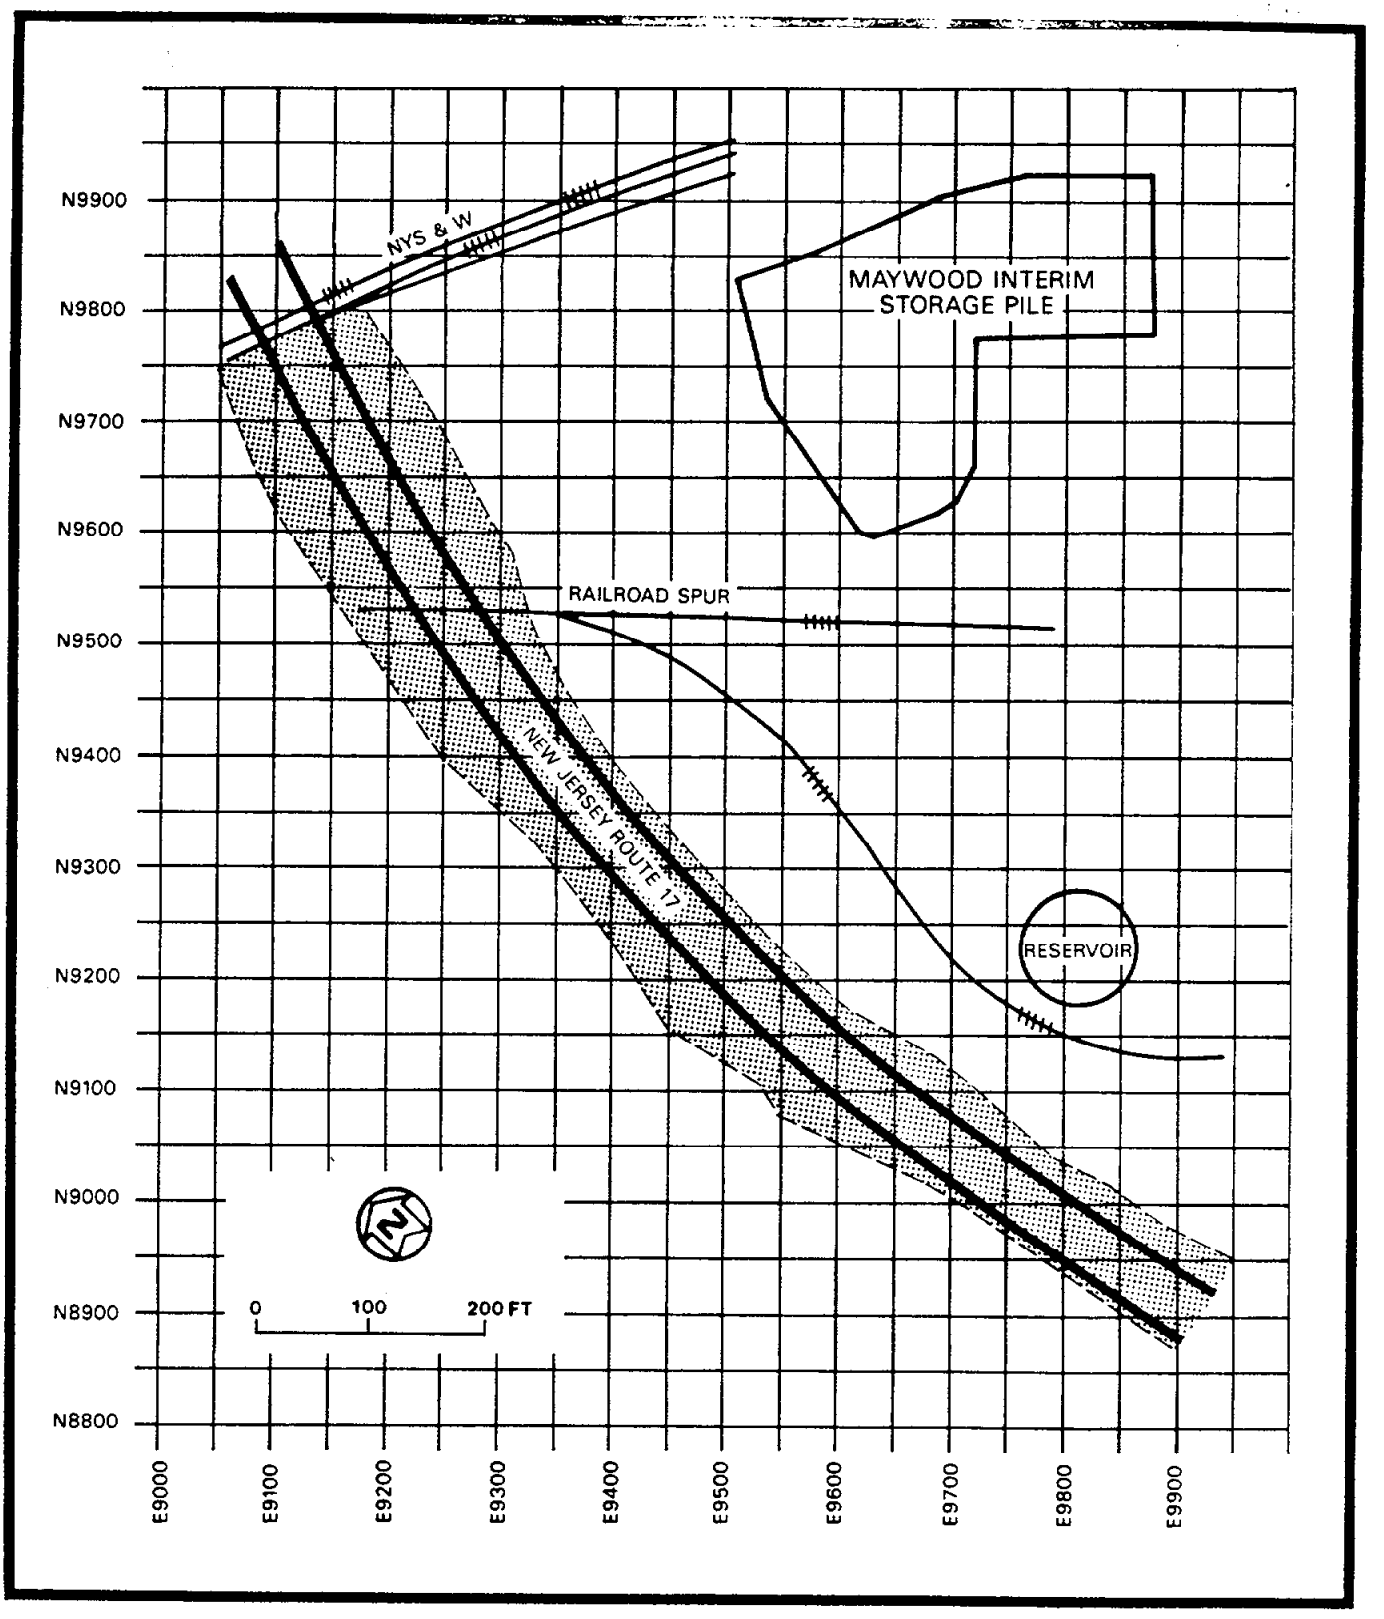
FIGURE 1 AREA OF ROUTE 17 CHARACTERIZATION

Route 17 borders the entire western boundary of the MISS. The section of Route 17 that was characterized is illustrated in Figure 1; it extends along Route 17 from the intersection of the New York, Susquehanna, and Western (NYS&W) Railroad and Route 17, south to Grove Avenue.

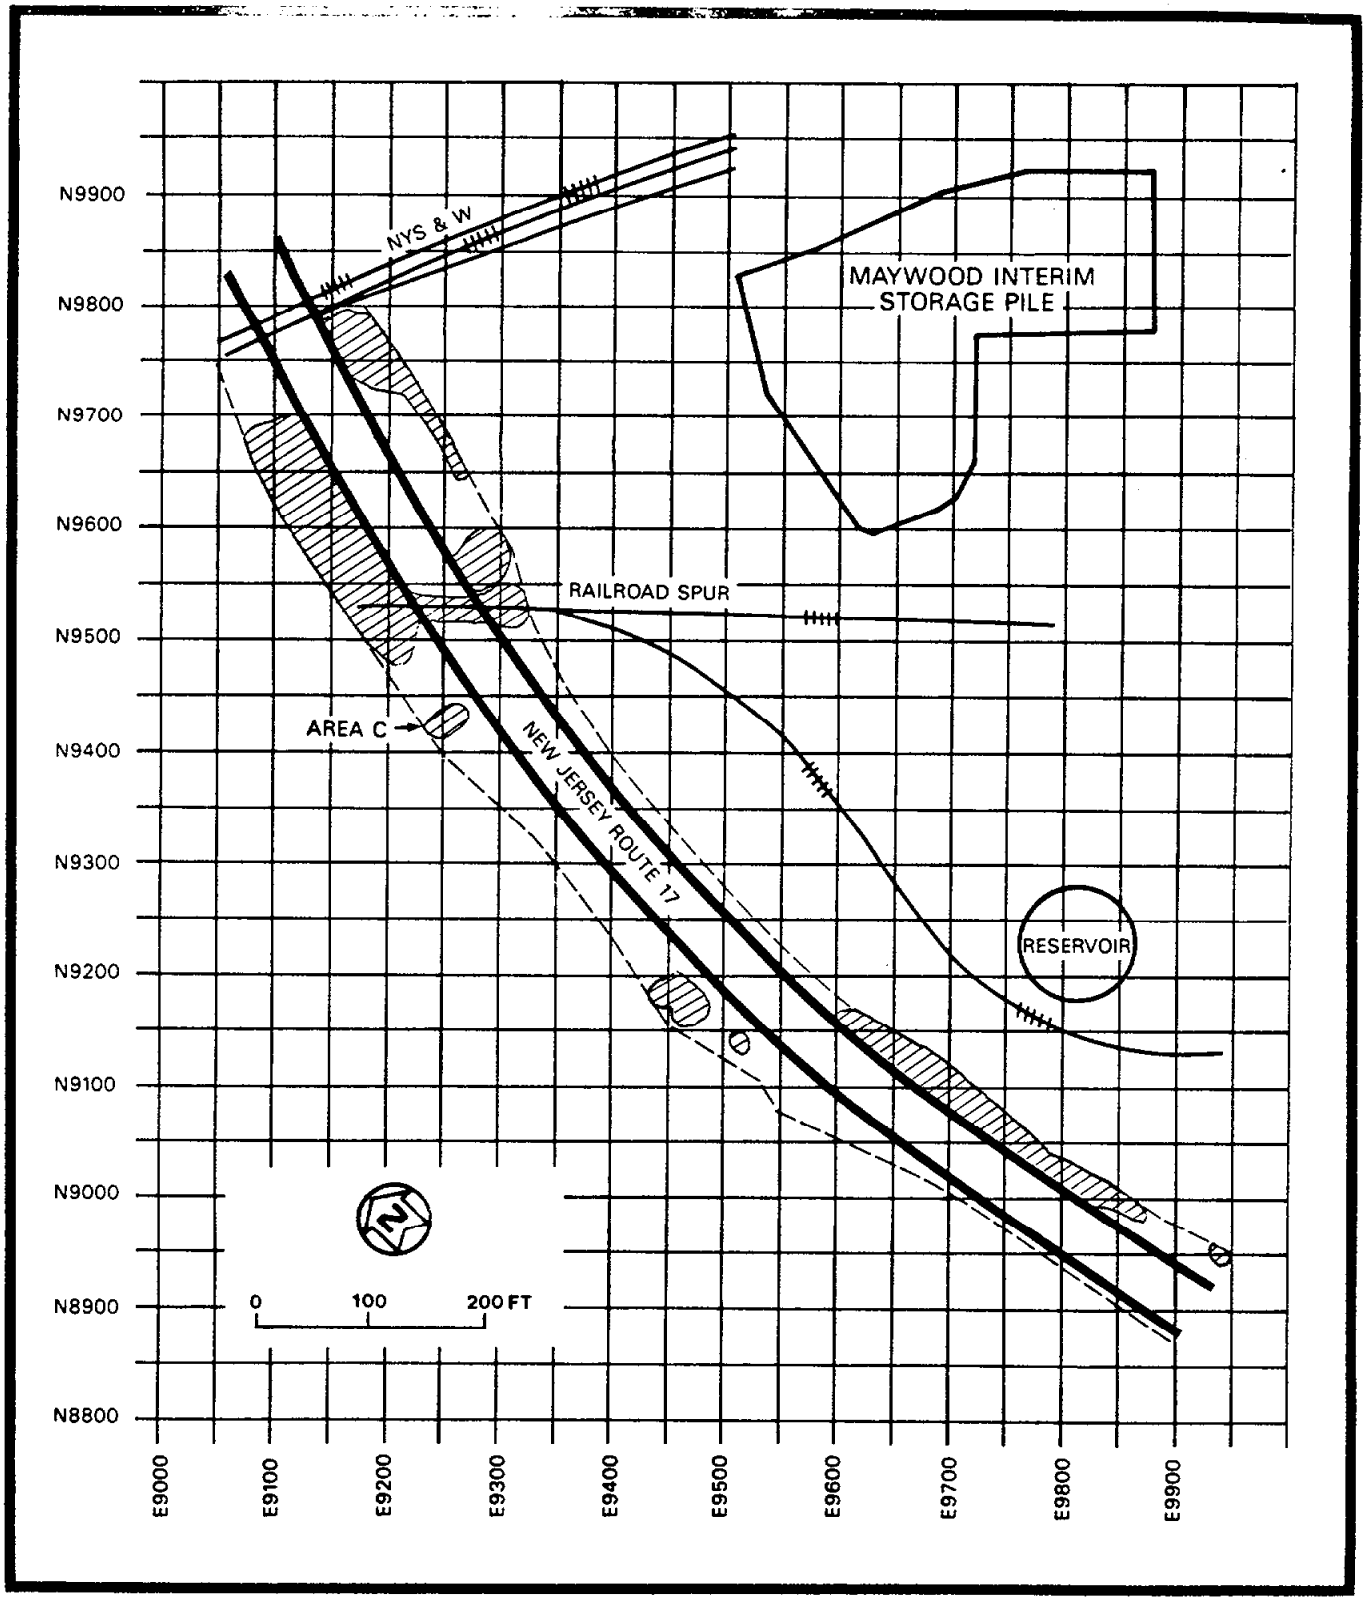
FIGURE 2 BOUNDARIES OF THE SURFACE CONTAMINATION ON THE EMBANKMENTS OF ROUTE 17

The areas with surface contamination found during this survey are shown in Figure 2. The data in Table 1 show the concentrations of thorium-232 in the surface soil samples; the concentrations ranged from 0.9 to 17.7 pCi/g. The sampling locations are shown in Figure 3. Because soil samples were taken from locations where the measurement was at or near the guideline, it should be noted that not all soil samples indicated contamination. Data from the shielded detector establish that the contamination ranges from a background level to approximately 90 pCi/g. An evaluation of the data indicates approximately 1500 yd^3 of surface soil is contaminated.

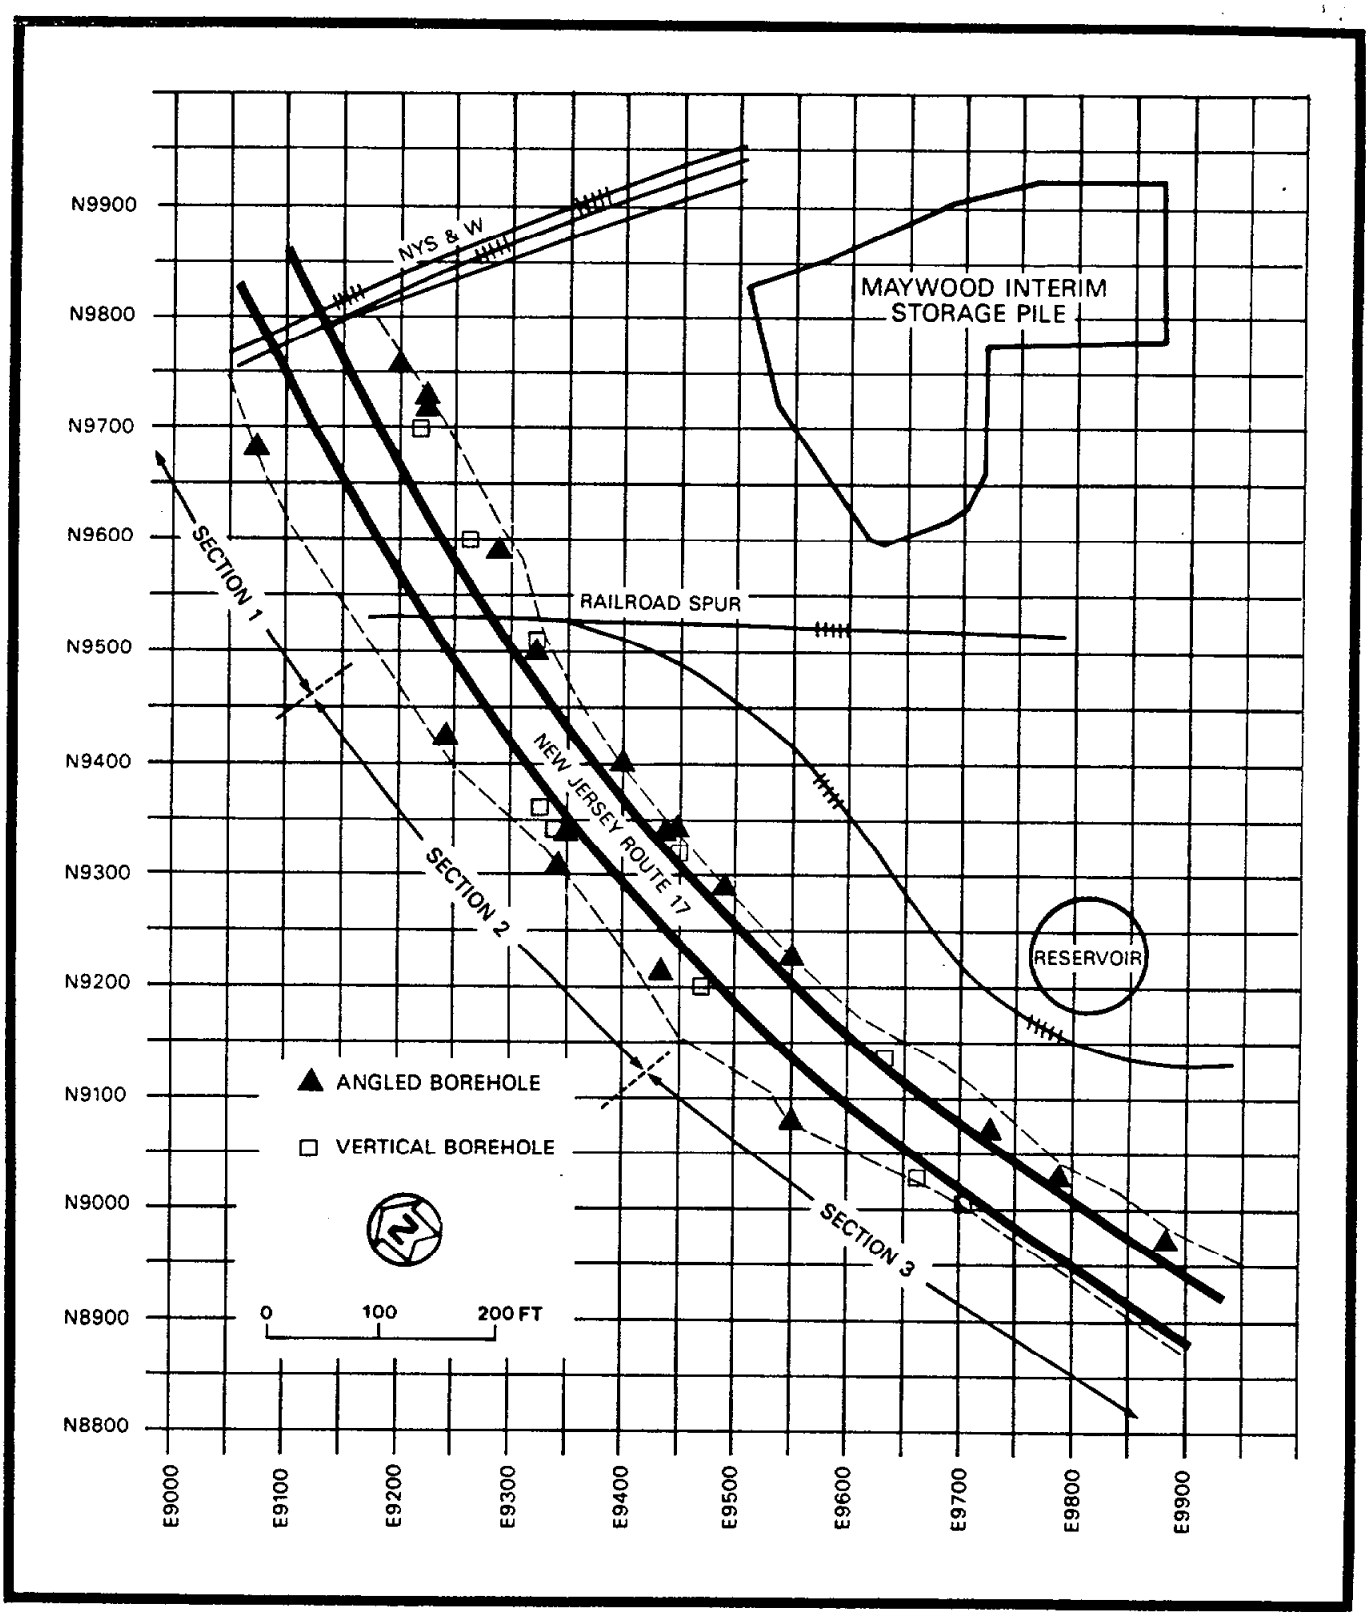
FIGURE 4 ANGLED AND VERTICAL BOREHOLE LOCATIONS ALONG ROUTE 17

The high embankment south of the main NYS&W railroad undercrossing (shown as Section 1 in Figure 4) was constructed primarily of sand with occasional cobbles. Cobbles are found on the slope where the sand matrix appears to have eroded leaving them exposed, although the cobbles were seldom encountered during drilling. The sand

The intermediate section of the embankment, south of the railroad spur undercrossing (shown as Section 2 in Figure 4), is 10 to 15 ft high. The construction materials used in this section were sands with some silt. The upper materials were dry, but locally damp to moist zones were encountered. As the auger approached the elevation of the basal interface, the embankment materials became notably wetter. Intermixing of sludge materials into the embankment sands was visible near the interface.

The low embankment section (shown as Section 3 in Figure 4) is 1 to 3 ft high and was constructed of a dark, sticky, silty sand. Local clay zones are present and suggest that construction procedures did not require intermixing or blending of individual truck loads of material during placement. The upper layers of the low embankment are gravels, probably because they are part of the road base sequence. Water was encountered in the angle holes drilled into the low embankment. The embankment materials were wet, grading to saturation. It is possible that water, which accumulates on the east or uphill side of the highway during precipitation events, migrates downgradient through this section of the embankment.

During the course of the subsurface investigation, 19 angled and 10 vertical holes were drilled and gamma logged to determine the depth and approximate concentration of radioactive contamination along Route 17. Borehole locations are shown in Figure 4 (boring logs for these holes will be included in the MISS characterization report). The lengths of the angled boreholes ranged from 30 to 79 ft; the depths of the vertical boreholes ranged from 3 to 6 ft. Gamma logging data for the angled boreholes are given in Table 2, and in Table 3 for the vertical boreholes. The borehole logs were reviewed to identify trends, regardless of whether concentrations exceeded the DOE guidelines.

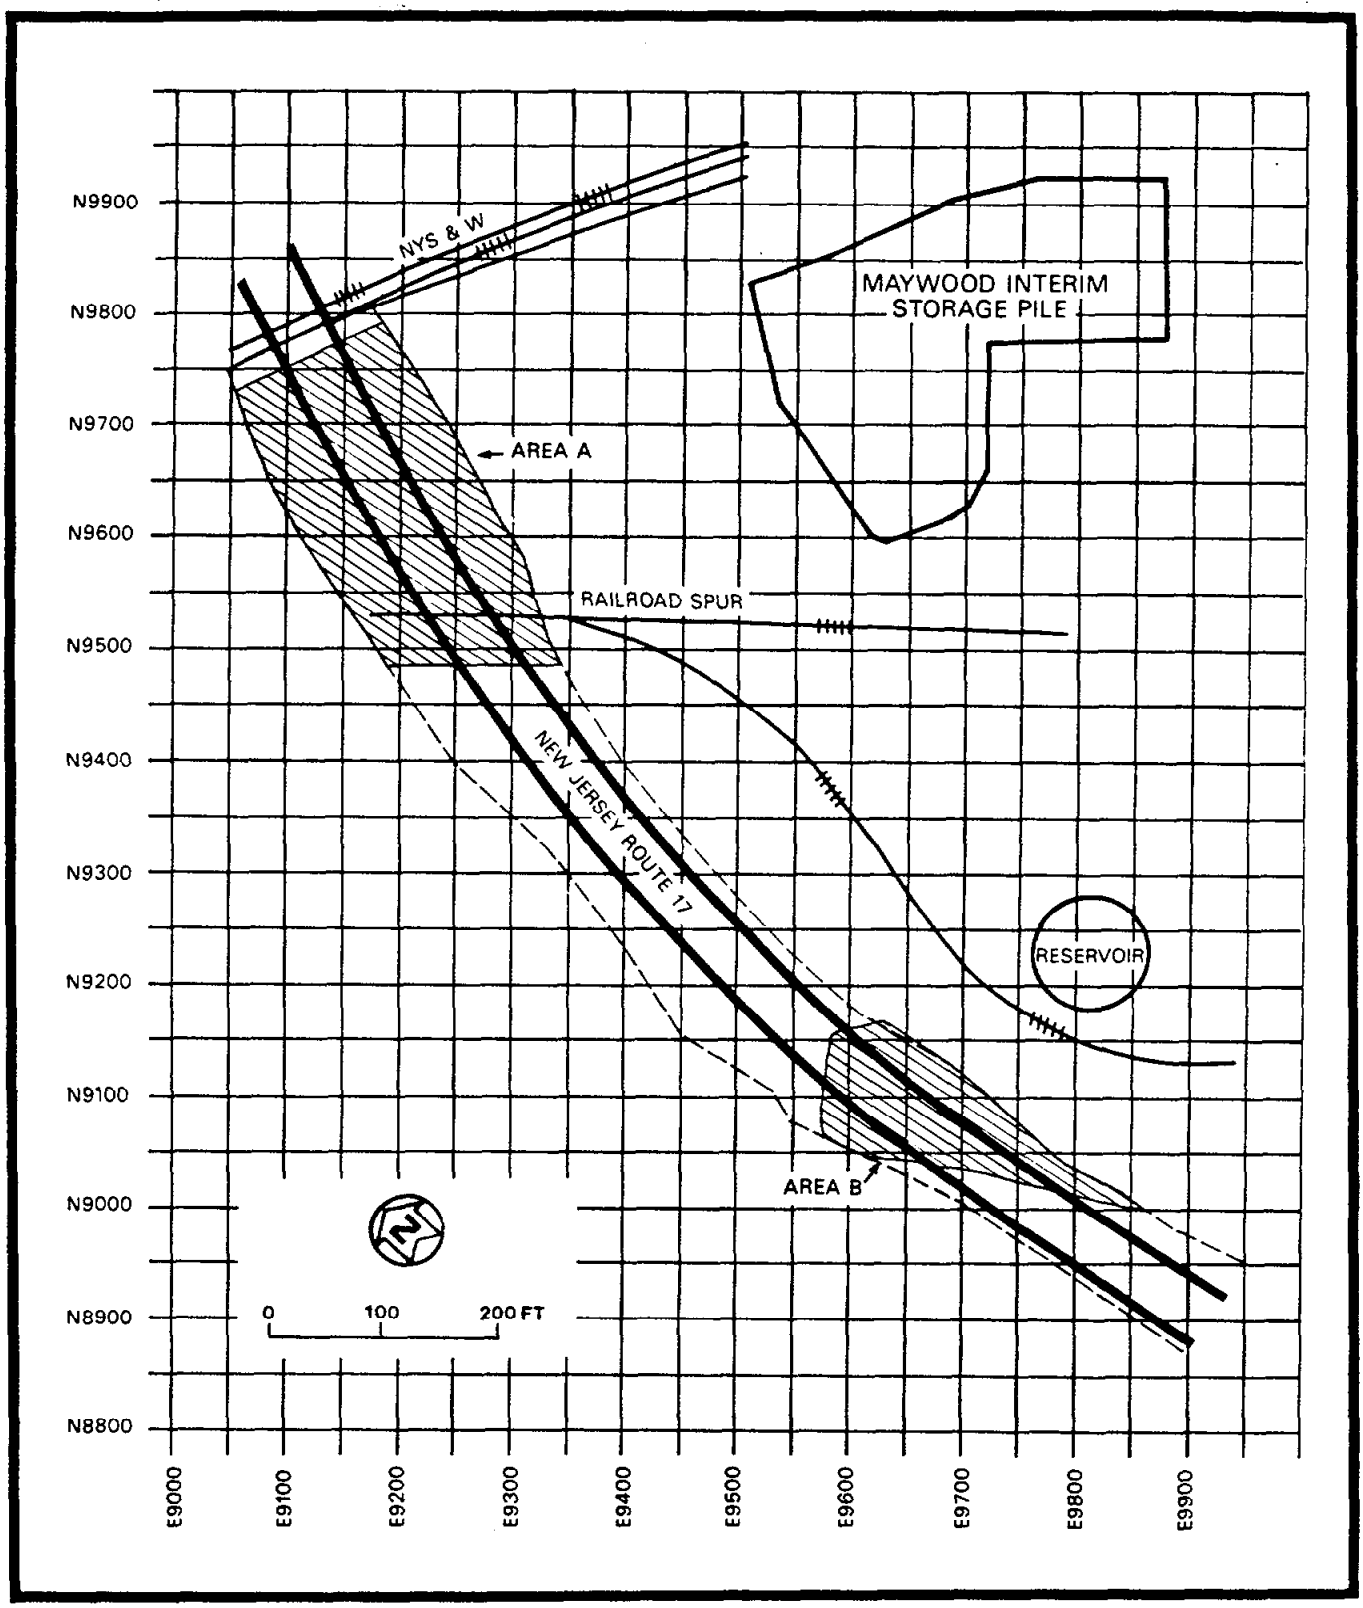
FIGURE 5 LOCATION OF FORMER RETENTION PONDS UNDER ROUTE 17

Route 17 was constructed in 1932 through an area formerly owned by the Maywood Chemical Works; the road divided the Maywood Chemical Works property, and was built over two areas previously used as retention ponds to store process residues. These residues resulted from operations conducted by the Maywood Chemical Works to extract thorium from monazite sands, and were buried or otherwise deposited at various locations on the property, including the two retention ponds. The primary contaminant in the residues is thorium-232. Previous investigations by the New Jersey Department of Environmental Protection, the Nuclear Regulatory Commission, H.W. Morton (a consultant to the Stepan Company), the Environmental Protection Agency, and BNI have detected concentrations of thorium-232 and radium-226 exceeding DOE guidelines and unacceptable levels of uranium-238 along the section of Route 17 that is contiguous with the MISS.
