DOE/OR/20722-172

RADIOLOGICAL CHARACTERIZATION REPORT FOR THE RESIDENTIAL PROPERTY AT 22 LONG VALLEY ROAD

Lodi, New Jersey

November 1988

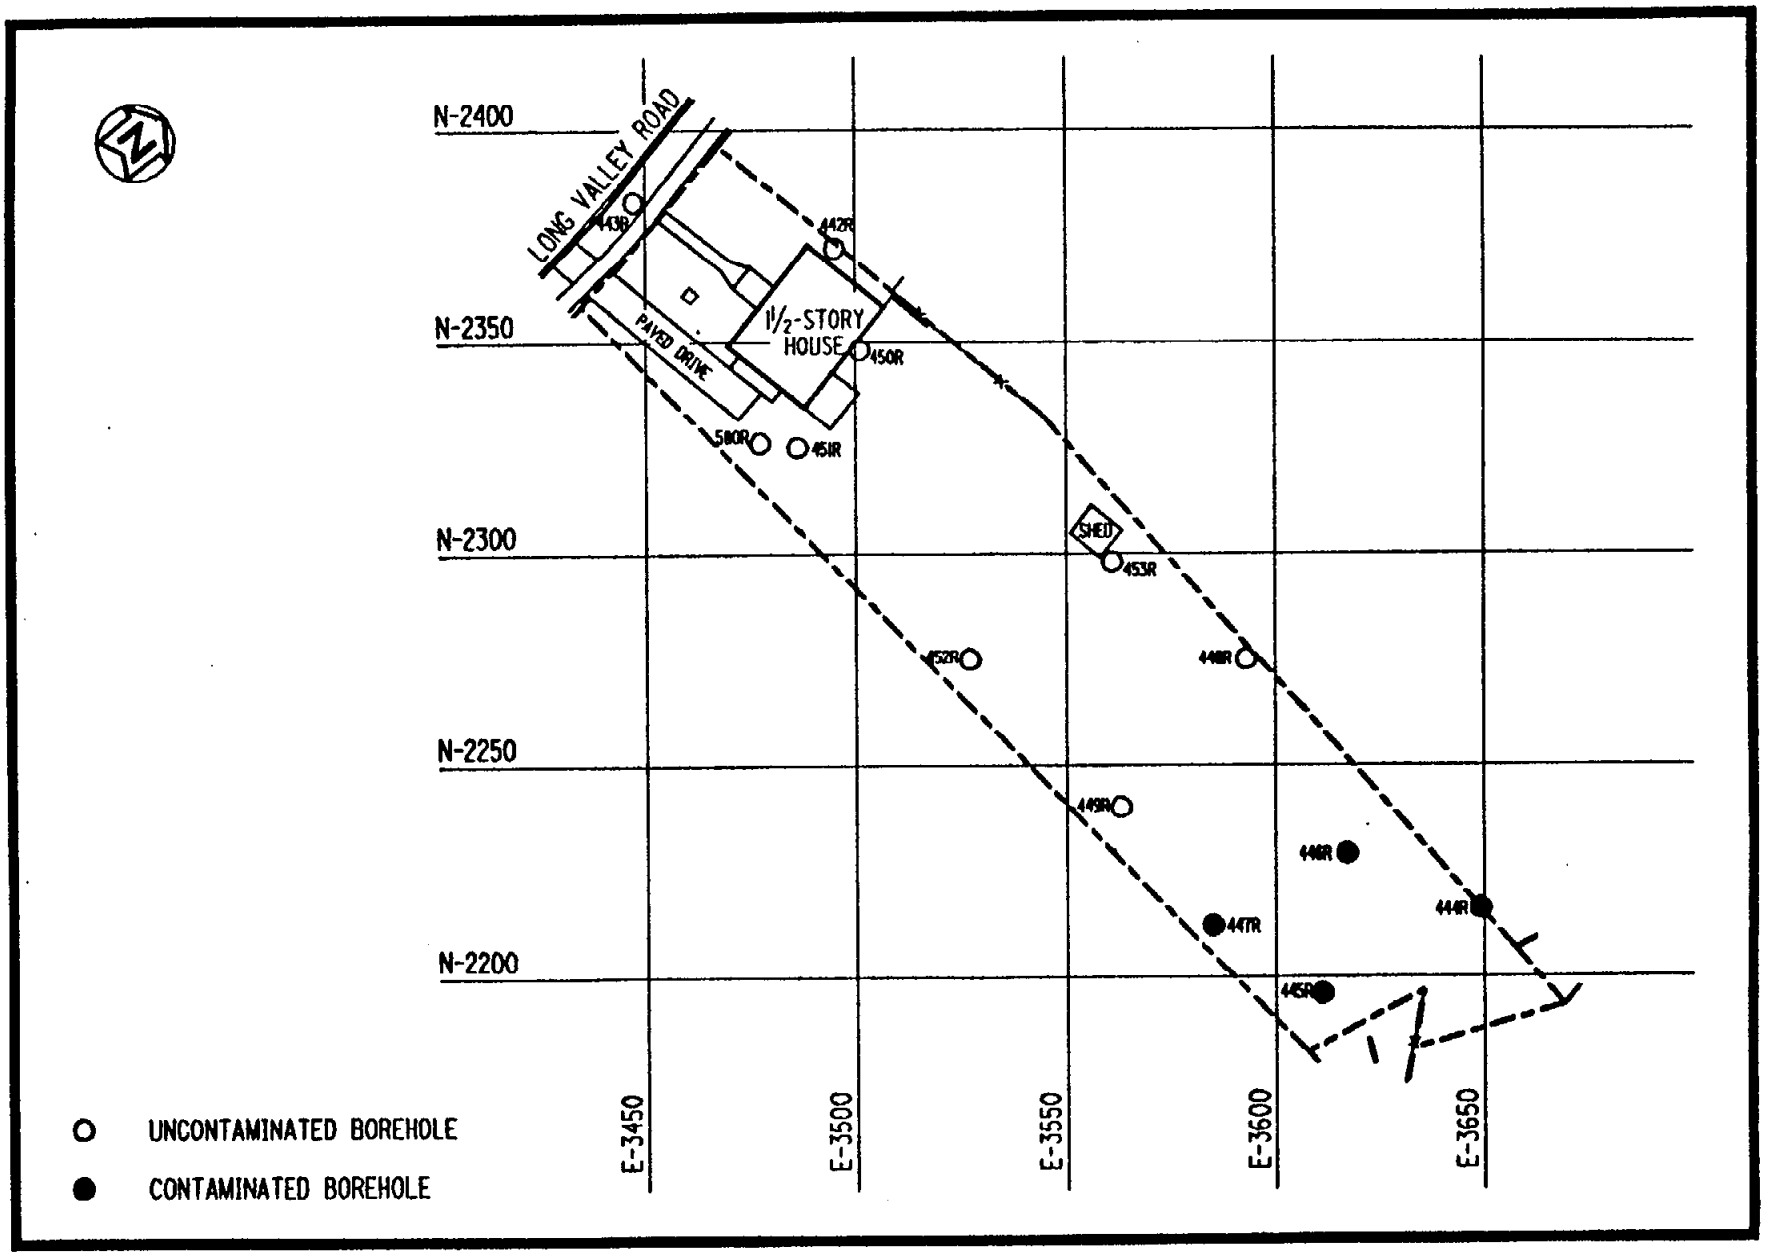
FIGURE 4-1 BOREHOLE LOCATIONS AT 22 LONG VALLEY ROAD

locate subsurface contamination where there is no surface manifestation. The subsurface characterization consisted of drilling and gamma logging 13 boreholes (Figure 4-1) using either a 3-in.- or 6-in.-diameter auger bit; holes were drilled to depths determined in the field by the radiological and geological support representatives.

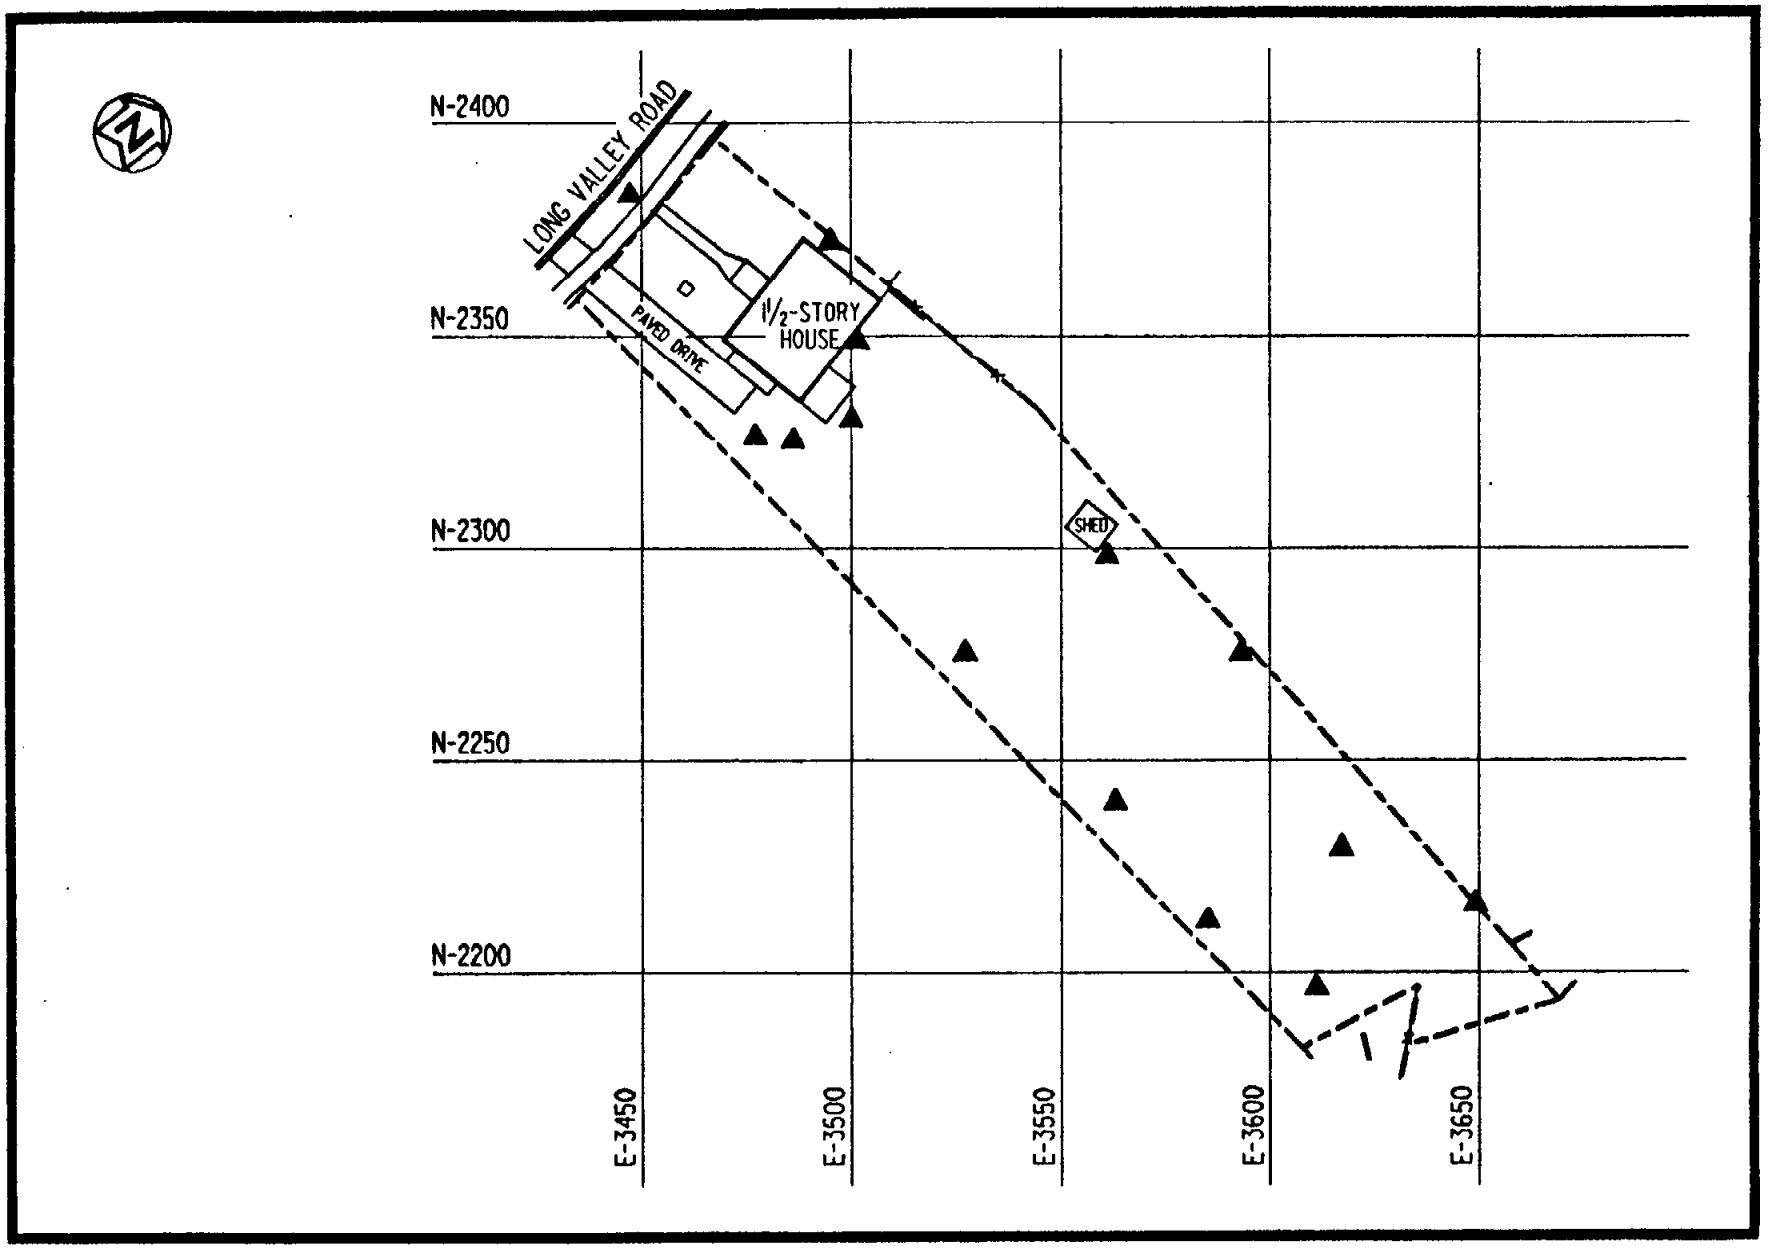
FIGURE 4-2 SURFACE AND SUBSURFACE SOIL SAMPLING LOCATIONS AT 22 LONG VALLEY ROAD

Surface soil samples were taken from 13 locations on the property (Figure 4-2). These samples were analyzed for thorium-232 and radium-226. The concentrations in these samples ranged from 1.5 to 63.9 pCi/g for thorium-232 and from 0.8 to 5.5 pCi/g for radium-226. Analysis results for surface soils (from 0.0 to 0.5 ft) are provided in Table 5-1. Results showed concentrations of thorium-232 in excess of DOE guidelines (5 pCi/g plus background of 1 pCi/g for surface soils) with a maximum concentration of 63.9 pCi/g. Use of the "less than" (<) notation in reporting results indicates that the radionuclide was not present in concentrations that are quantitative with the instruments and techniques used. The "less than" value represents the lower bound of the quantitative capacity of the instrument and technique used and is based on various factors, including the volume, size, and weight of the sample; the type of detector used; the counting time, and the background count rate. The actual concentration of the radionuclide is less than the value indicated. In addition, since radioactive decay is a random process, a correlation between the rate of disintegration and a given radionuclide concentration cannot be precisely established. For this reason, the exact concentration of the radionuclide cannot be determined. As such, each value that can be quantitatively determined has an associated uncertainty

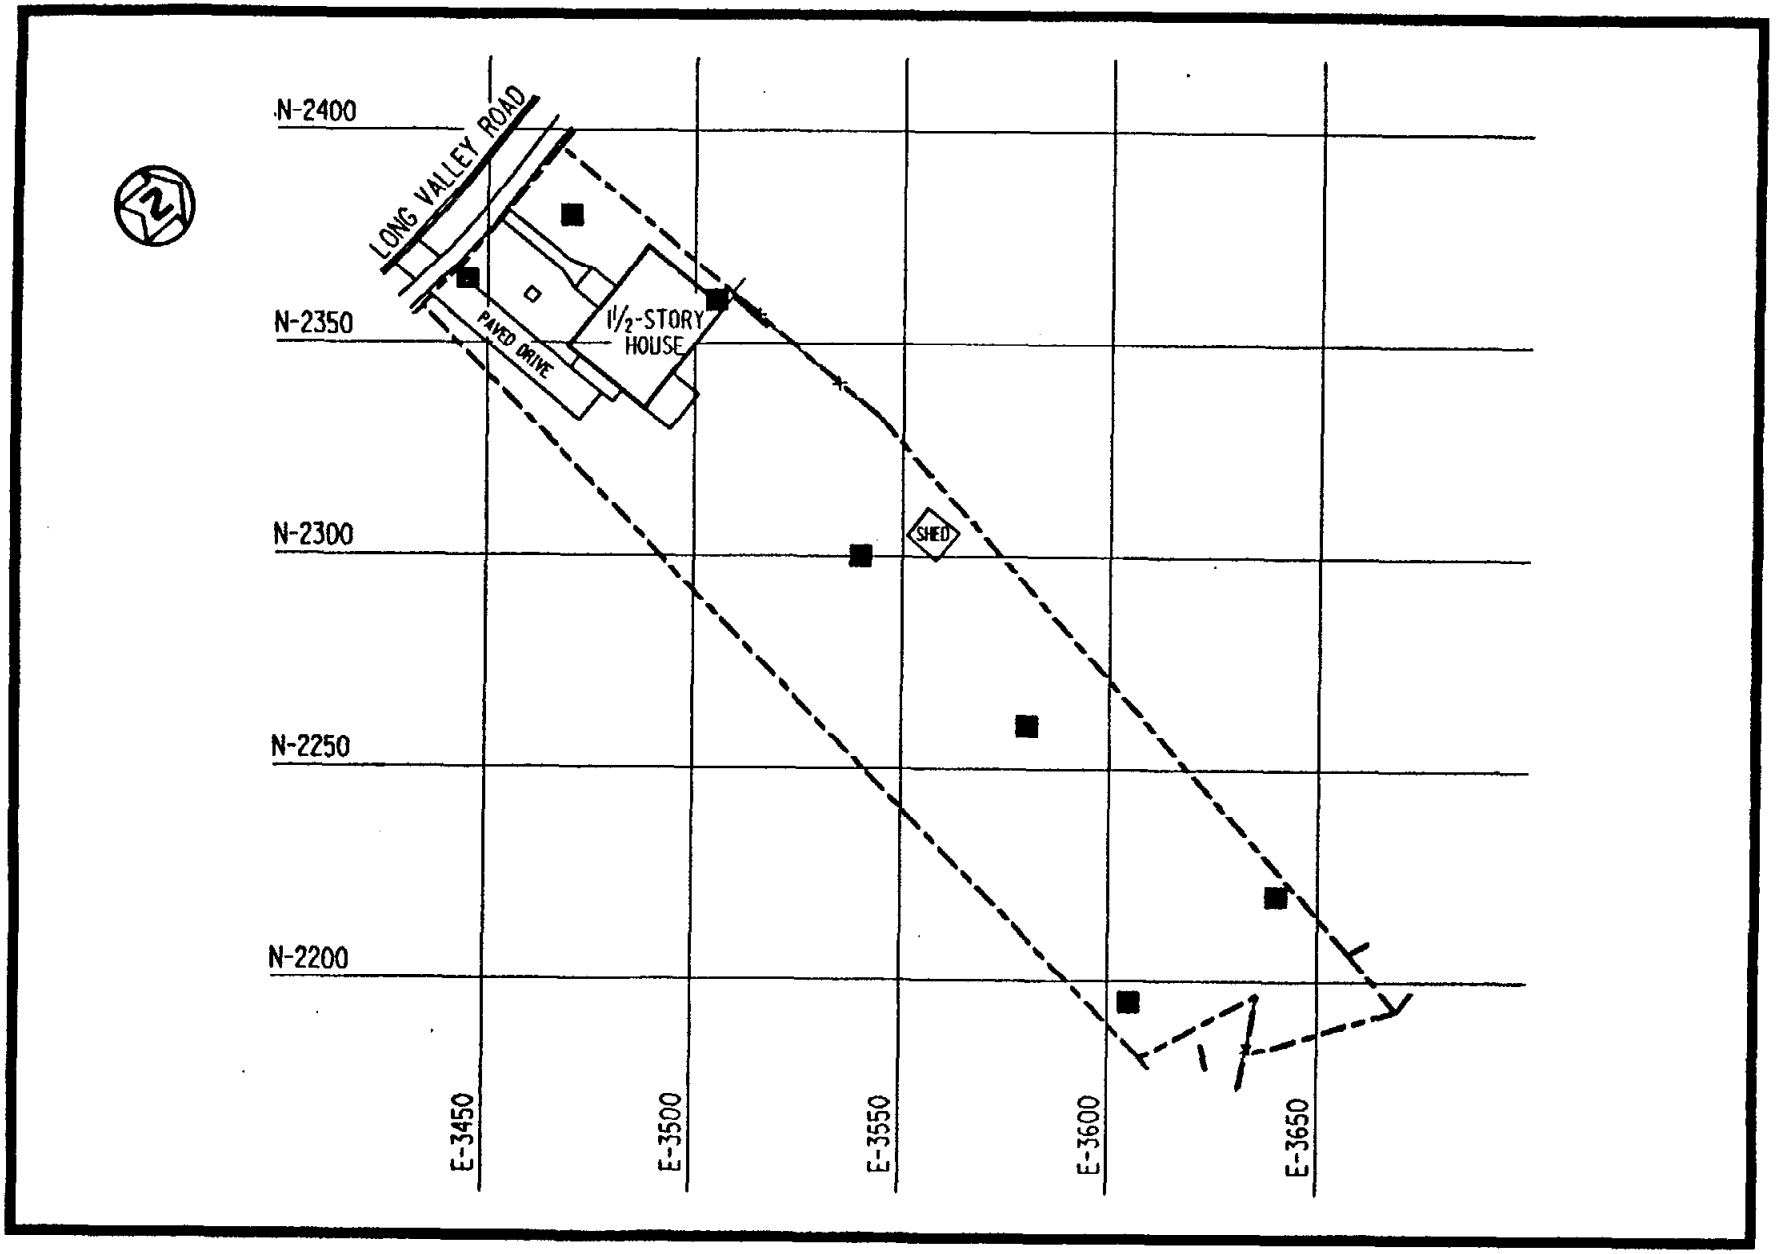
FIGURE 4-3 EXPOSURE RATE MEASUREMENT LOCATIONS AT 22 LONG VALLEY ROAD

Exterior gamma radiation exposure measurements ranged from 8 to 36 μR/h, including background. The highest gamma exposure rate was measured in the area where the surface soil sample result for thorium-232 was also the highest (27.7 pCi/g). The indoor exposure rate measurement was 6 μR/h, including background.

Exterior gamma exposure rate measurements were made at seven locations throughout the property grid system using either a 2-in. by 2-in. thallium-activated sodium iodide gamma scintillation detector used to detect gamma radiation only, or a pressurized ionization chamber (PIC) (Figure 4-3). The PIC instrument has a response to gamma radiation that is proportional to exposure in roentgens. A conversion factor for gamma scintillation to the PIC was established through a correlation of these two measurements at four locations in the vicinity of the property. The unshielded gamma scintillation detector readings were then used to estimate gamma exposure rates for each location. These measurements were taken 3 ft above the ground, and the locations were determined to be representative of the entire property. Interior measurements are generally obtained with the gamma scintillation instrument rather than the PIC because of its smaller size and the desire to minimize the technician's time inside the residence.

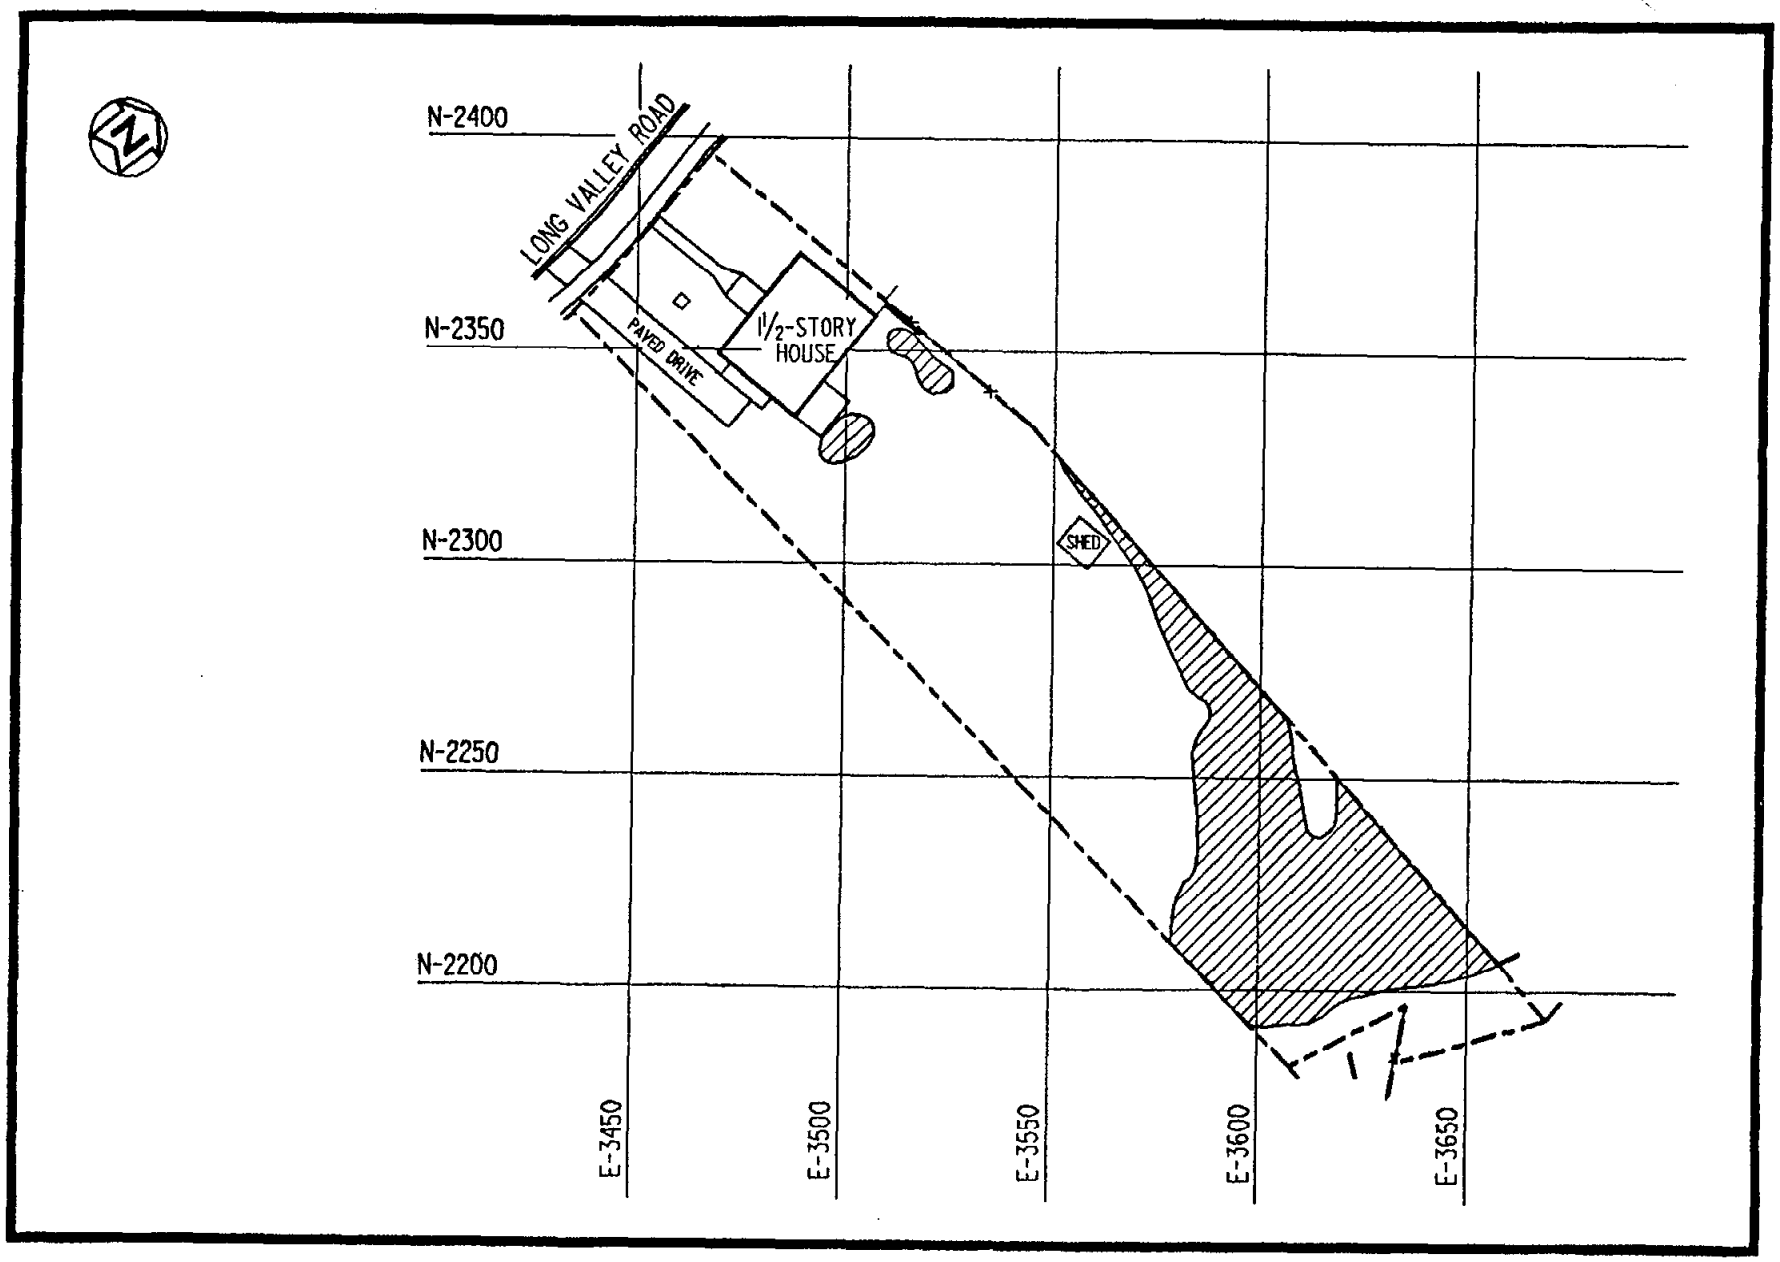
FIGURE 5-1 AREAS OF SURFACE CONTAMINATION AT 22 LONG VALLEY ROAD

Near-surface gamma radiation measurements on the property ranged from 3,800 cpm to approximately 124,000 cpm. The average background level for this area is 5,000 cpm. A measurement of 11,000 cpm is approximately equal to the DOE guideline for thorium-232 of 5 pCi/g above background for surface soil contamination. Using this correlation, the near-surface gamma measurements were used to determine the extent of surface contamination as well as the basis for selecting the locations of soil samples. Areas of surface contamination are shown in Figure 5-1.

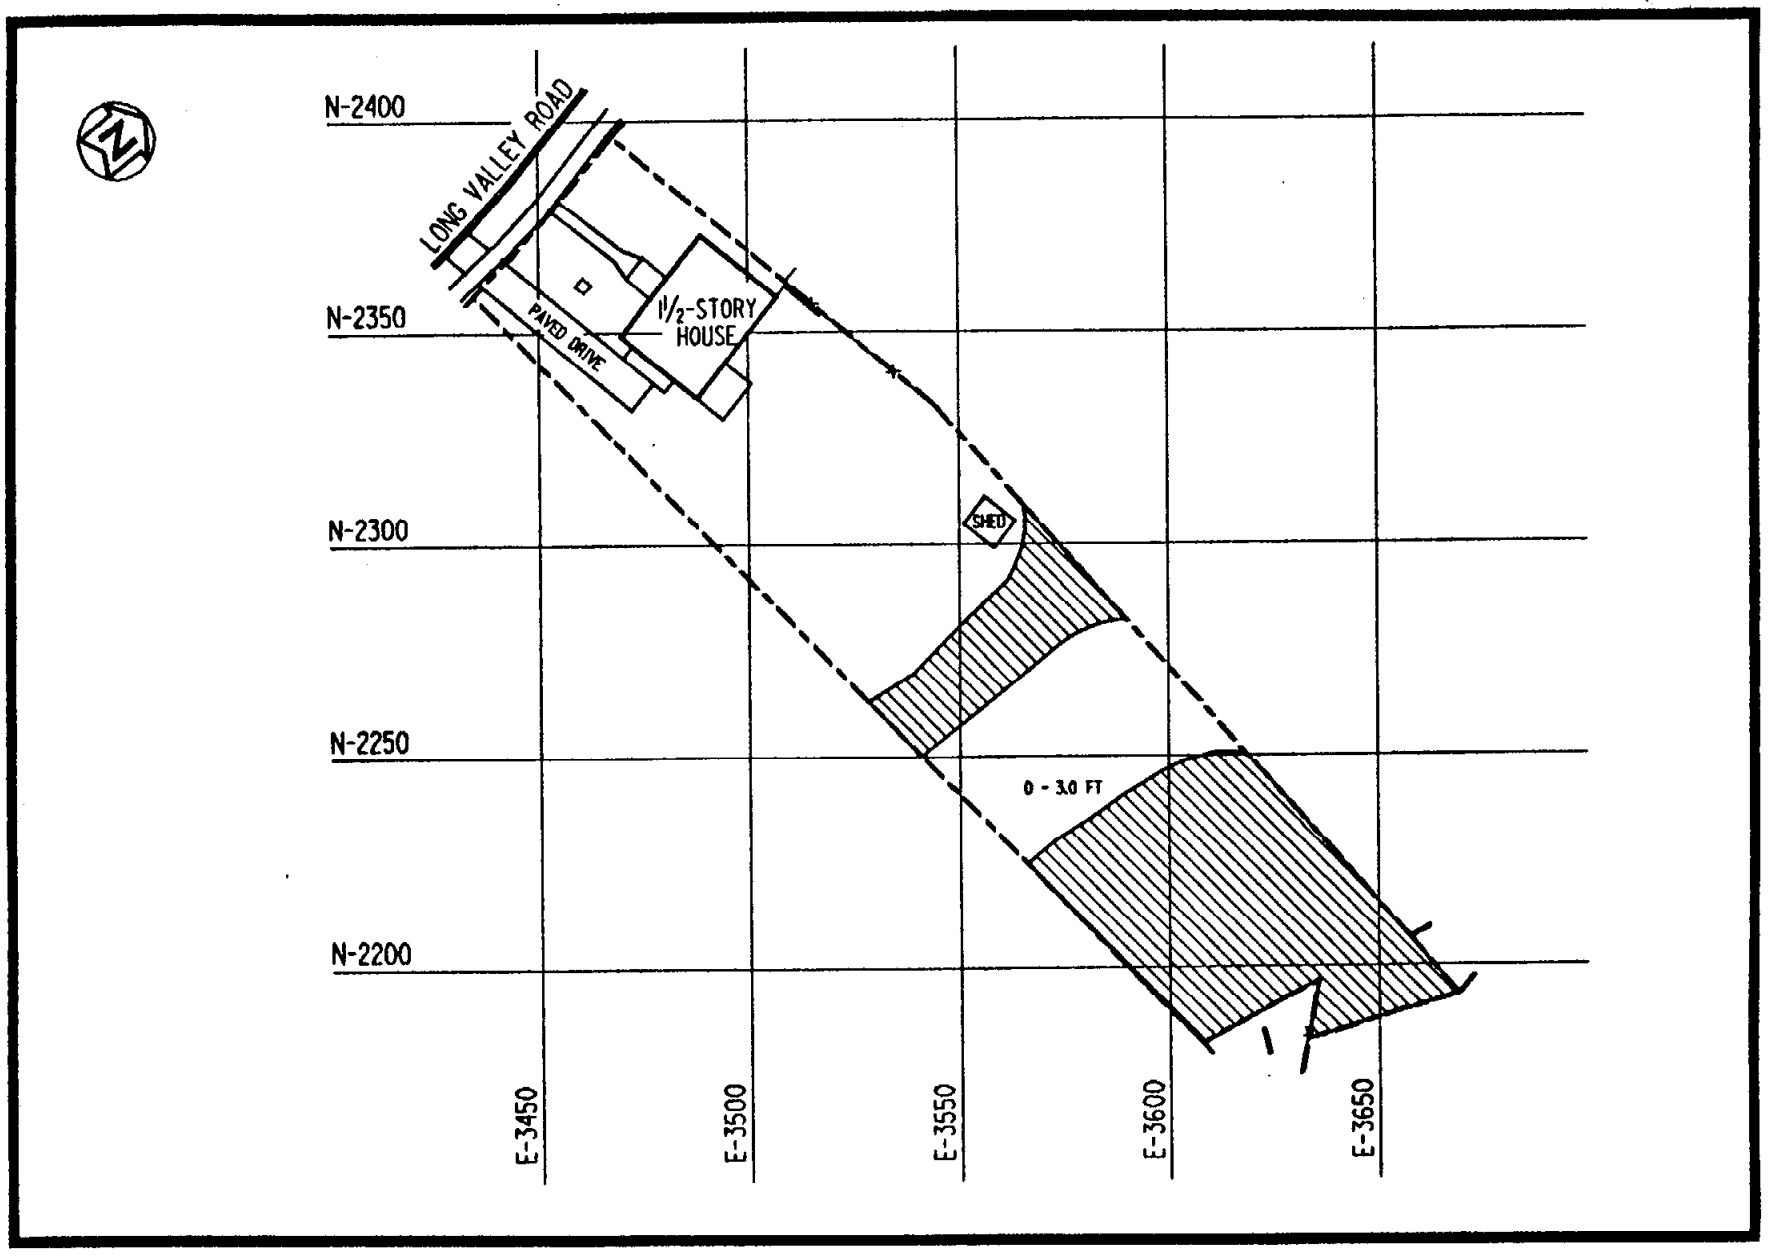
FIGURE 5-2 AREAS OF SUBSURFACE CONTAMINATION AT 22 LONG VALLEY ROAD

Soil analysis data for this property showed surface contamination. Subsurface investigation by gamma logging indicated contamination to a depth of 3.0 ft.
