DOE/OR/20722-174

RADIOLOGICAL CHARACTERIZATION REPORT FOR THE RESIDENTIAL PROPERTY AT 11 REDSTONE LANE

Lodi, New Jersey

November 1988

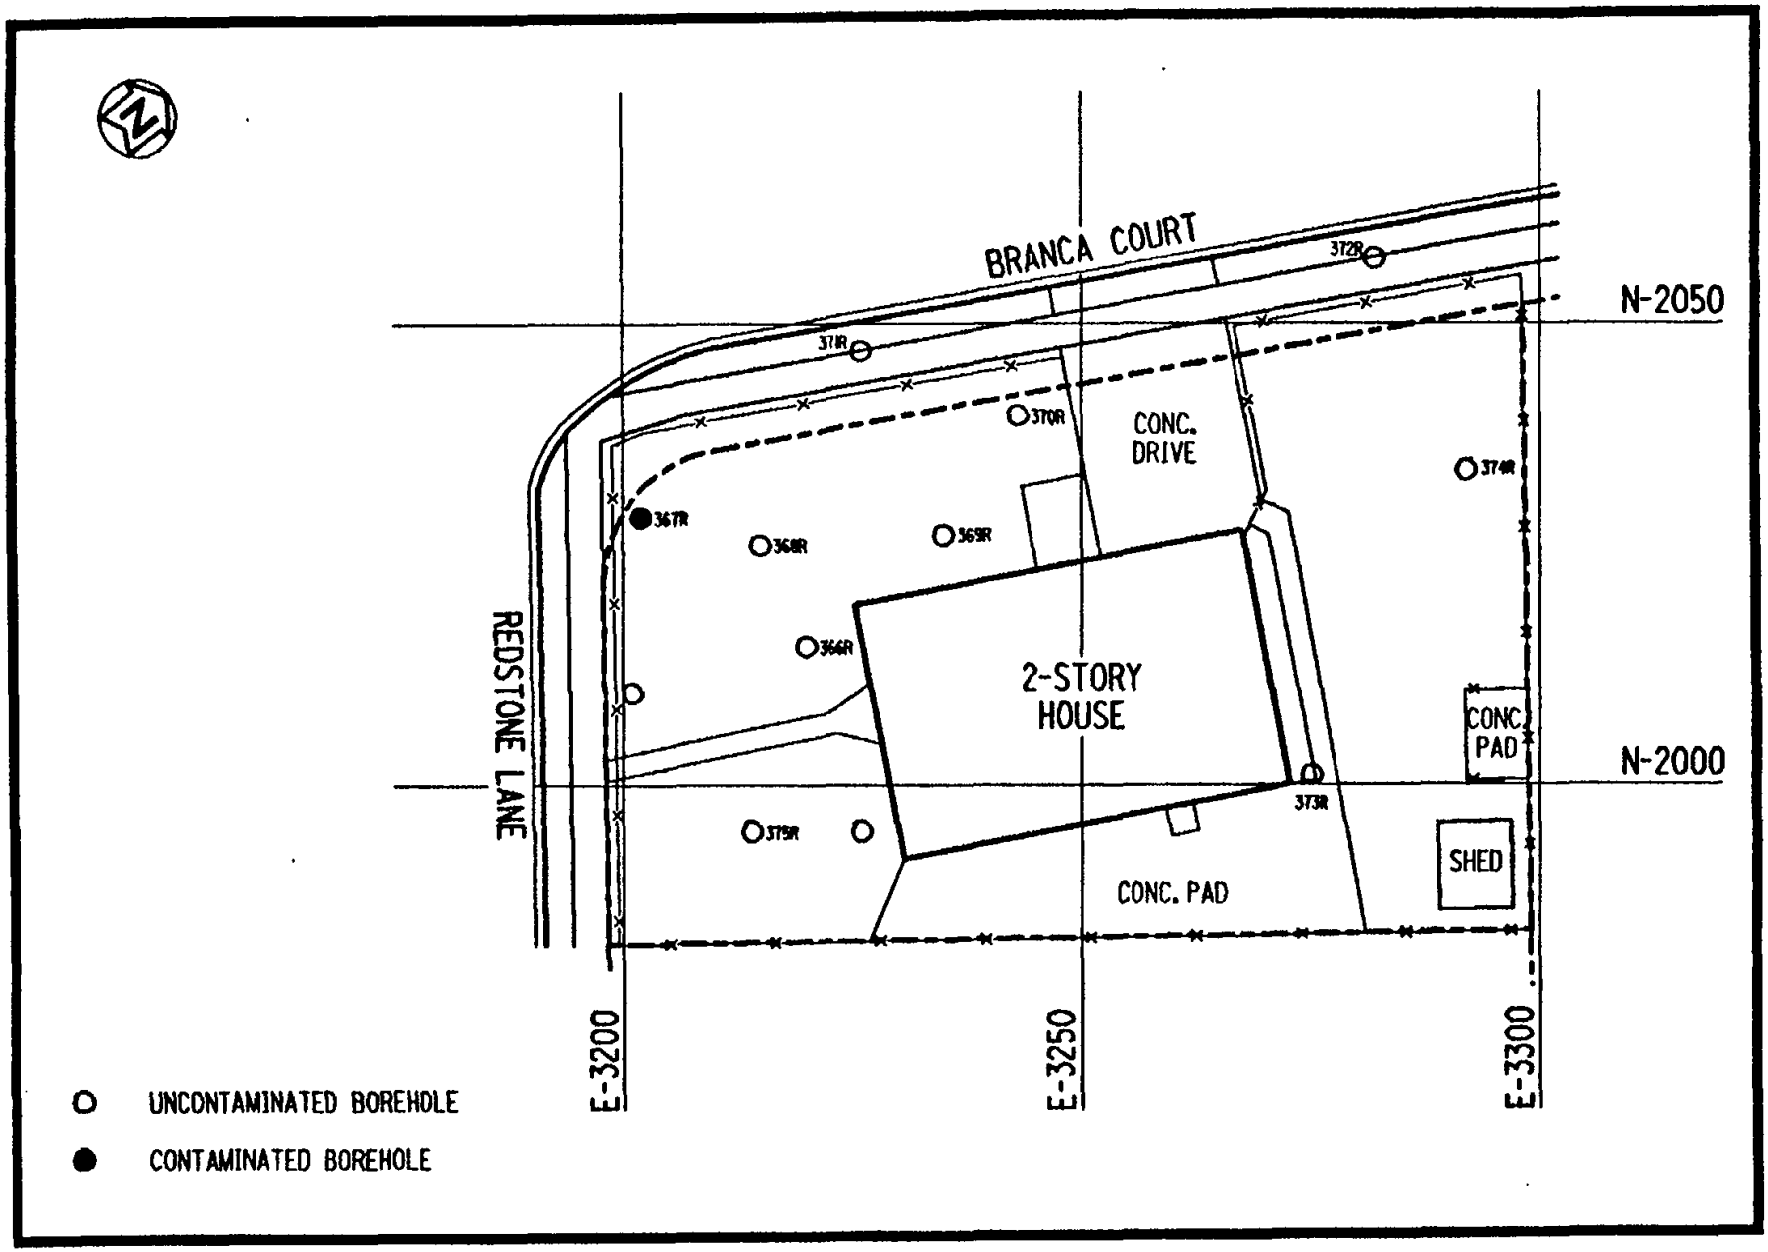
FIGURE 4-1 BOREHOLE LOCATIONS AT 11 REDSTONE LANE

locate subsurface contamination where there is no surface manifestation. The subsurface characterization consisted of drilling and gamma logging 12 boreholes (Figure 4-1) using either a 3-in.- or 6-in.-diameter auger bit; holes were drilled to depths determined in the field by the radiological and geological support representatives.

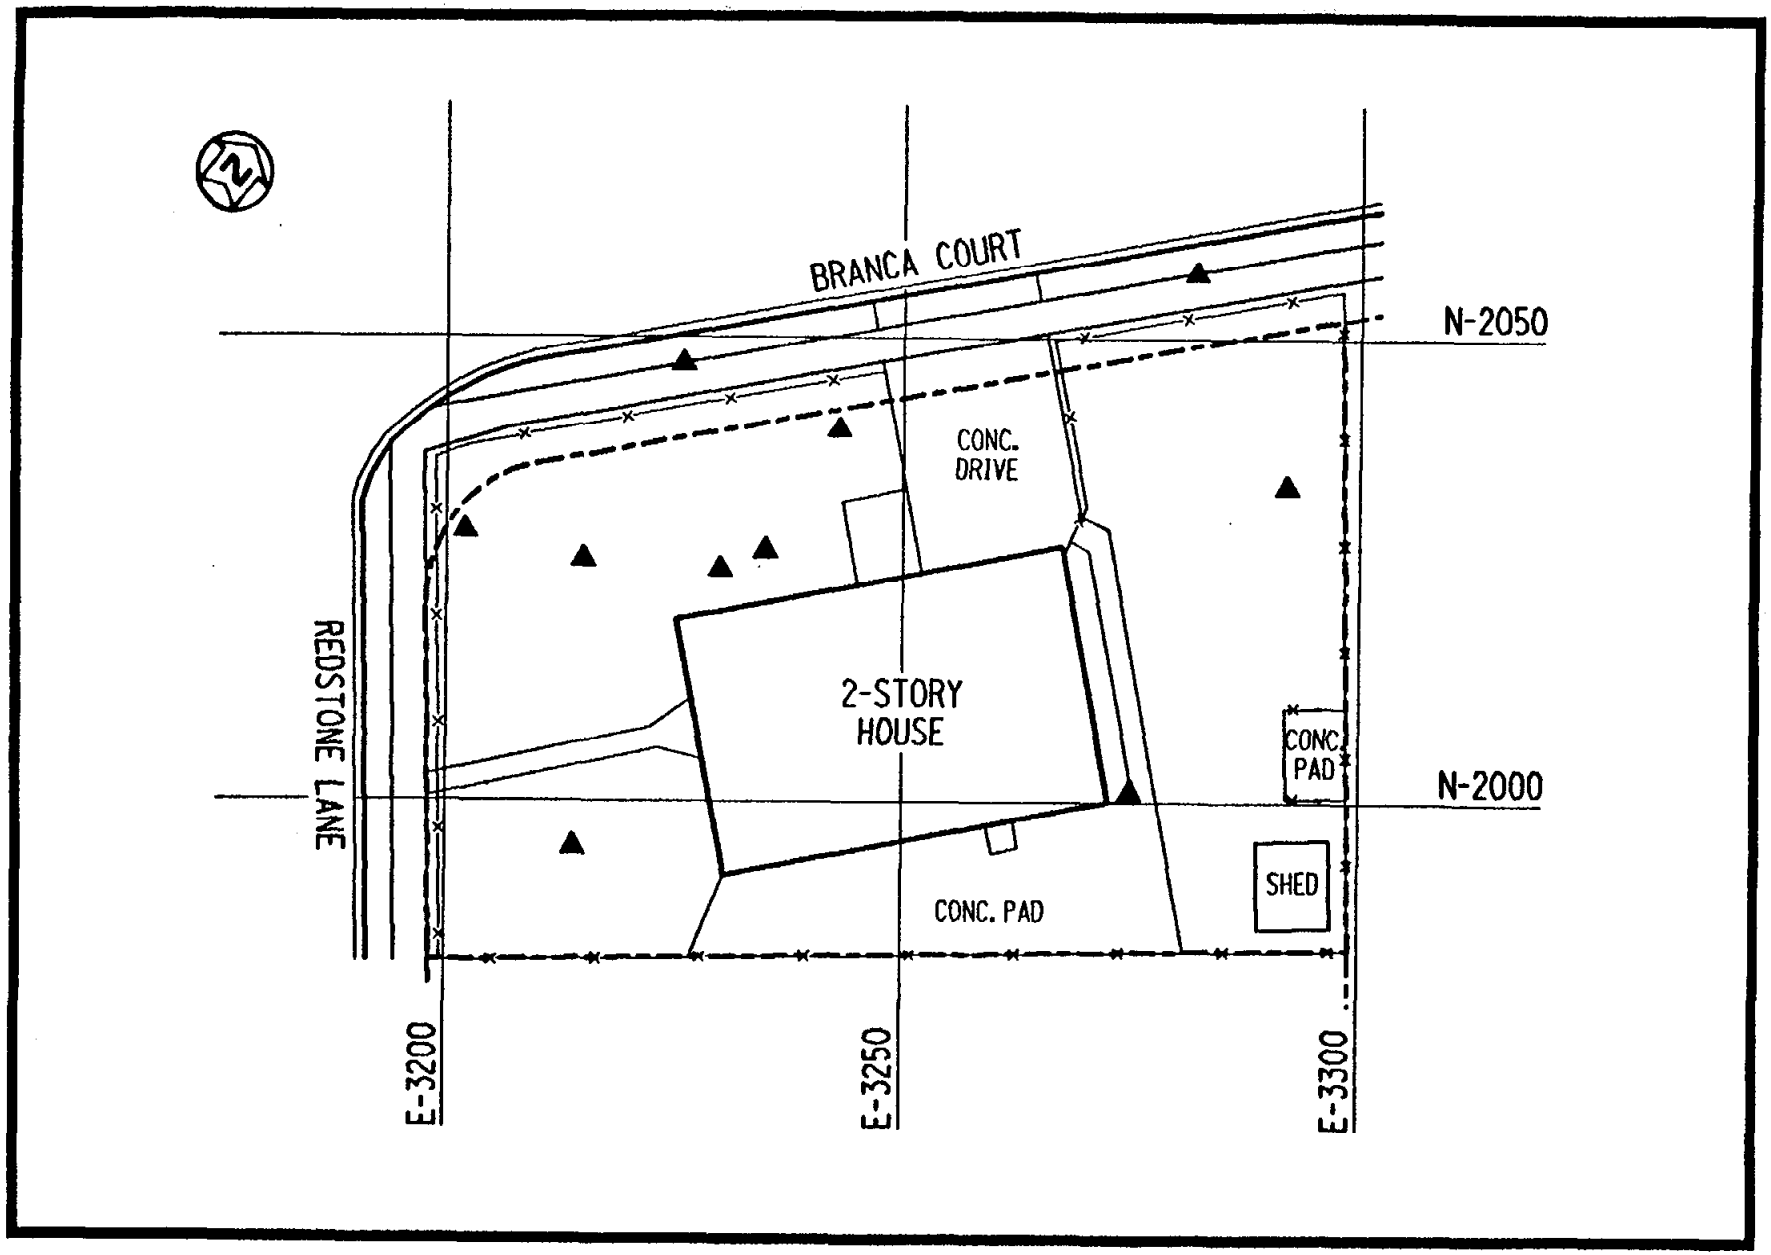
FIGURE 4-2 SURFACE AND SUBSURFACE SOIL SAMPLING LOCATIONS AT 11 REDSTONE LANE

Subsurface soil samples were collected from nine locations (Figure 4-2) using the side wall sampling method and were analyzed to compare laboratory soil sample results to downhole gamma radiation measurements. A cup or can attached to a steel pipe or wooden stake was inserted into the borehole and used to scrape samples off the side of the borehole at a specified depth. The subsurface soil samples were analyzed for radium-226, uranium-238, and thorium-232 in the same manner as the surface soil samples.

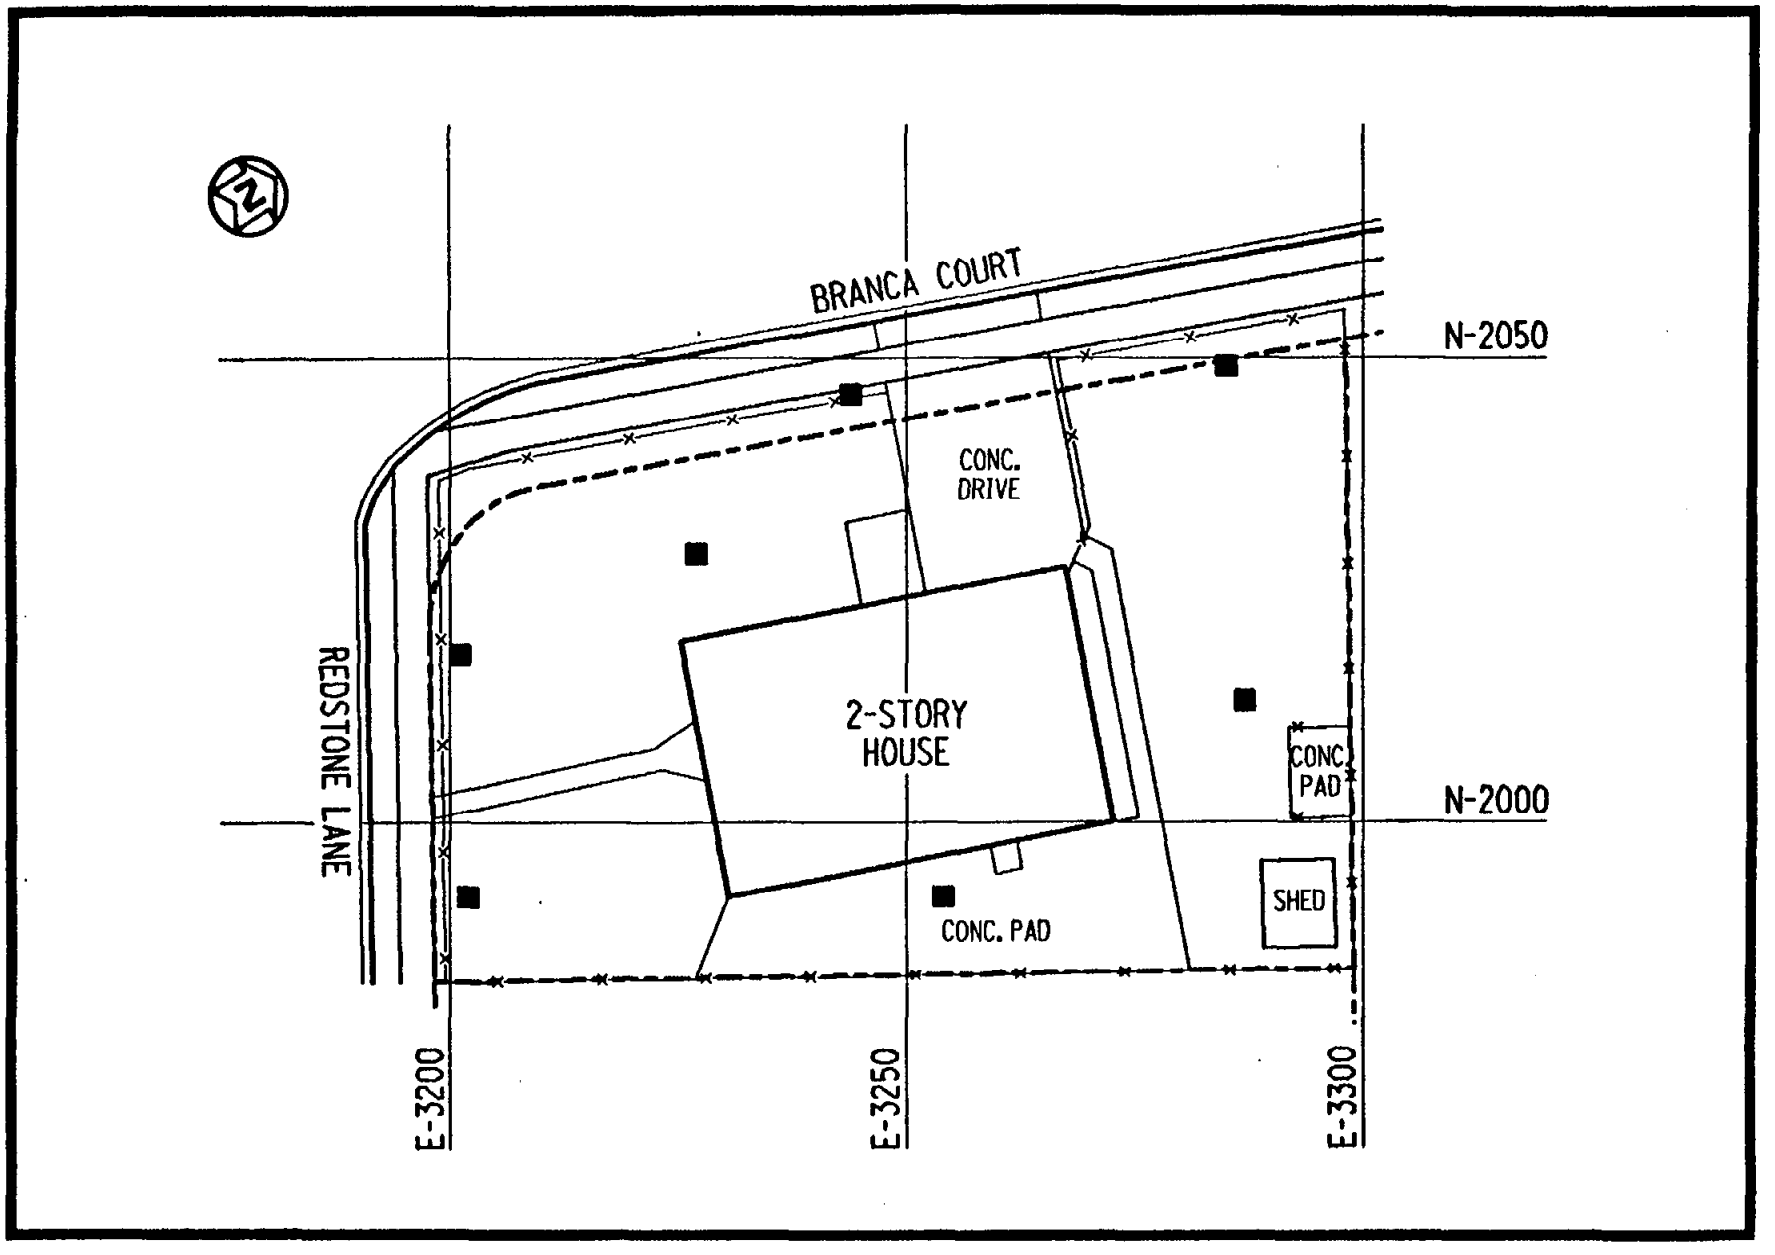
FIGURE 4-3 EXPOSURE RATE MEASUREMENT LOCATIONS AT 11 REDSTONE LANE

Exterior gamma exposure rate measurements were made at seven locations throughout the property grid system and at one location inside the residence using either a 2-in. by 2-in. thallium-activated sodium iodide gamma scintillation detector used to detect gamma radiation only, or a pressurized ionization chamber (PIC) (Figure 4-3). The PIC instrument has a response to gamma radiation that is proportional to exposure in roentgens. A conversion factor for gamma scintillation to the PIC was established through a correlation of these two measurements at four locations in the vicinity of the property. The unshielded gamma scintillation detector readings were then used to estimate gamma exposure rates for each location. These measurements were taken 3 ft above the ground, and the locations were determined to be representative of the entire property. Interior measurements are generally obtained with the gamma scintillation instrument rather than the PIC because of its smaller size and the desire to minimize the technician's time inside the residence.

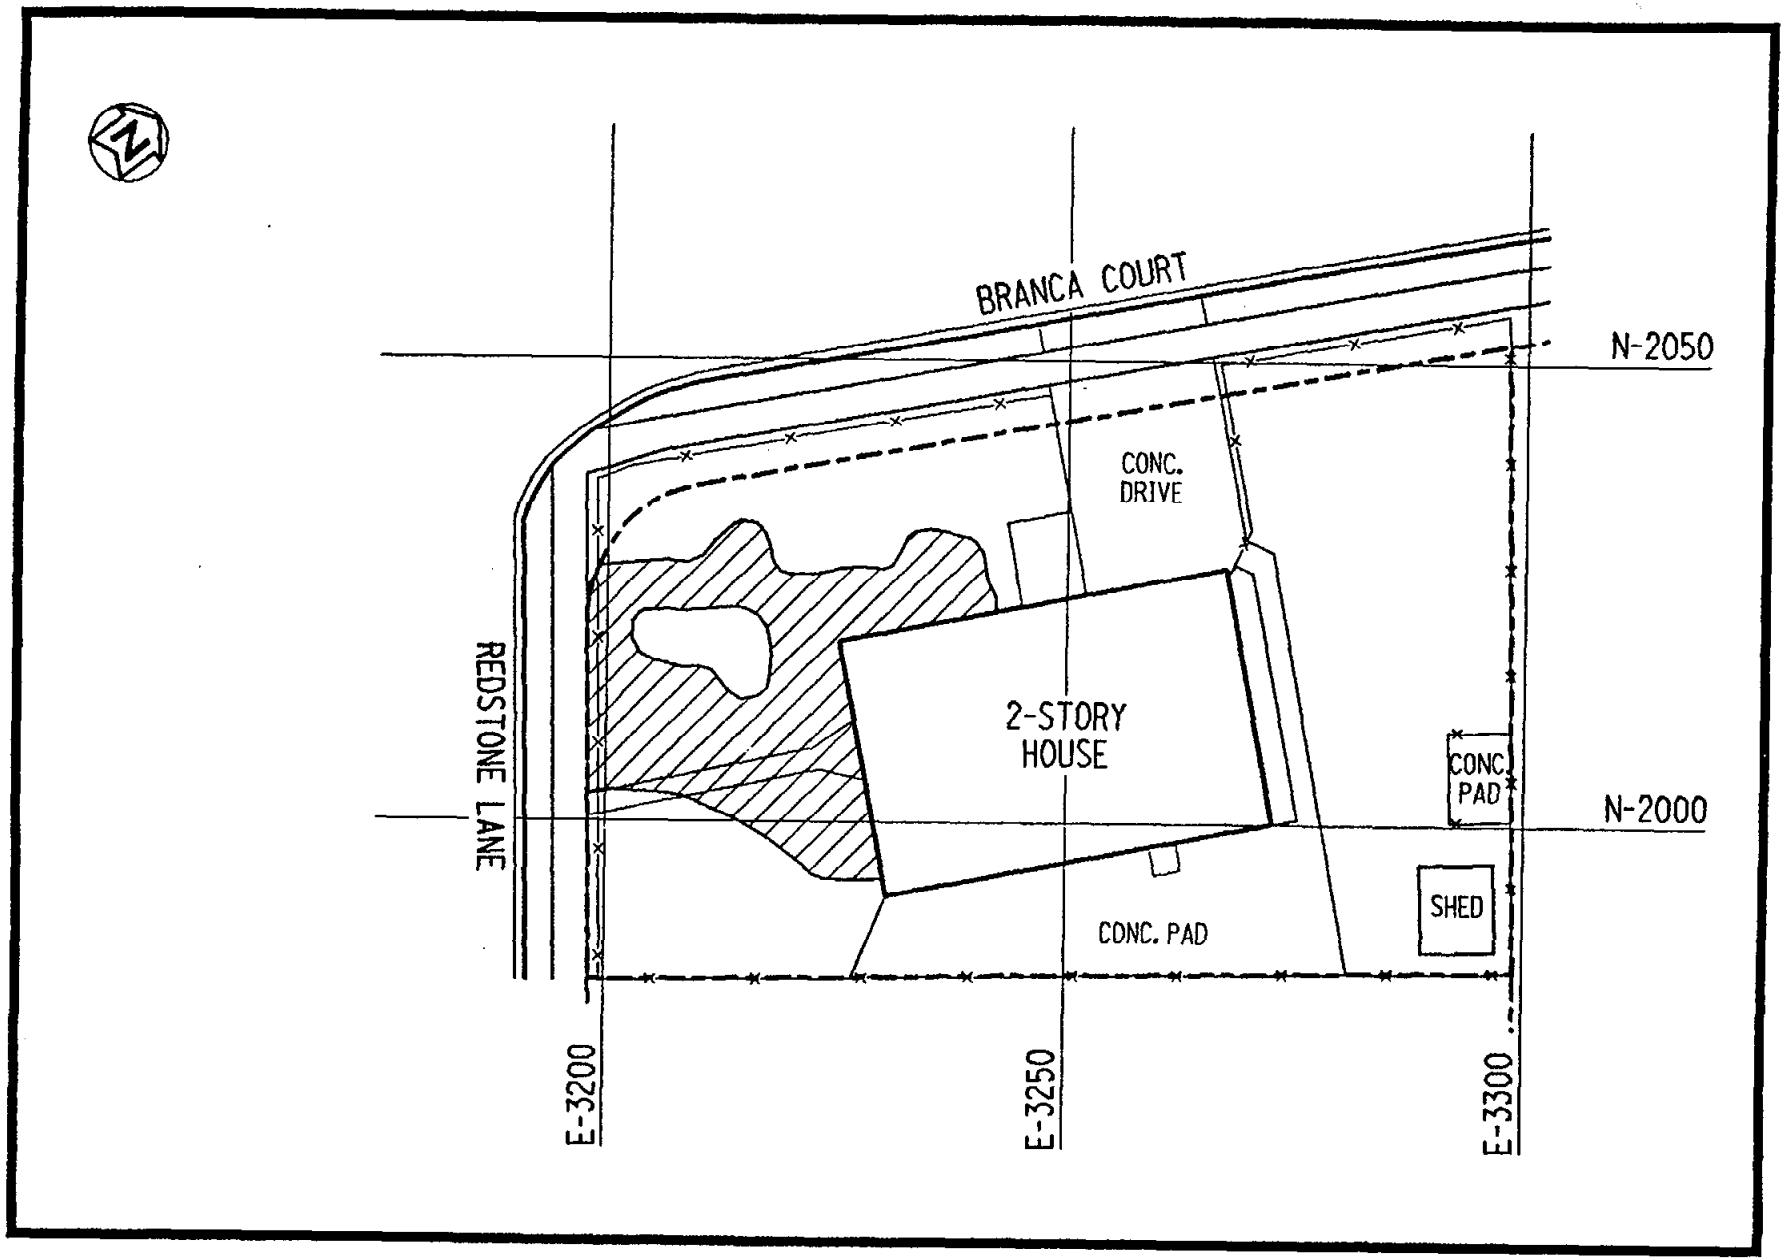
FIGURE 5-1 AREAS OF SURFACE CONTAMINATION AT 11 REDSTONE LANE

On the basis of near-surface gamma radiation measurements, surface soil sample analysis, and borehole gamma logging, contamination of this property is believed to consist of surface and subsurface contamination. Areas of surface contamination are shown in Figure 5-1. An area of subsurface contamination was detected at a depth of 4 ft and is shown in Figure 5-2.

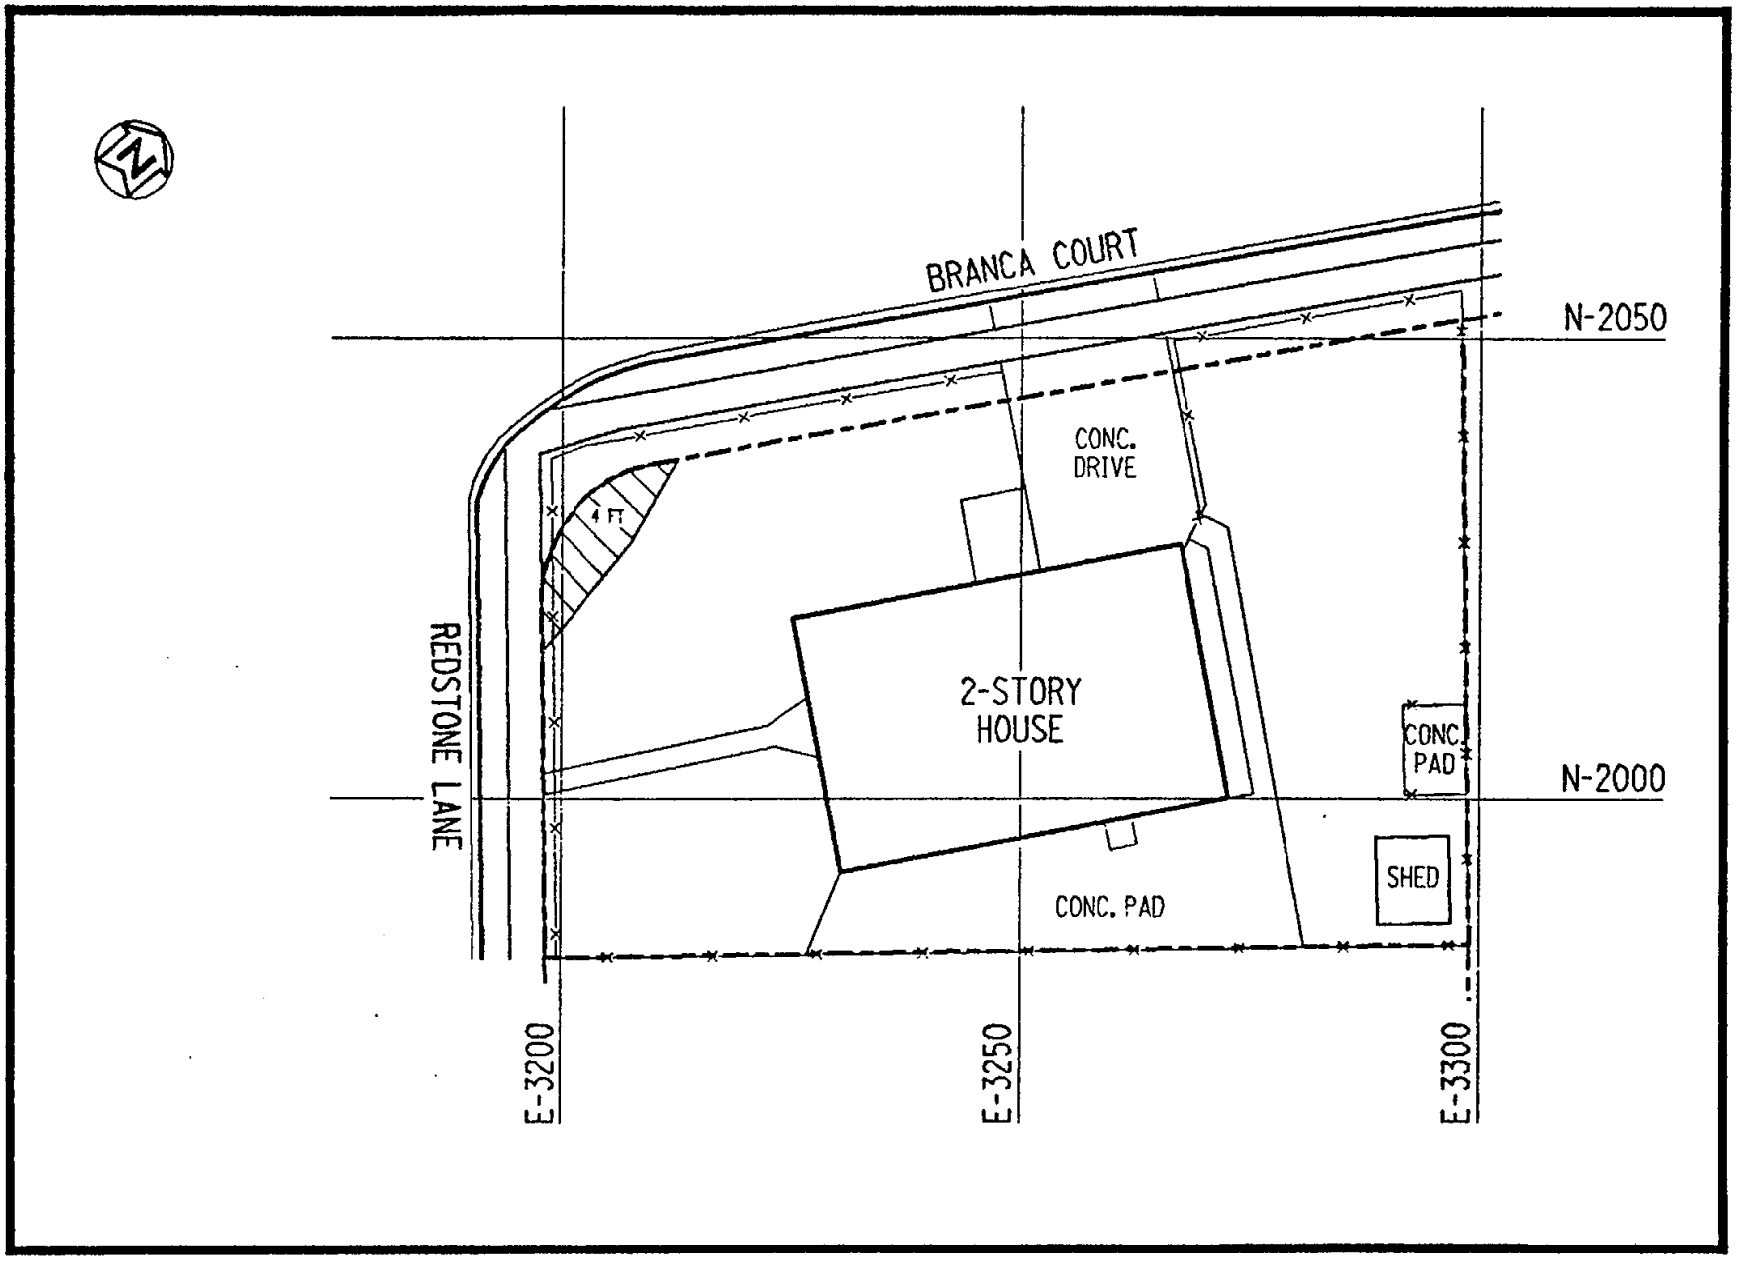
FIGURE 5-2 AREA OF SUBSURFACE CONTAMINATION AT 11 REDSTONE LANE

Analysis results for subsurface soil samples given in Table 5-1 (depths from 0.5 to 1.0 ft) are consistent with the gamma logging data in Table 5-2. The results in Table 5-2 showed a range from

7,000 cpm to 28,000 cpm. A measurement of 40,000 cpm is approximately equal to the DOE guideline for subsurface contamination of 15 pCi/g. Analyses of subsurface soil samples indicated thorium-232 concentrations ranging from 0.8 to 23.0 pCi/g, uranium-238 concentrations ranging from less than 12.4 to less than 17.7 pCi/g, and radium-226 concentrations ranging from 0.6 to less than 1.9 pCi/g.
