ORNL/RASA-88/37

RESULTS OF THE RADIOLOGICAL SURVEY AT 62 TRUDY DRIVE, LODI, NEW JERSEY (LJ080)

A radiological survey of the private, residential property at 62 Trudy Drive, Lodi, New Jersey, was conducted during 1988. The survey and sampling of the ground surface were carried out on May 7, 1988, and the follow-up subsurface investigation was performed on June 11, 1988.

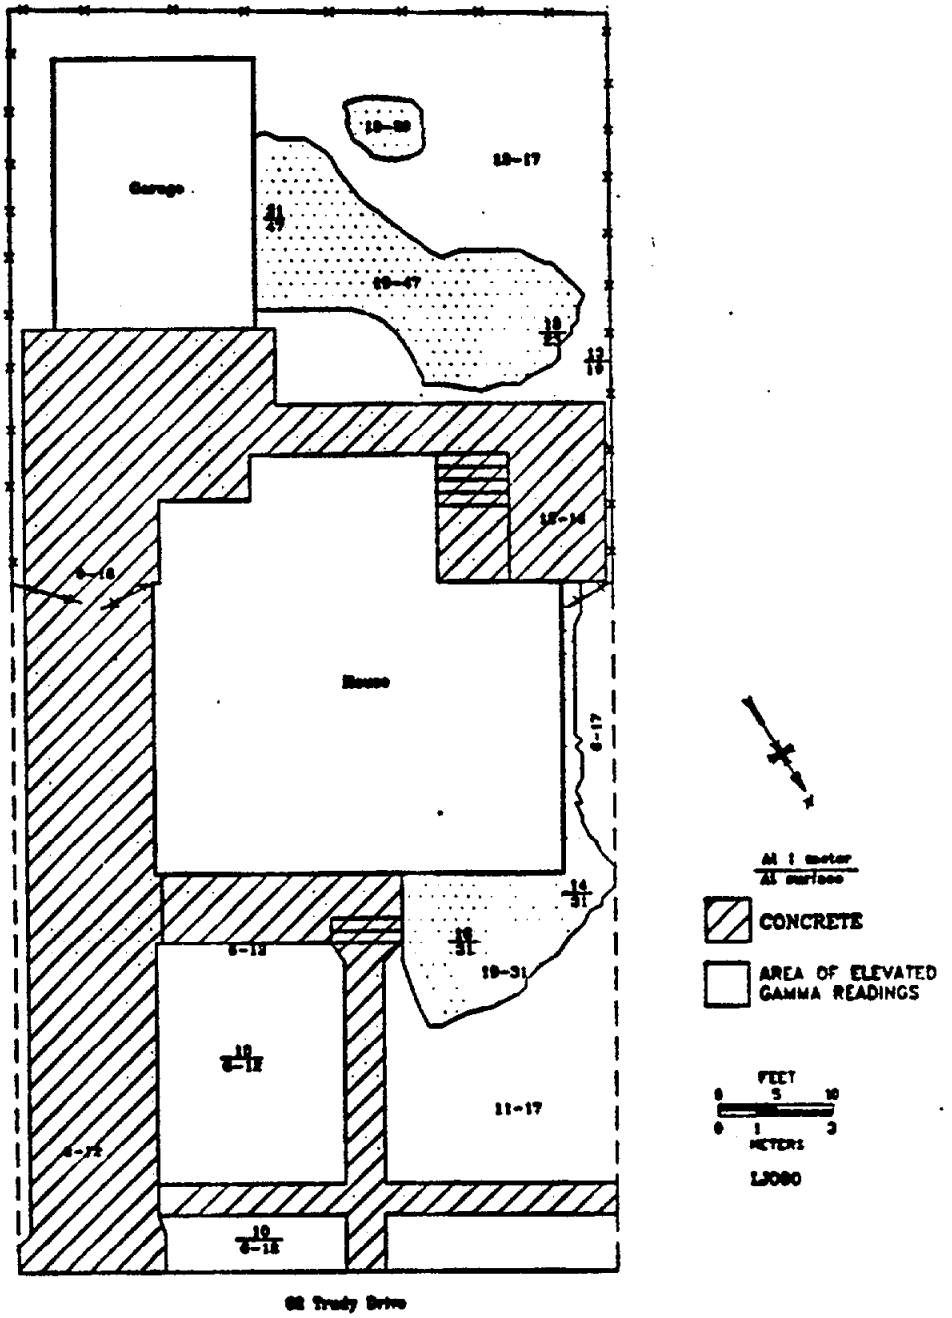
ORNL-DWG 89-10635

Gamma radiation levels measured during a gamma scan of the surface of the property are given in Fig. 1, with corresponding measurements one meter above the surface where indicated. Gamma exposure rates over the major portion of the property surface ranged from 6 to 17 μR/h. One-meter readings were between 10 and 31 μR/h; the normal background level at one meter is 8 μR/h for the northern New Jersey area (Table 2). Elevated readings were in scattered areas of both the front and back yards, with the highest levels ranging from 19 to 31 μR/h on the north and west sides of the house and from 19 to 47 μR/h in the back yard; corresponding one-meter readings for these two areas were 14 to 16 and 18 to 31 μR/h, respectively (Fig. 1). Another isolated spot in the back yard was 19 to 28 μR/h.

Fig. 1. Gamma radiation levels (μR/h) measured on the surface at 62 Trudy Drive, Lodi, New Jersey (LJ080), with corresponding measurements one meter above the surface where indicated.

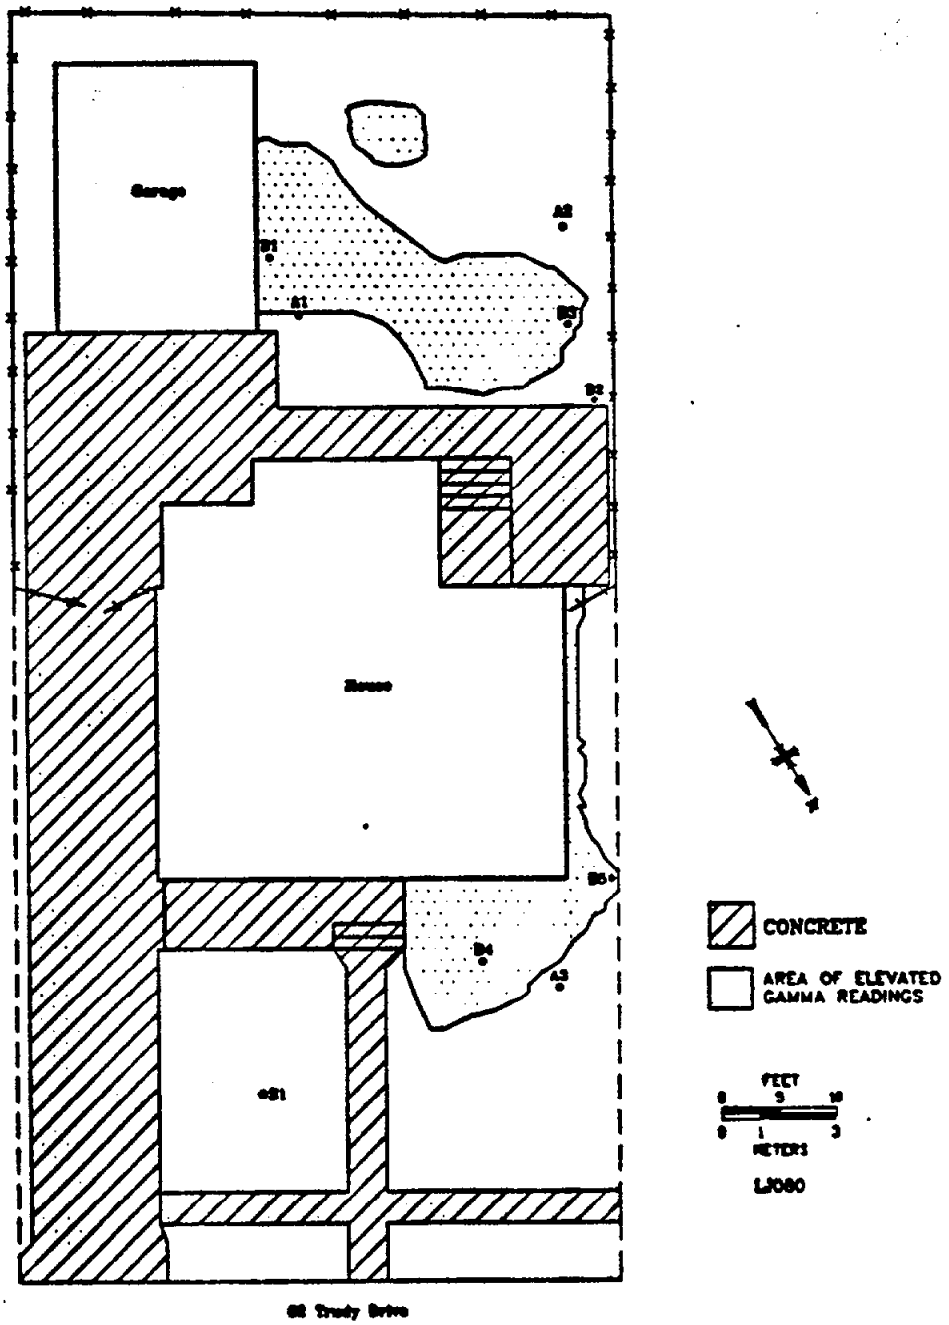
ORNL-DWG 89-10636

Systematic and biased soil samples were taken from various locations on the property for radionuclide analyses. Locations of the systematic (S) and biased (B) samples are shown in Fig. 2, with results of laboratory analyses provided in Table 3. Concentrations of radium, thorium, and uranium in these samples ranged from 0.65 to 6.6 pCi/g, 0.93 to 21 pCi/g, and <0.73 to 15 pCi/g, respectively. Biased samples B1A–C, B2A, B3A, B4A, and B5A were above DOE guidelines for ^{232}Th, and B5A also exceeded criteria for ^{226}Ra (Table 1). All systematic samples were near or above normal background levels for the northern New Jersey area (Table 2).

Varying thicknesses of subsurface soil were sampled from depths of 15 to 215 cm in two of the auger holes (A) drilled at three separate locations indicated in Fig. 2. Auger hole A3 was drilled but not sampled due to low gamma levels in this hole. The results of analyses of these samples are given in Table 3. Concentrations of ^{226}Ra, ^{232}Th, and ^{238}U in soil samples ranged from 0.74 to 5.6, 0.99 to 50, and <1.0 to <15 pCi/g, respectively. Radionuclide concentrations in samples A2C–G were above DOE criteria (Table 1) for thorium, with levels ranging from 18 to 50 pCi/g. These elevated concentrations were found at depths between 60 and 135 cm.

Fig. 2. Diagram showing locations of soil samples taken at 62 Trudy Drive, Lodi, New Jersey (LJ080).

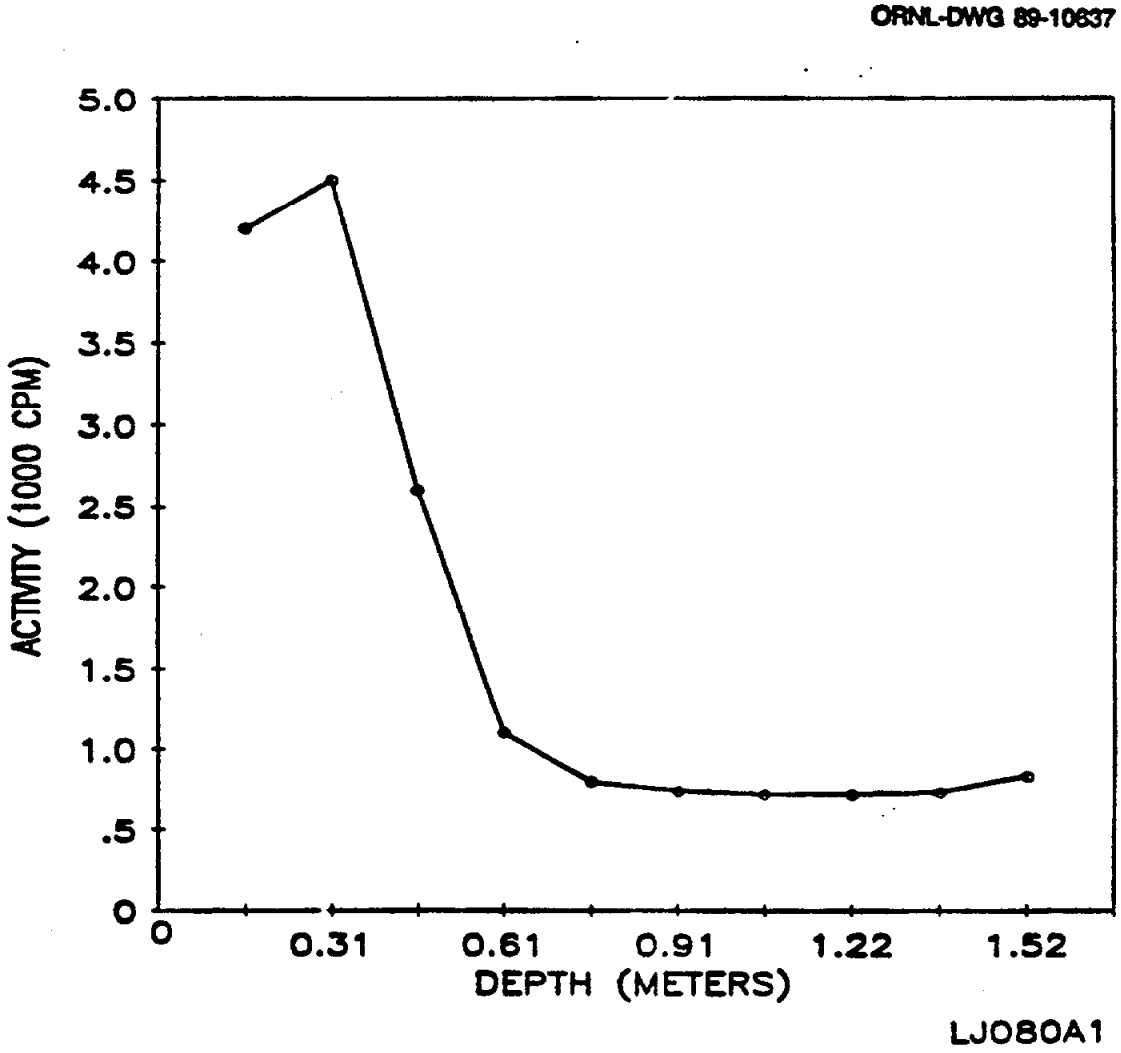
hole 1 were elevated from the surface to 0.6 m, with a maximum of 4554 cpm at 0.3 m. Elevated readings in hole 2 extended from ground surface to 2.0 m, with a maximum of 8799 cpm at 0.9 m. All readings in hole 3 were less than 1000 cpm. The areas of highest gamma readings correspond to the greatest concentrations of radionuclides shown in Table 3.

Fig. 3. Gamma profile for auger hole 1 (LJ080A1) at 62 Trudy Drive, Lodi, New Jersey.

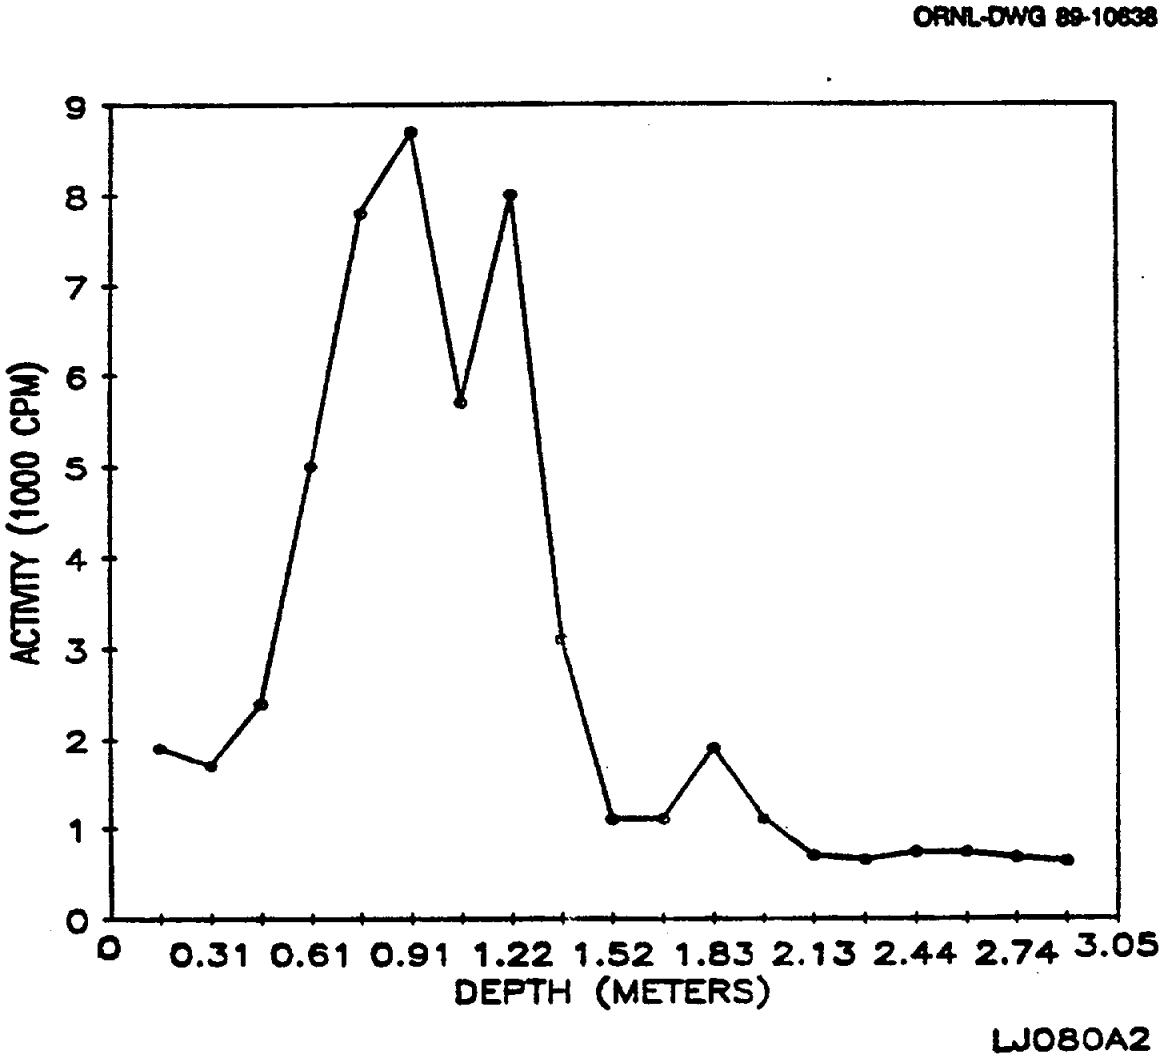
Fig. 4. Gamma profile for auger hole 2 (LJ080A2) at 62 Trudy Drive, Lodi, New Jersey.

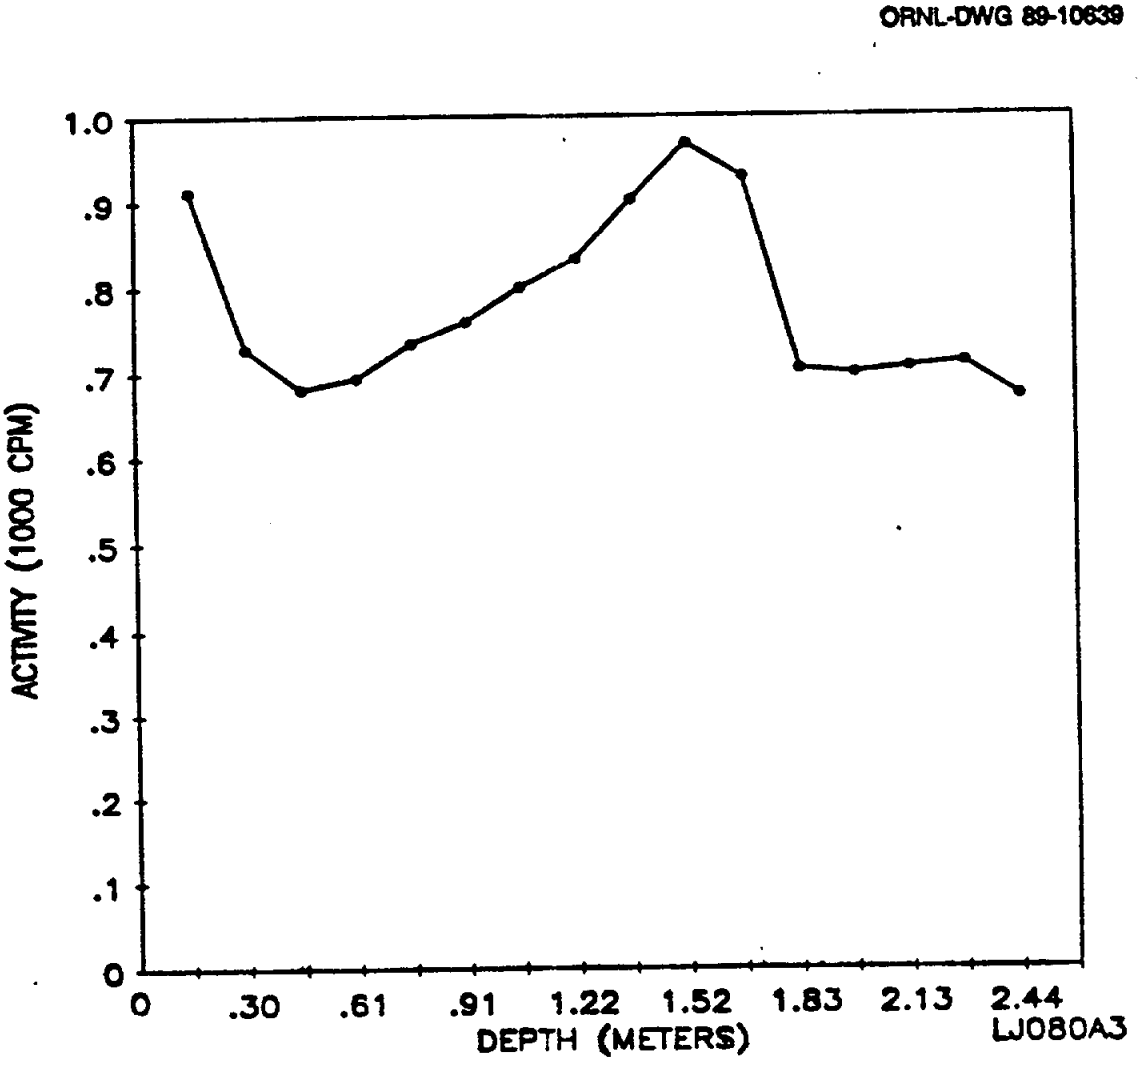
Fig. 5. Gamma profile for auger hole 8 (LJ080A3) at 62 Trudy Drive, Lodi, New Jersey.
