Lodi, New Jersey

September 1989

Bechtel National, Inc.

RADIOLOGICAL CHARACTERIZATION REPORT FOR THE RESIDENTIAL PROPERTY AT 19 REDSTONE LANE LODI, NEW JERSEY

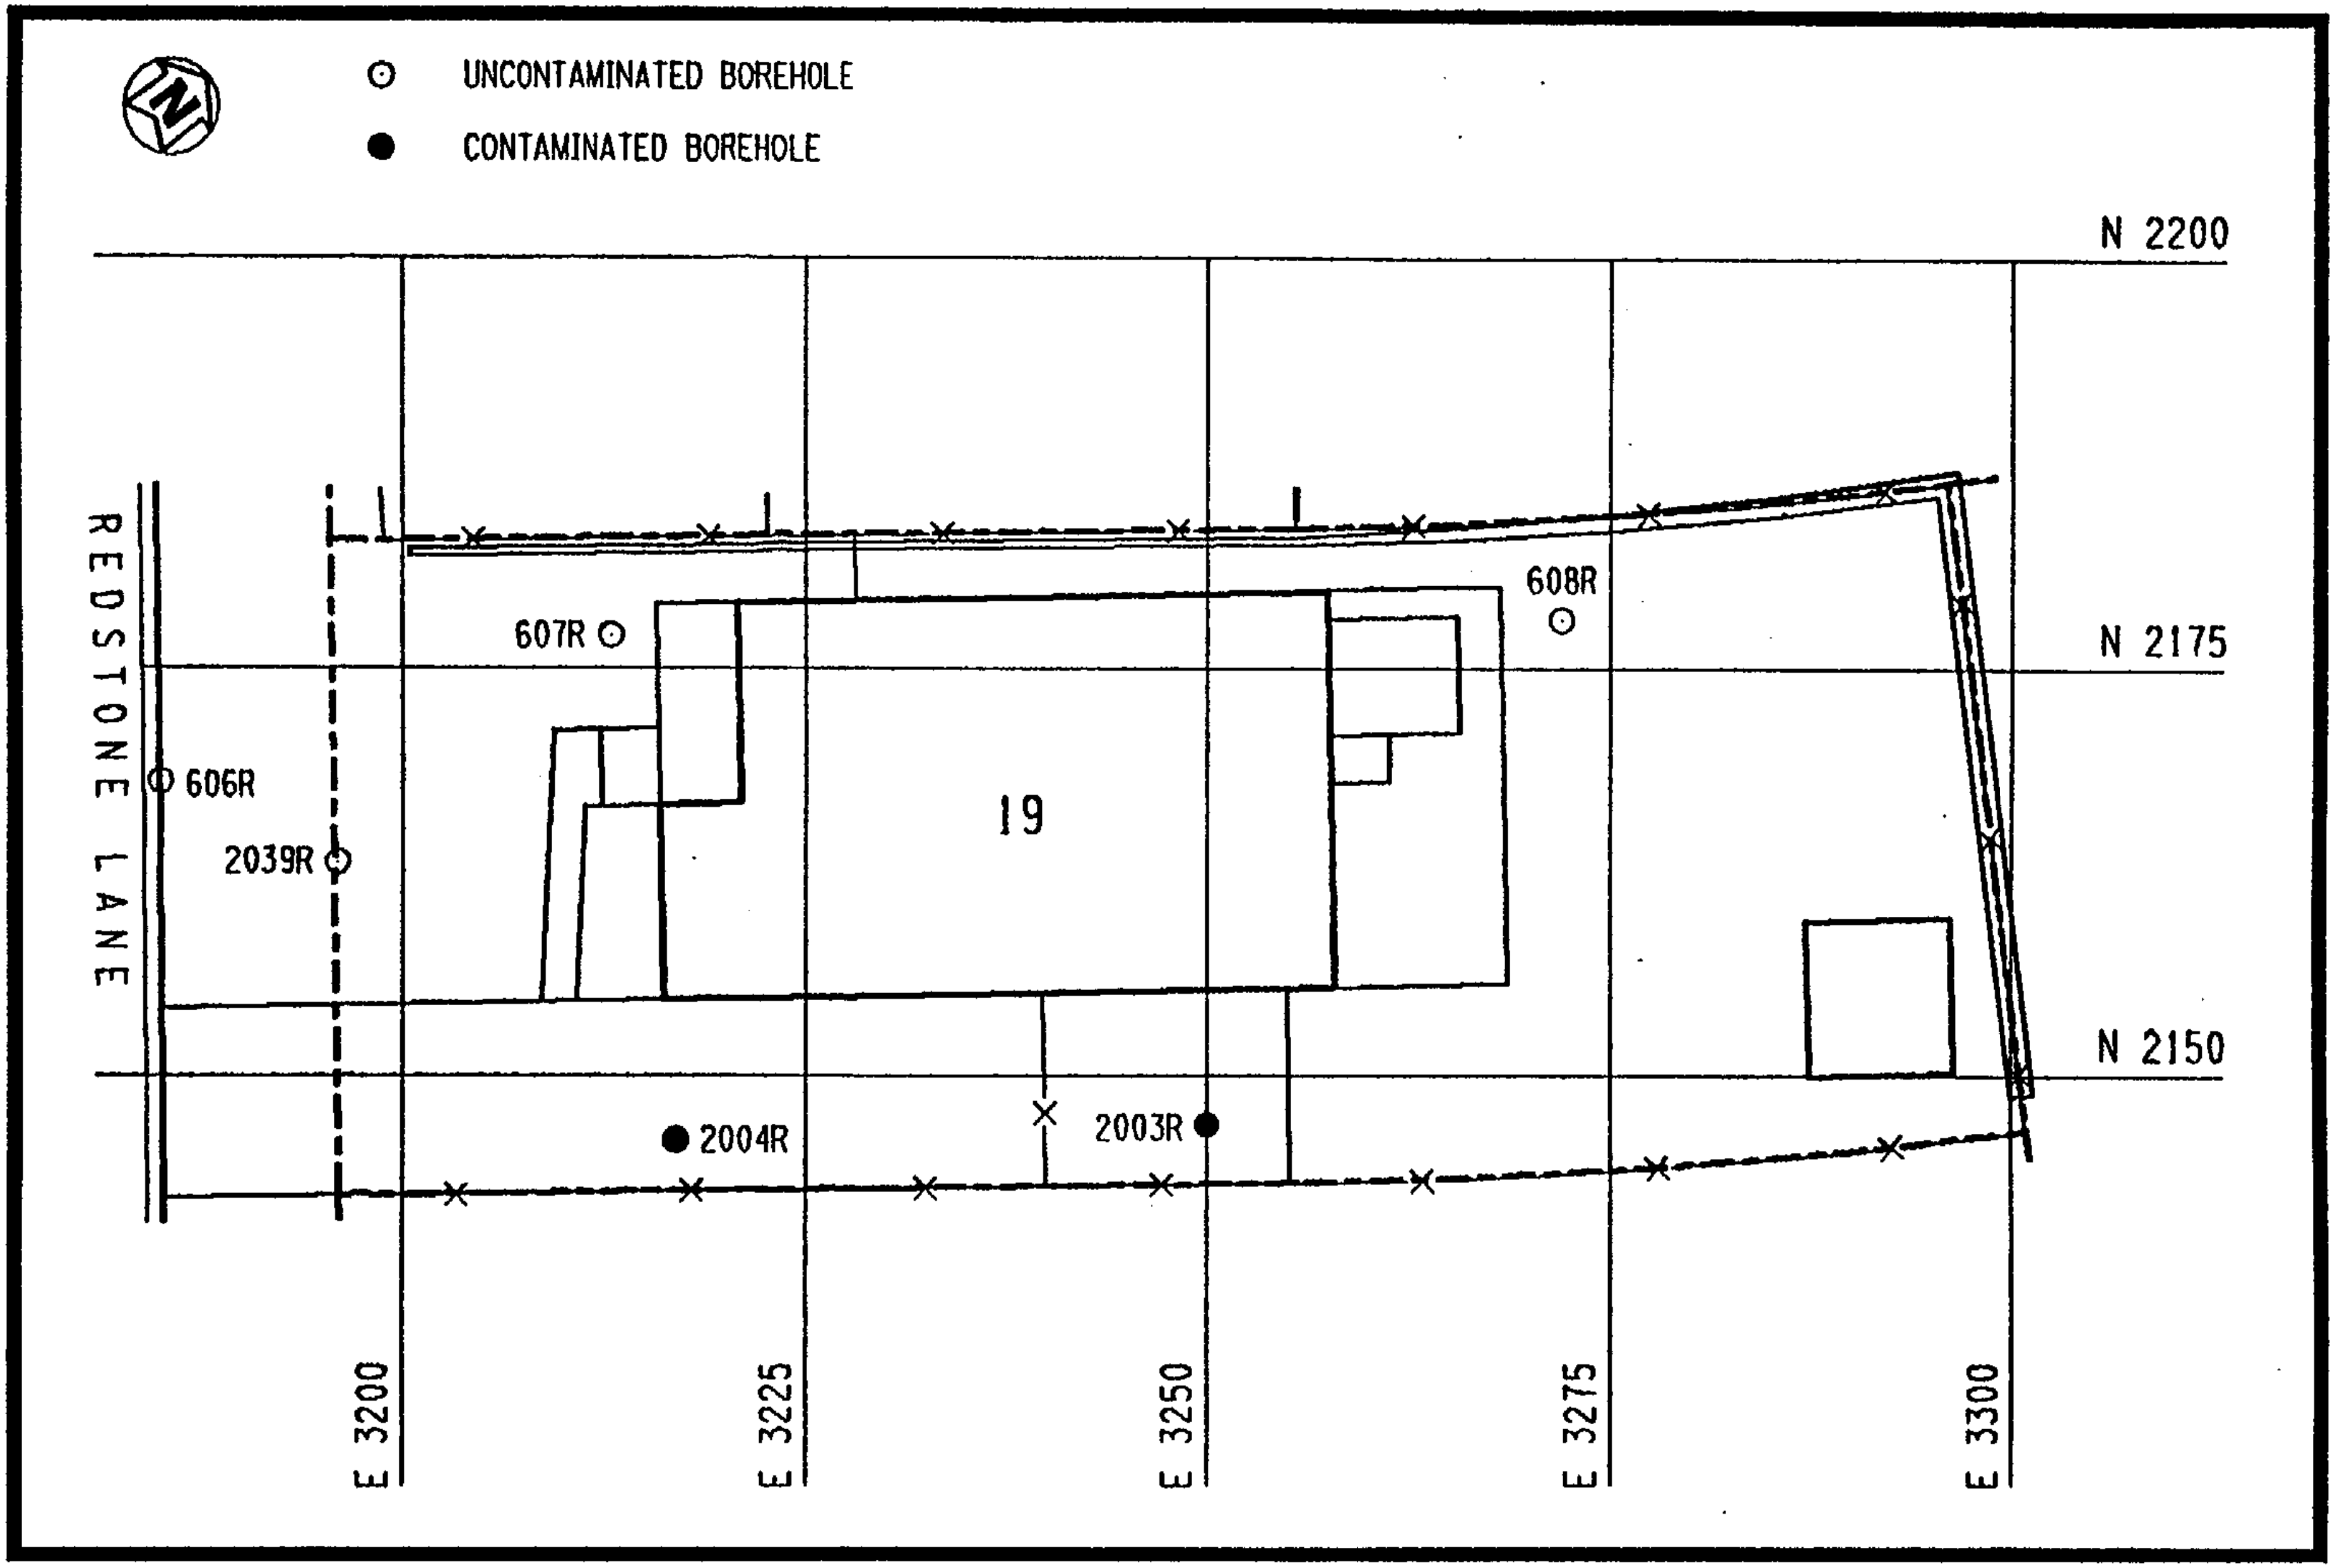
FIGURE 4-1 BOREHOLE LOCATIONS AT 19 REDSTONE LANE

A subsurface investigation was conducted to determine the depth to which the previously identified surface contamination extended and to locate subsurface contamination where there was no surface manifestation. The subsurface characterization consisted of drilling six boreholes (Figure 4-1) [using either a 7.6-cm- (3-in.-) or 15.2-cm- (6-in.-) diameter auger bit], and gamma logging them. The boreholes were drilled to depths determined in the field by the radiological and geological support representatives.

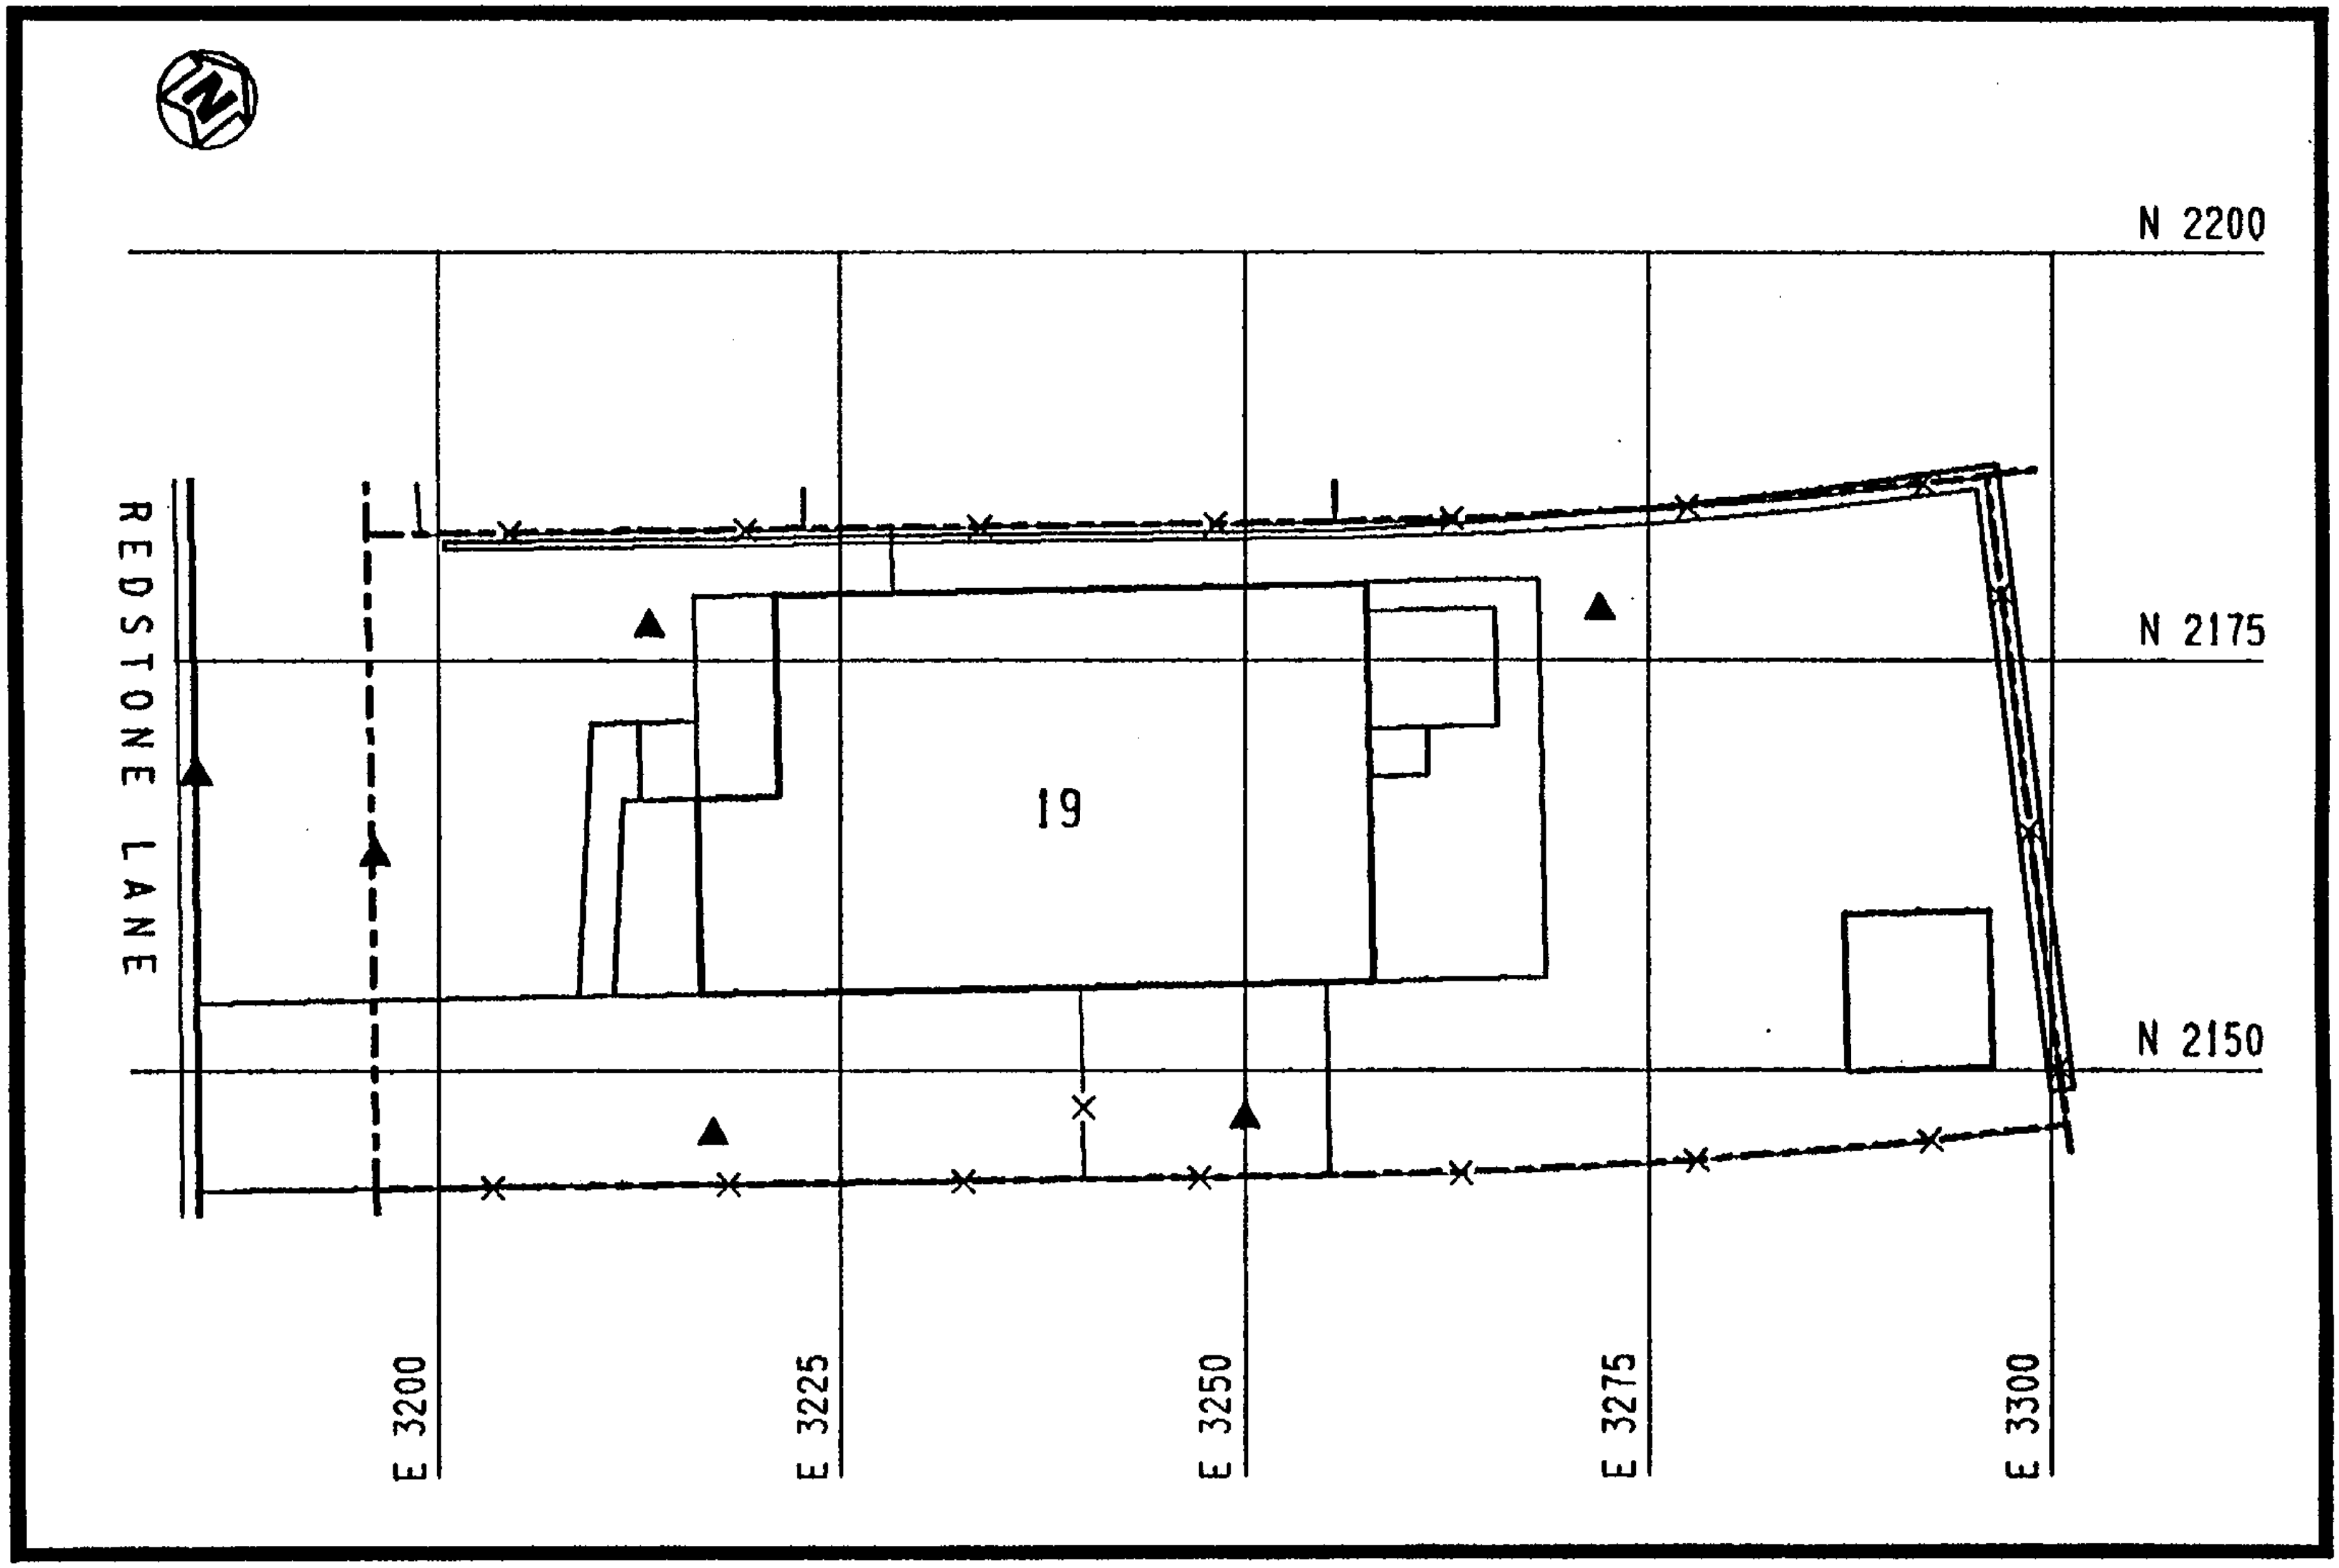
FIGURE 4-2 SURFACE AND SUBSURFACE SOIL SAMPLING LOCATIONS AT 19 REDSTONE LANE

Subsurface soil samples were collected from six locations (Figure 4-2) using the side-wall sampling method and were analyzed to compare laboratory soil sample results to downhole gamma radiation measurements. A cup or can attached to a steel pipe or wooden stake was inserted into the borehole and used to scrape samples off the side of the borehole at a specified depth. The subsurface soil samples were analyzed for radium-226, uranium-238, and thorium-232 in the same manner as the surface soil samples.

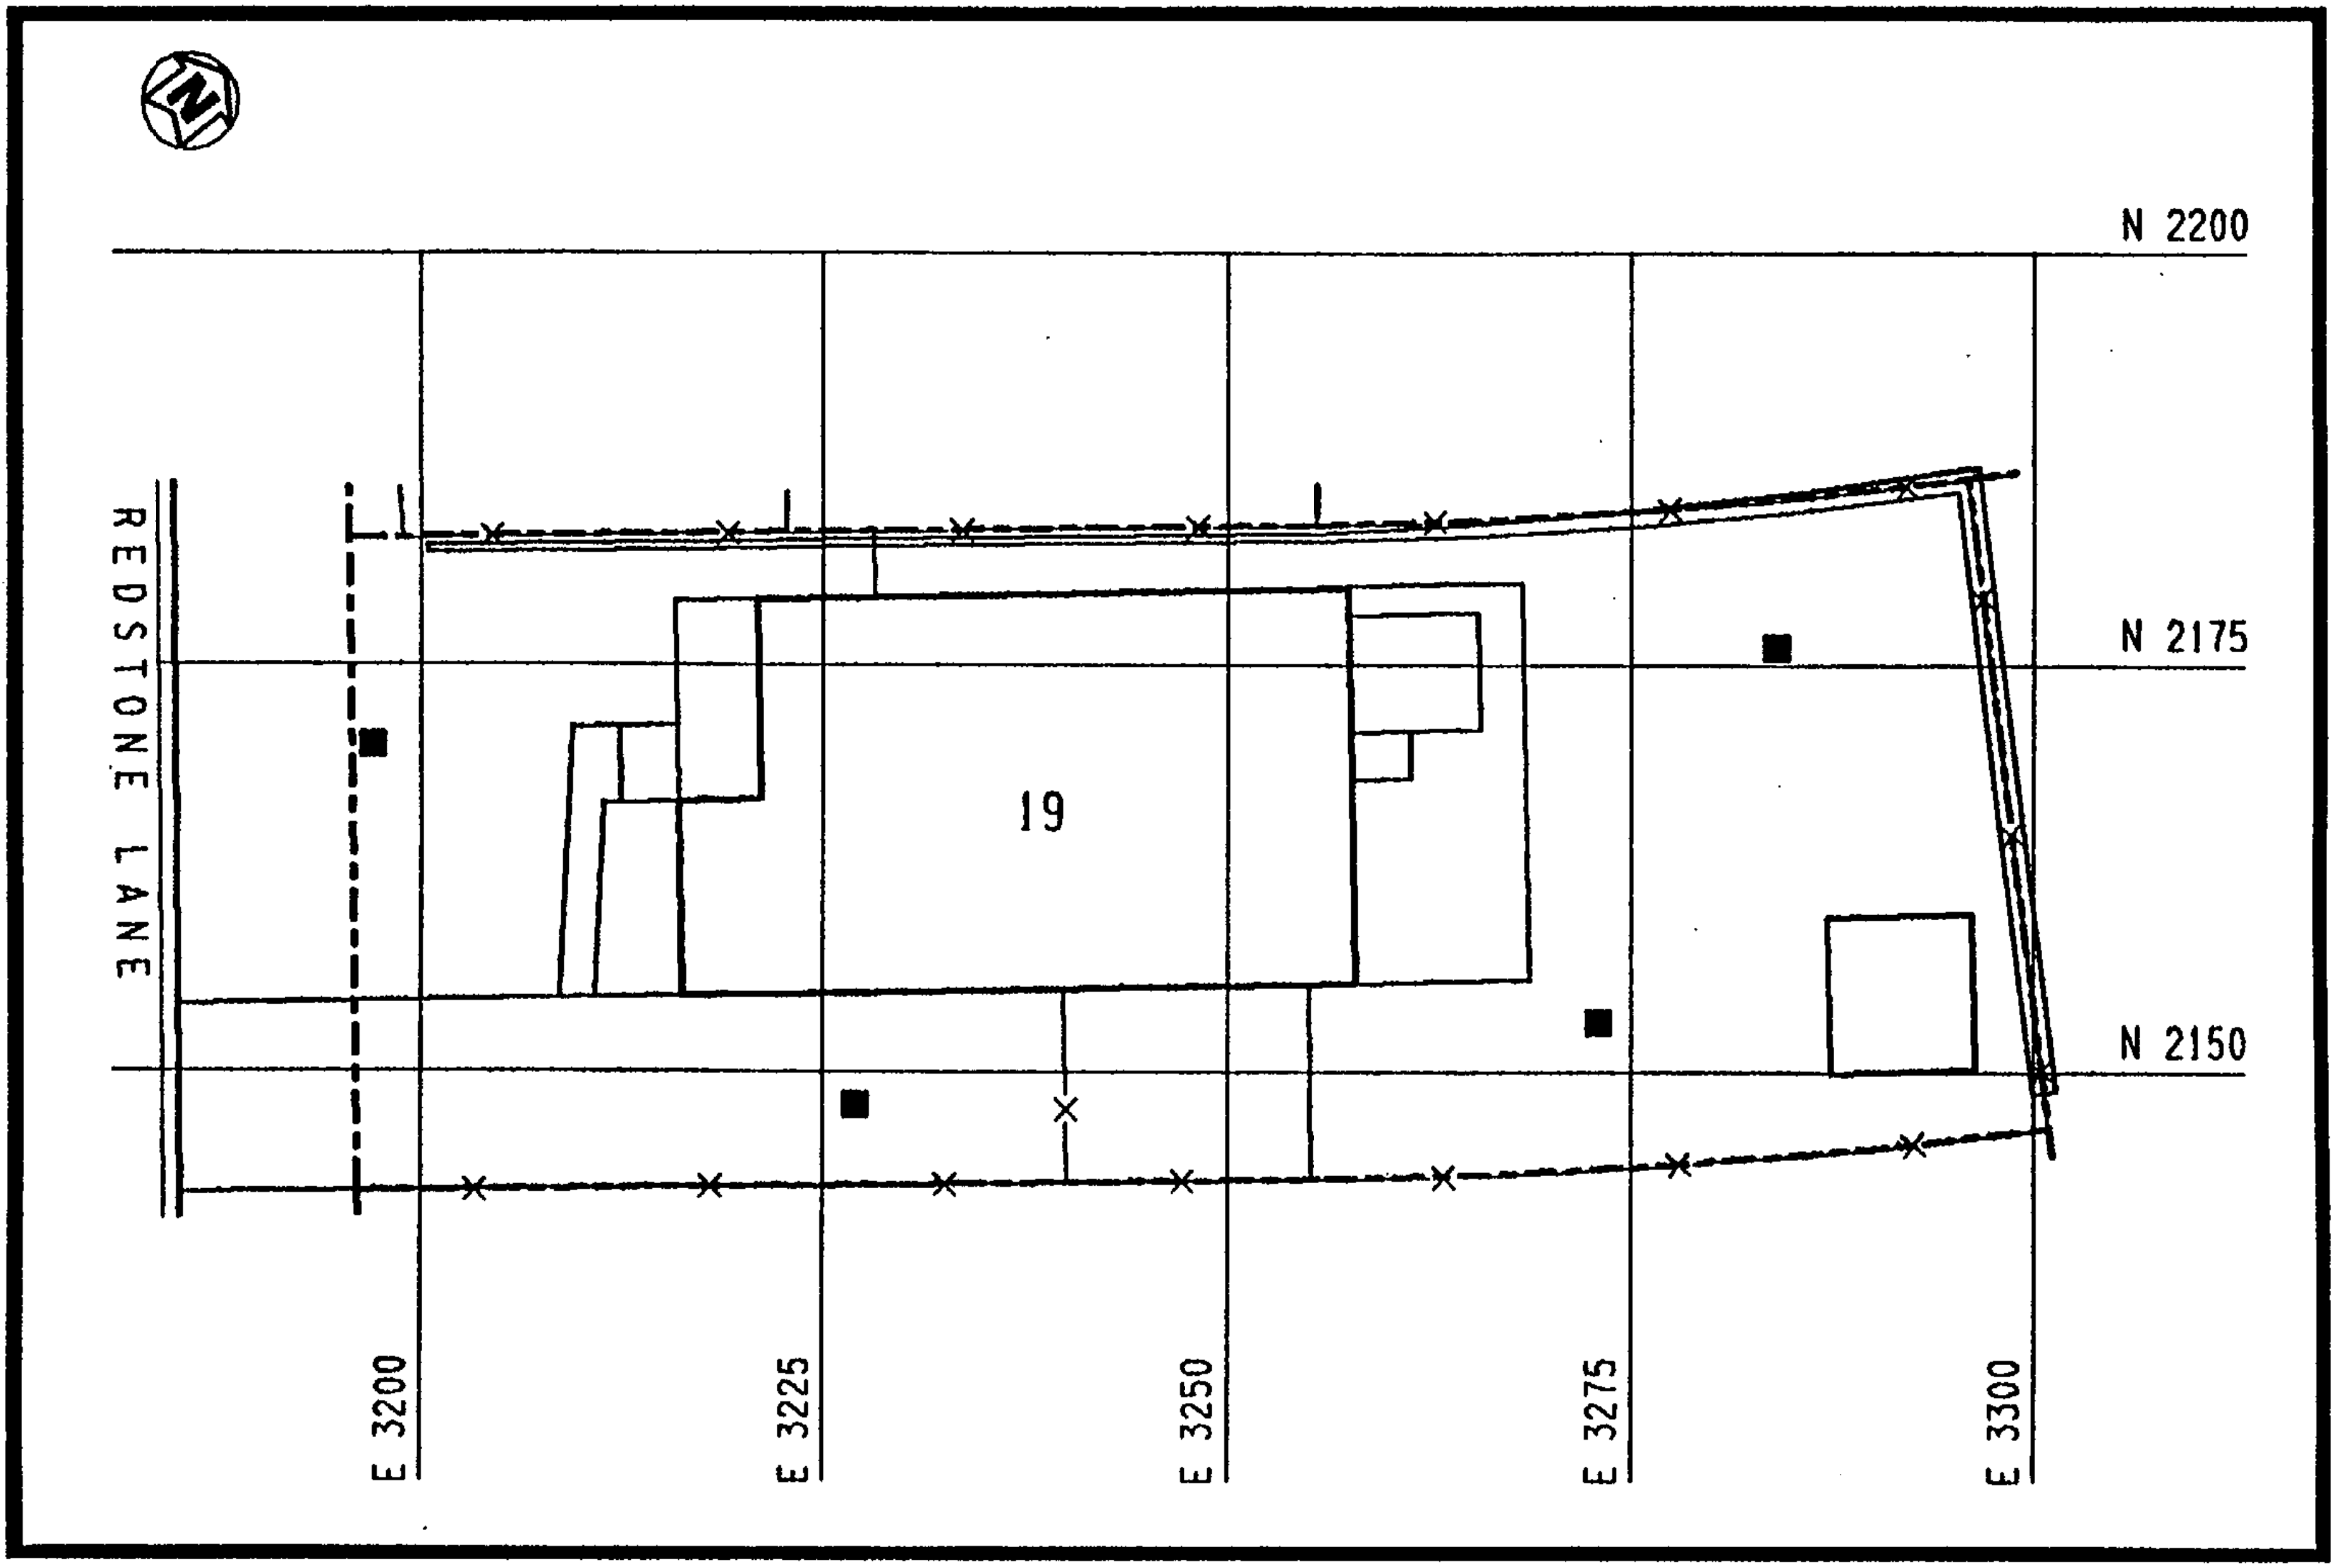
FIGURE 4-3 GAMMA EXPOSURE RATE MEASUREMENT LOCATIONS AT 19 REDSTONE LANE

Exterior gamma exposure rate measurements were made at four locations throughout the property grid system. To obtain these measurements, either a 5.0- by 5.0-cm (2-by 2-in.) thallium-activated sodium iodide gamma scintillation detector designed to detect gamma radiation only or a pressurized ionization chamber (PIC) was used. Measurement locations are shown in Figure 4-3. The PIC instrument has a response to gamma radiation that is proportional to exposure in roentgens. A conversion factor for gamma scintillation to the PIC was established through a correlation of these two measurements at four locations in the vicinity of the property. The unshielded gamma scintillation detector readings were then used to estimate gamma exposure rates for each location. These measurements were taken 1 m (3 ft) above the ground. The locations were determined to be representative of the entire property.

Exterior gamma radiation exposure rate measurements ranged from 7 to 8 μR/h, including background. These results can be found in Table 5-3. These measurements are consistent with the average background exposure rate of 9 μR/h (Ref. 12). No indoor exposure rate measurement was obtained.

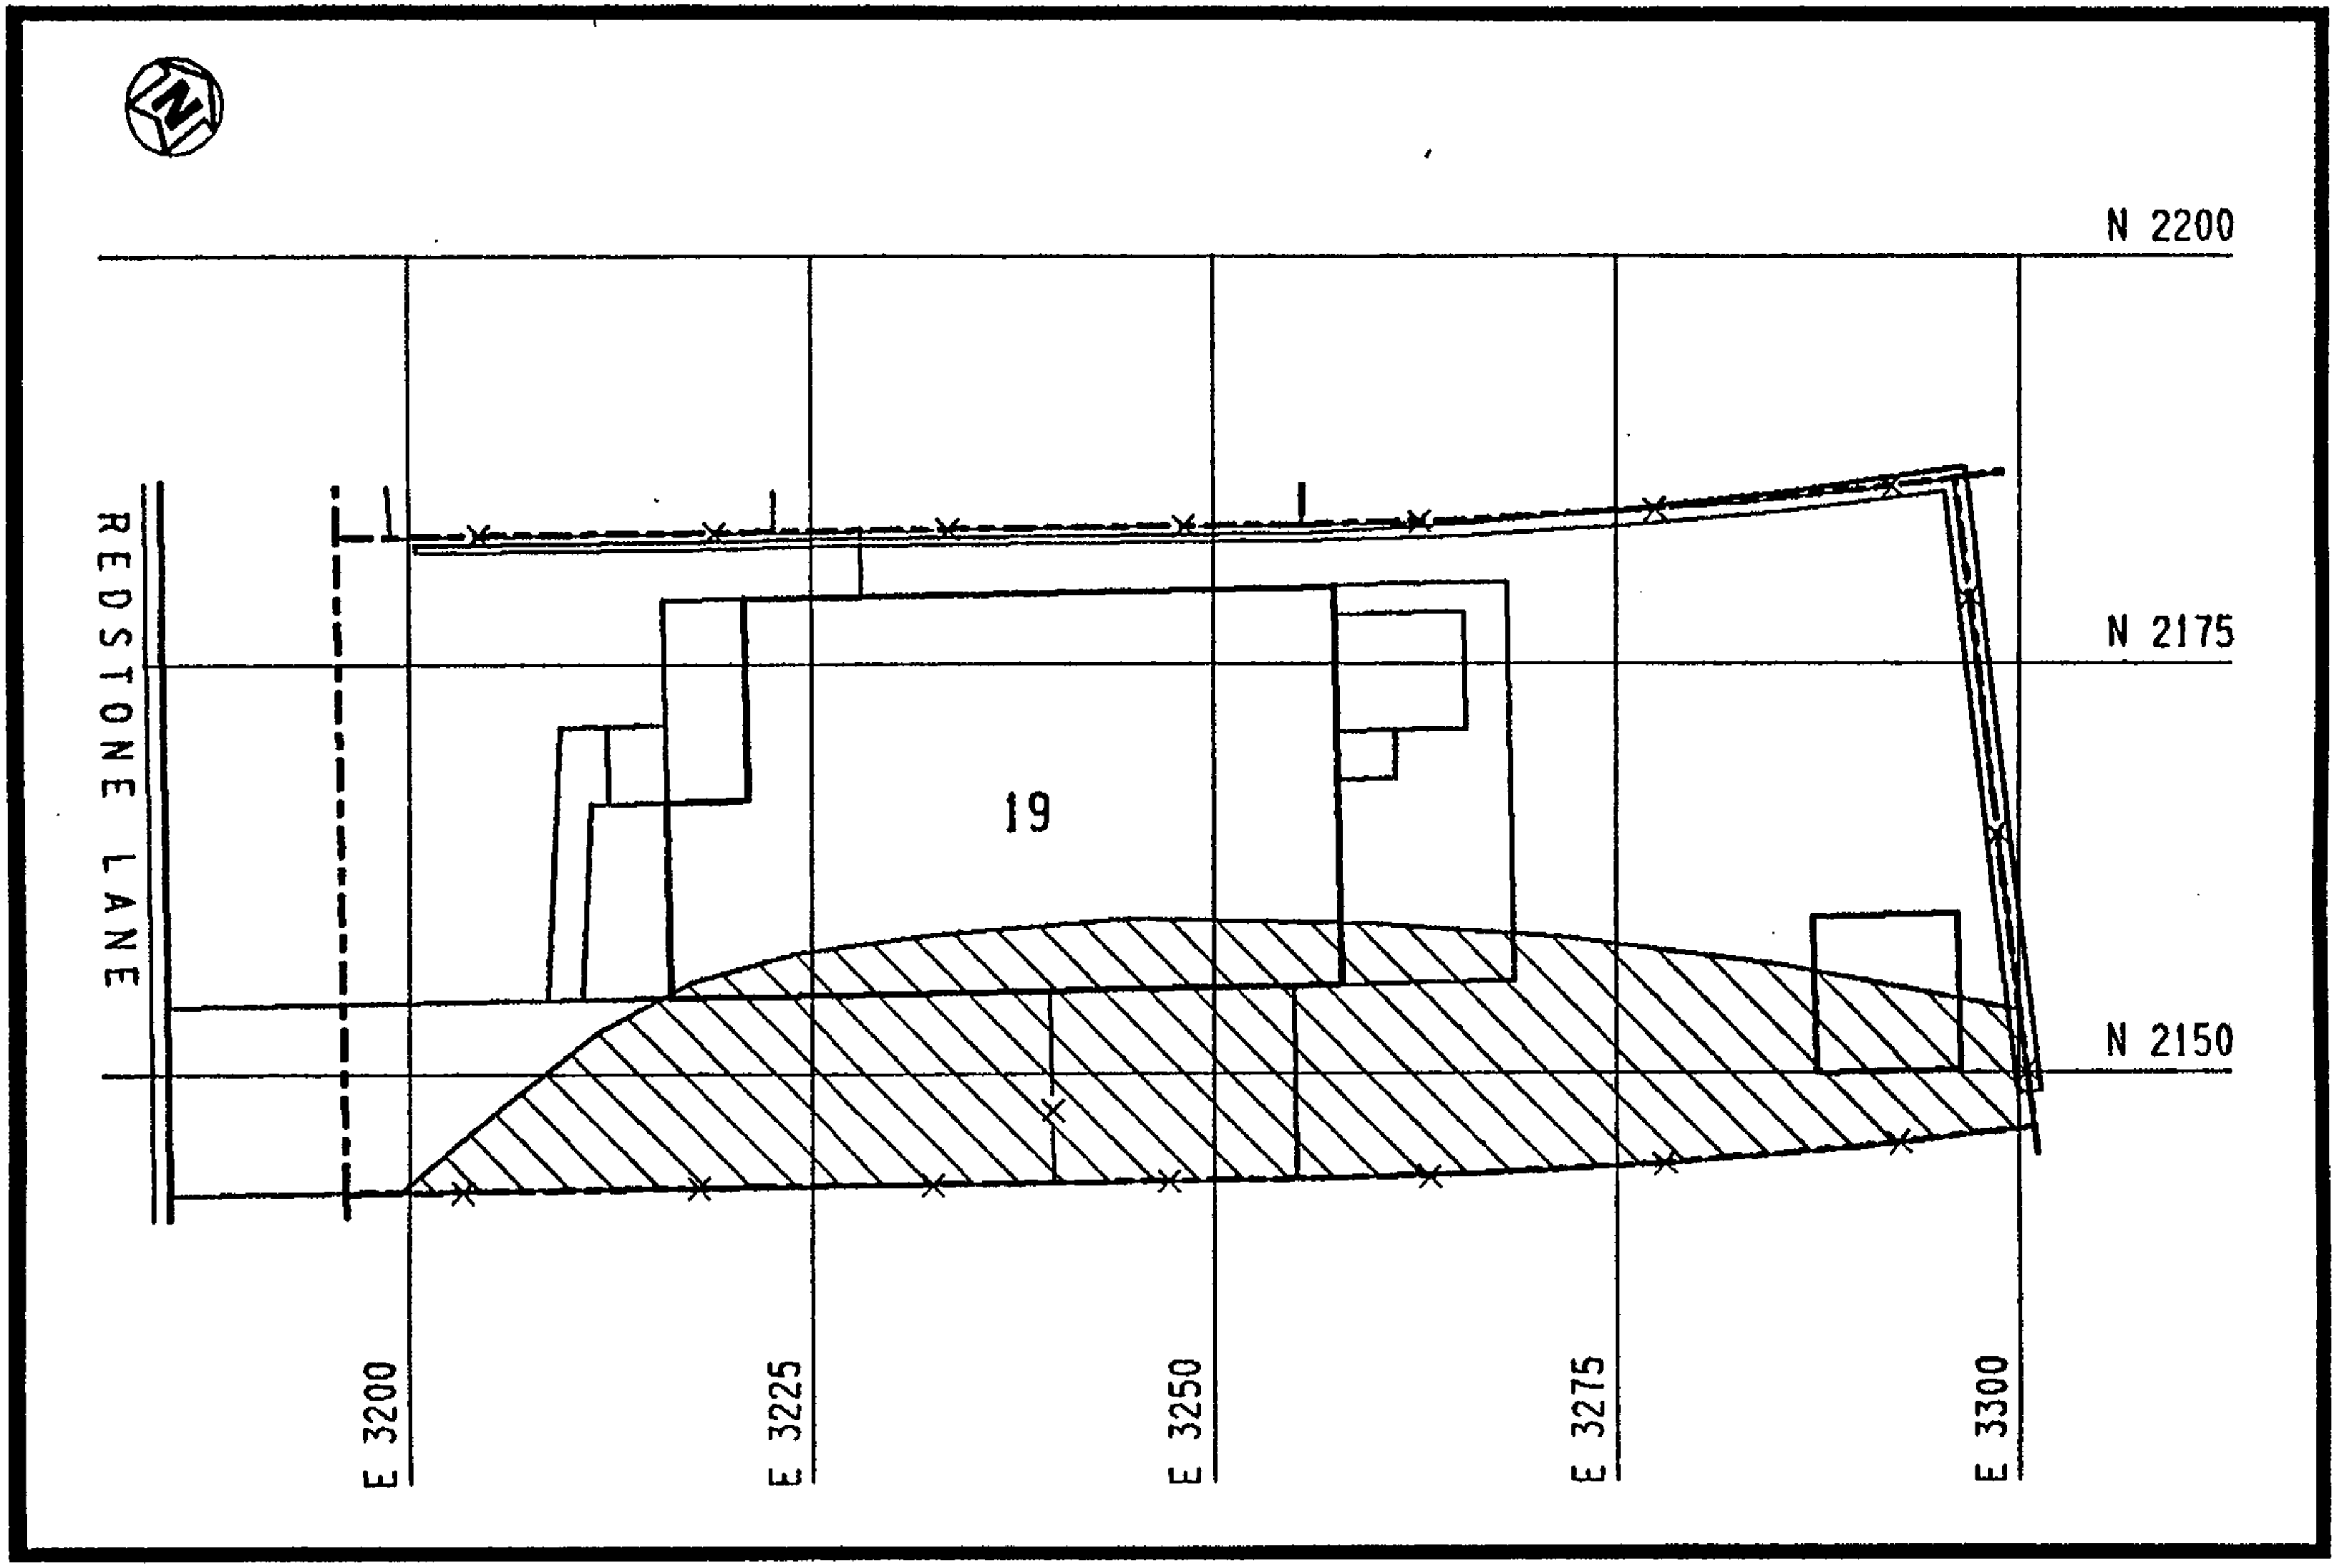
FIGURE 5-1 AREAS OF SUBSURFACE CONTAMINATION AT 19 REDSTONE LANE

Soil analysis data for this property did not indicate surface contamination. Subsurface investigation by gamma logging indicated contamination to a depth of 1.37 m (4.5 ft).

On the basis of near-surface gamma radiation measurements, surface and subsurface soil sample analyses, and downhole gamma logging, contamination on this property is believed to consist primarily of subsurface contamination at depths ranging from 1.06 m (3.5 ft) to 1.37 m (4.5 ft). The areas of subsurface contamination are shown in Figure 5-1. The subsurface contamination appears to extend beneath the residence.

It is apparent from review of historical documentation (e.g., aerial photographs of the area, interviews with local residents, and previous radiological surveys) that the subsurface contamination on this property lies along the former channel of Lodi Brook and its associated floodplain.

The contamination on this property is similar to contamination found on residential properties in close proximity to this property. It has been established that the Lodi Brook channel through these neighboring properties once occupied locations connecting to those where stream sediments were found at 19 Redstone Lane. Thus, the elevated gamma readings shown on gamma logs from boreholes drilled on this property serve as further indication of the suspected mechanism of transport for radiological contamination (i.e., stream deposition from Lodi Brook).
