RADIOLOGICAL CHARACTERIZATION REPORT FOR THE RESIDENTIAL PROPERTY AT 6 BRANCA COURT

Lodi, New Jersey

September 1989

Bechtel National, Inc.

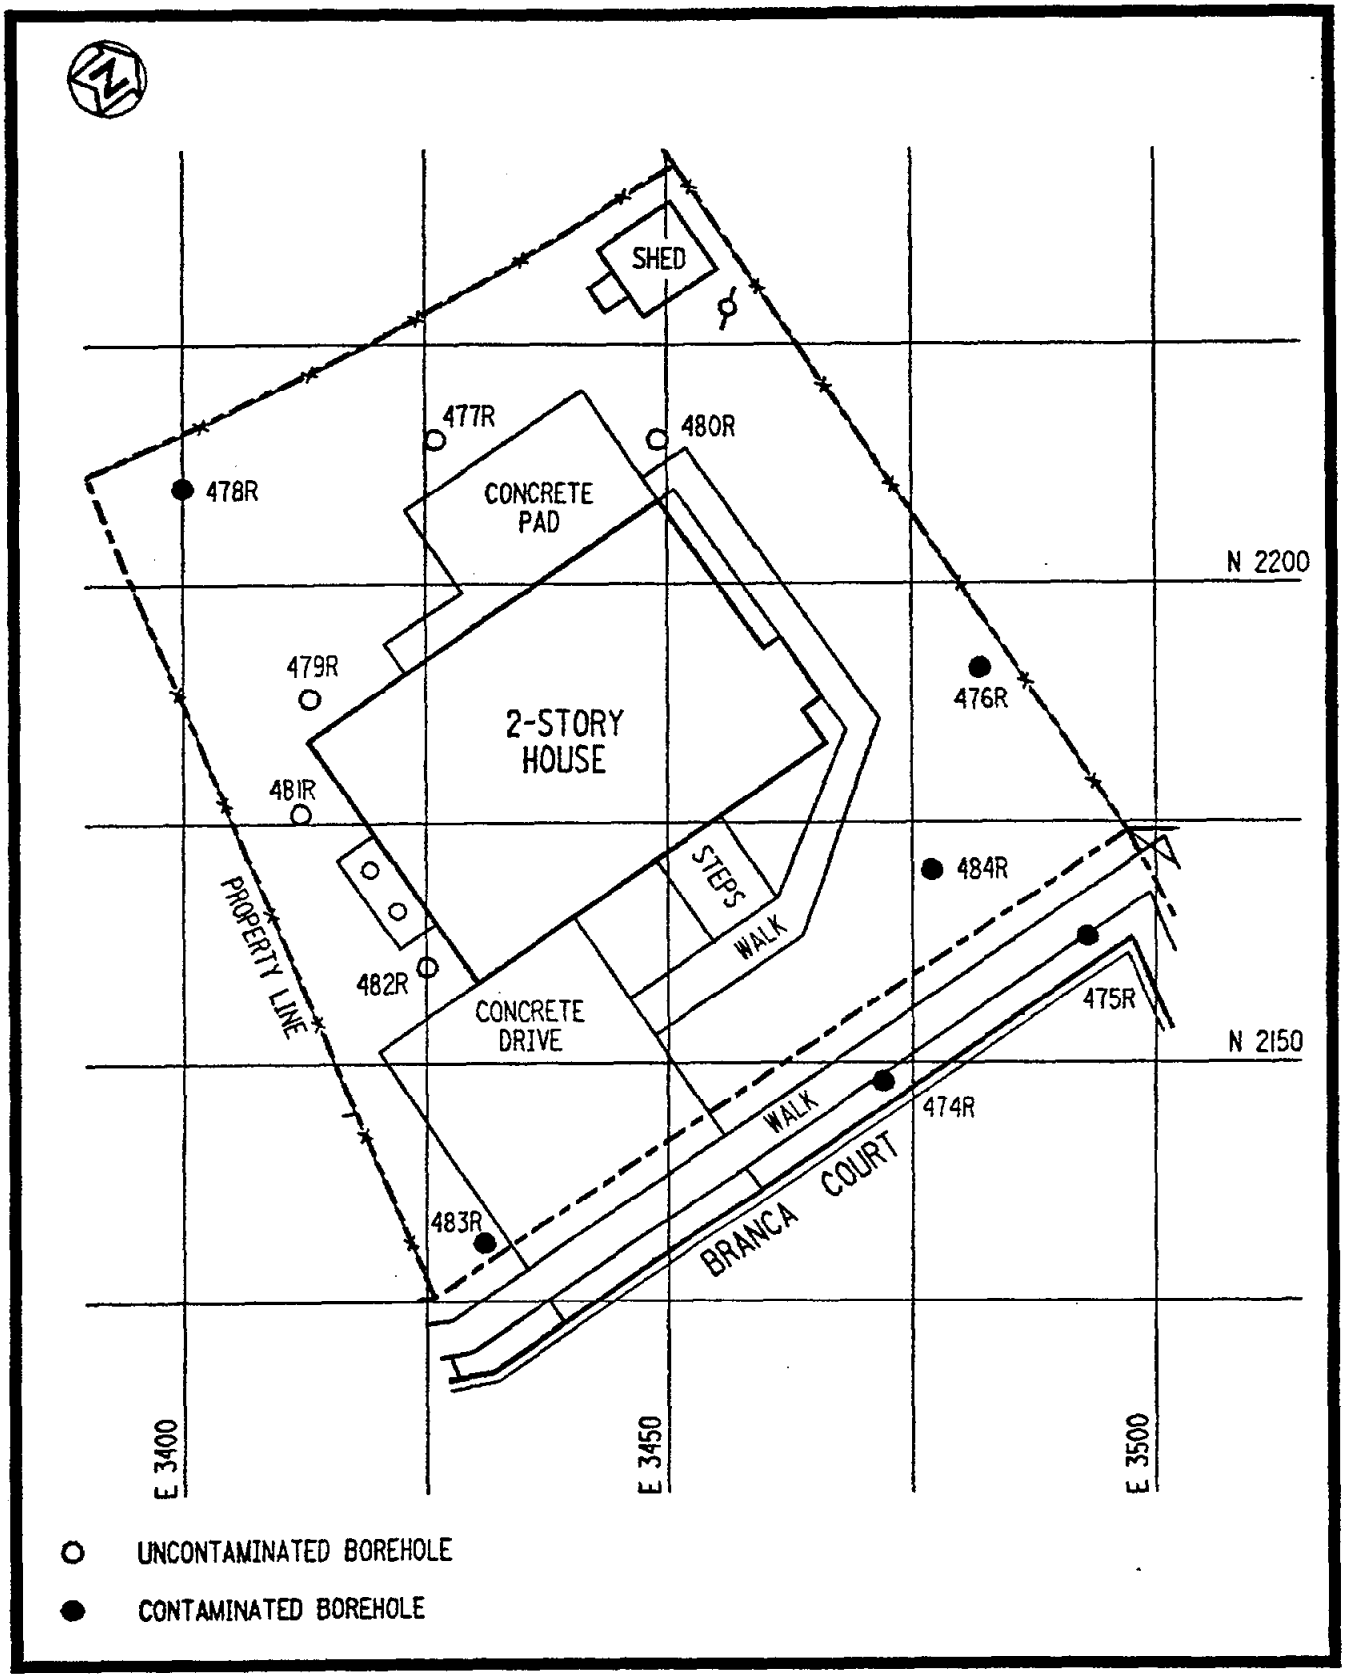
FIGURE 4-1 BOREHOLE LOCATIONS AT 6 BRANCA COURT

A subsurface investigation was conducted to determine the depth to which the previously identified surface contamination extended and to locate subsurface contamination where there was no surface manifestation. The subsurface characterization consisted of drilling eleven boreholes (Figure 4-1) [using either a 7.6-cm- (3-in.-) or 15.2-cm- (6-in.-) diameter auger bit], and gamma logging them. The boreholes were drilled to depths determined in the field by the radiological and geological support representatives.

concentration of the contamination. The gamma-logging data were reviewed to identify trends, whether or not concentrations exceeded the guidelines.

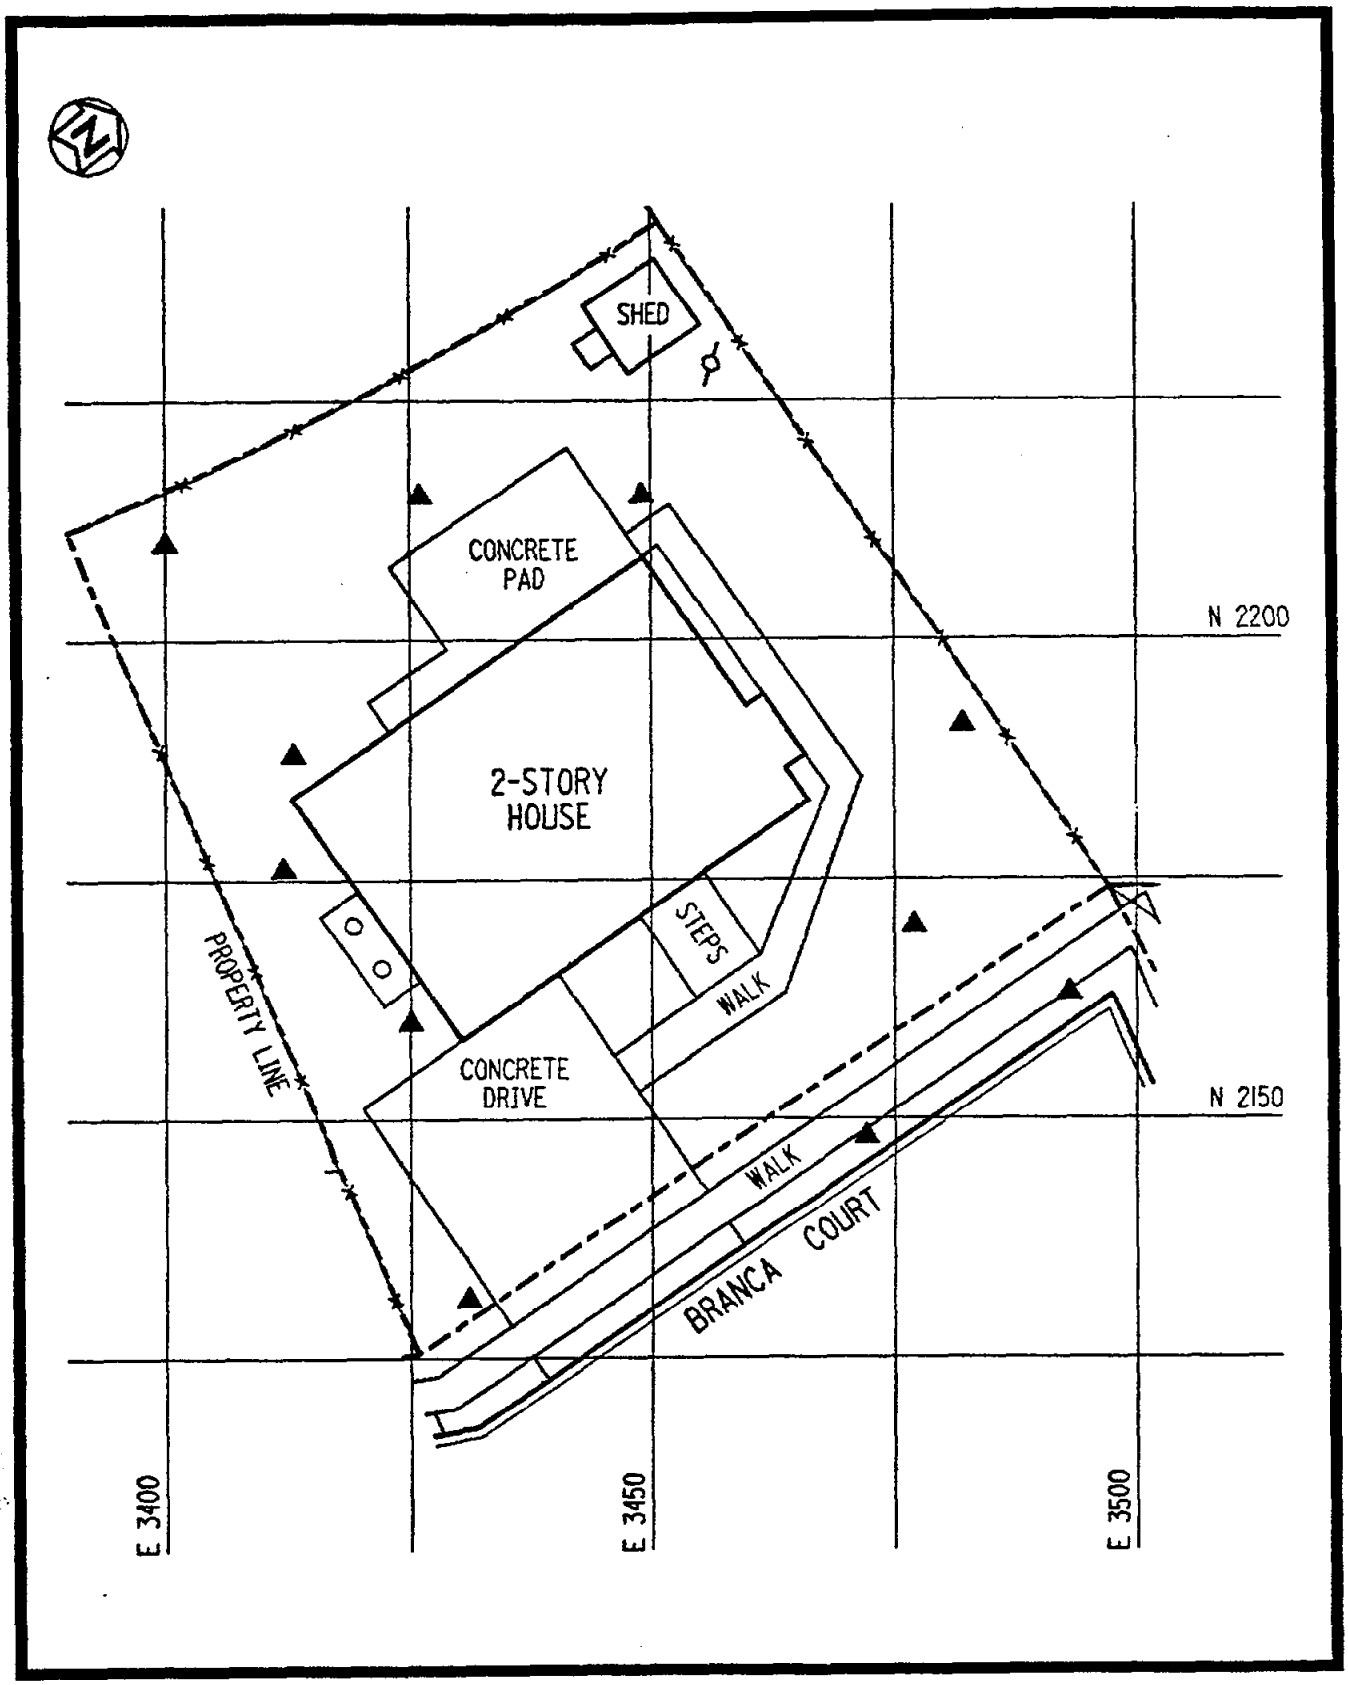
FIGURE 4-2 SURFACE AND SUBSURFACE SOIL SAMPLING LOCATIONS AT 6 BRANCA COURT

Subsurface soil sample concentrations ranged from 1.2 to 17.2 pCi/g for thorium-232 and from 0.4 to 1.7 pCi/g for radium-226. The average background level in this area for both radium-226 and thorium-232 is 1.0 pCi/g. The concentrations of uranium-238 in subsurface soil samples ranged from less than 4.4 to less than 12.8 pCi/g. Because the major contaminants at the vicinity properties are thorium and radium, the decontamination guidelines provide the appropriate guidance for the cleanup activities. DOE believes that these guidelines are conservative for

Surface soil samples [depths from 0.0 to 15.2 cm (0.5 in.)] were taken at eleven locations on the property (Figure 4-2). These samples were analyzed for thorium-232, uranium-238, and radium-226. The concentrations in these samples ranged from less than 5.3 to less than 8.0 pCi/g for uranium-238, from 0.7 to 11.6 pCi/g for thorium-232, and from 0.6 to 1.1 pCi/g for radium-226. Analytical results for surface soils are provided in Table 5-1; these data showed concentrations of thorium-232, in one soil sample, in excess of DOE guidelines (5 pCi/g plus background of 1 pCi/g for surface soils) with a maximum concentration of 11.6 pCi/g. Use of the "less than" (<) notation in reporting results indicates that the radionuclide was not present in concentrations that are quantitative with the instruments and techniques used. The "less than" value represents the lower bound of the

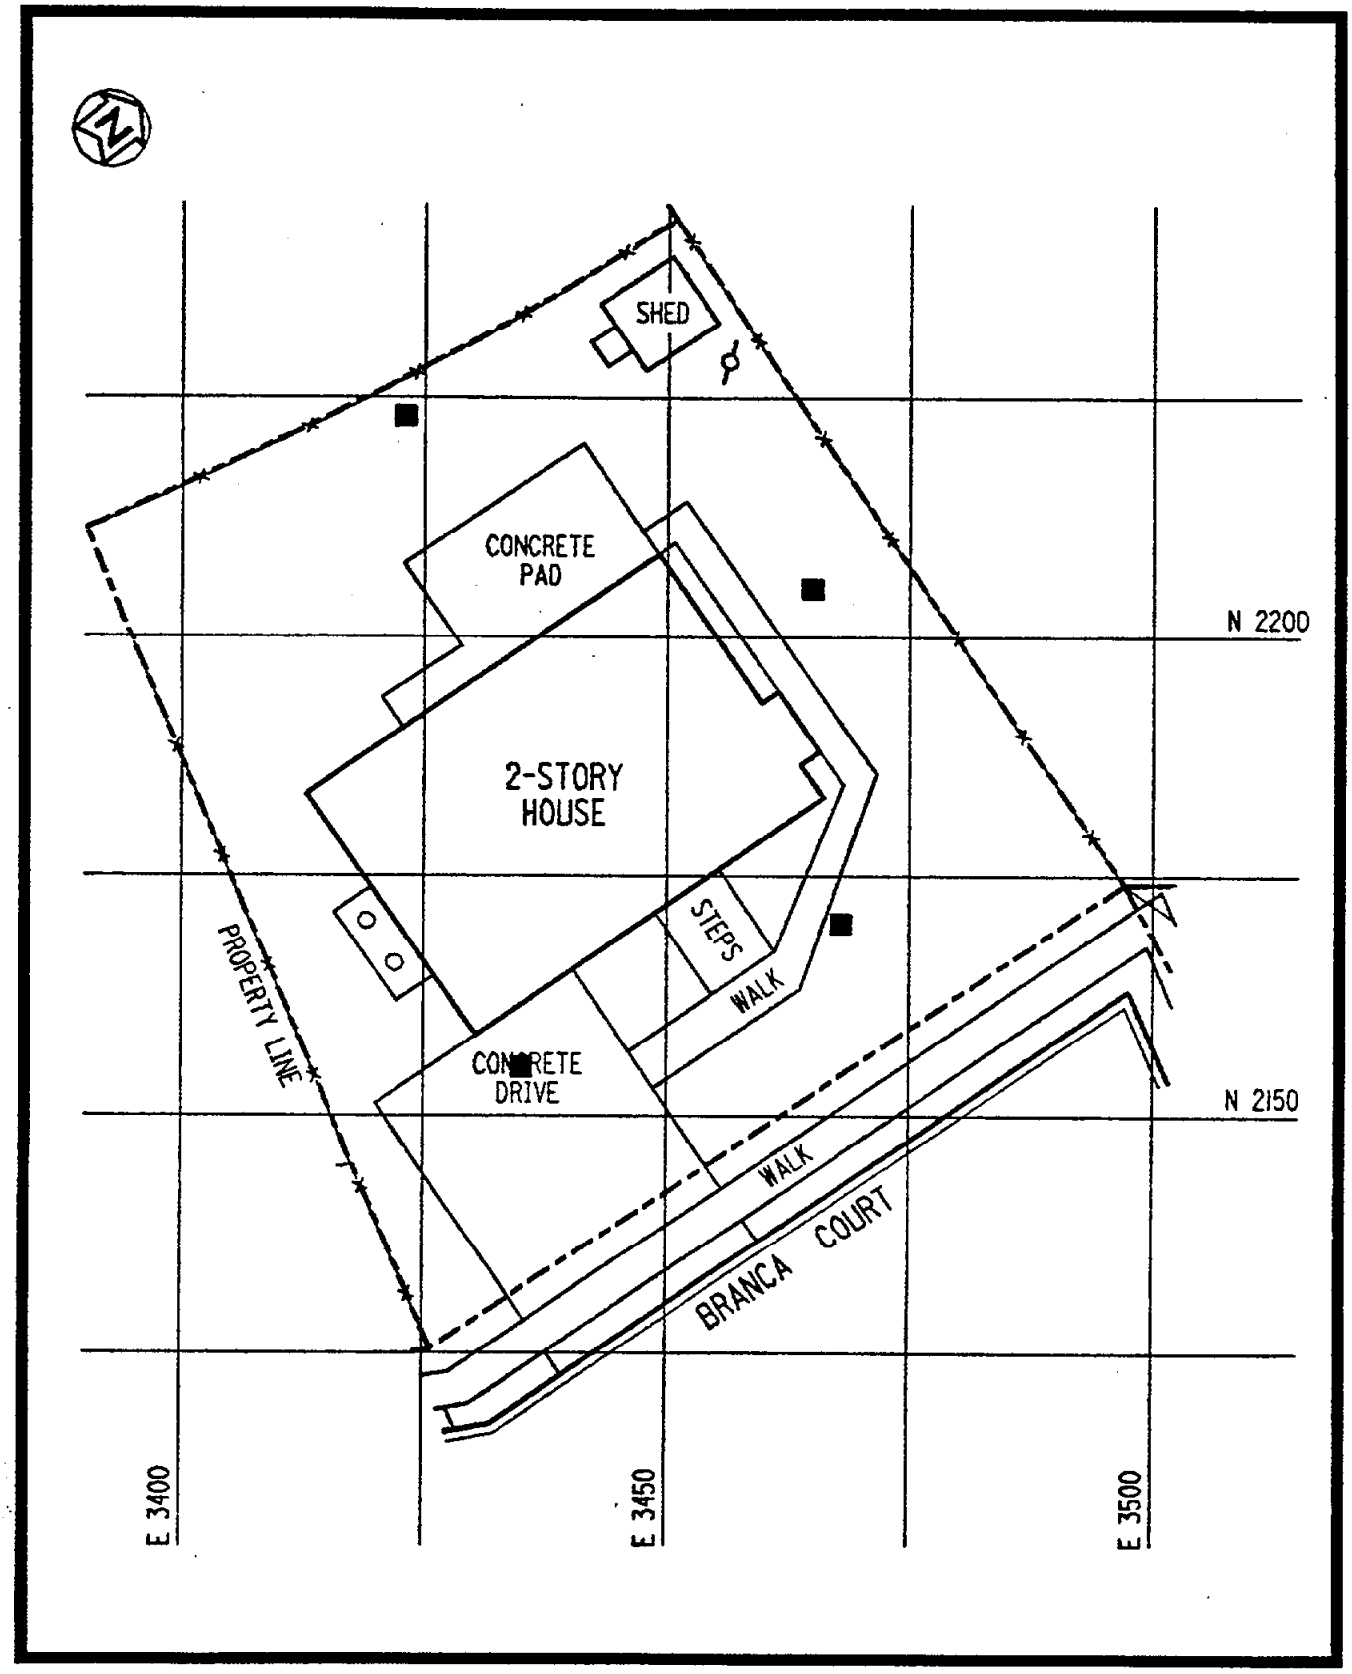
FIGURE 4-3 GAMMA EXPOSURE RATE MEASUREMENT LOCATIONS AT 6 BRANCA COURT

Exterior gamma radiation exposure rate measurements ranged from 8 to 9 μR/h, including background. These results can be found in Table 5-3. These measurements are consistent with the average background exposure rate of 9 μR/h (Ref. 13). The indoor exposure rate measurement was 5 μR/h, including background (Table 5-3). For comparison, the DOE guideline for indoor exposure rate is 20 μR/h.

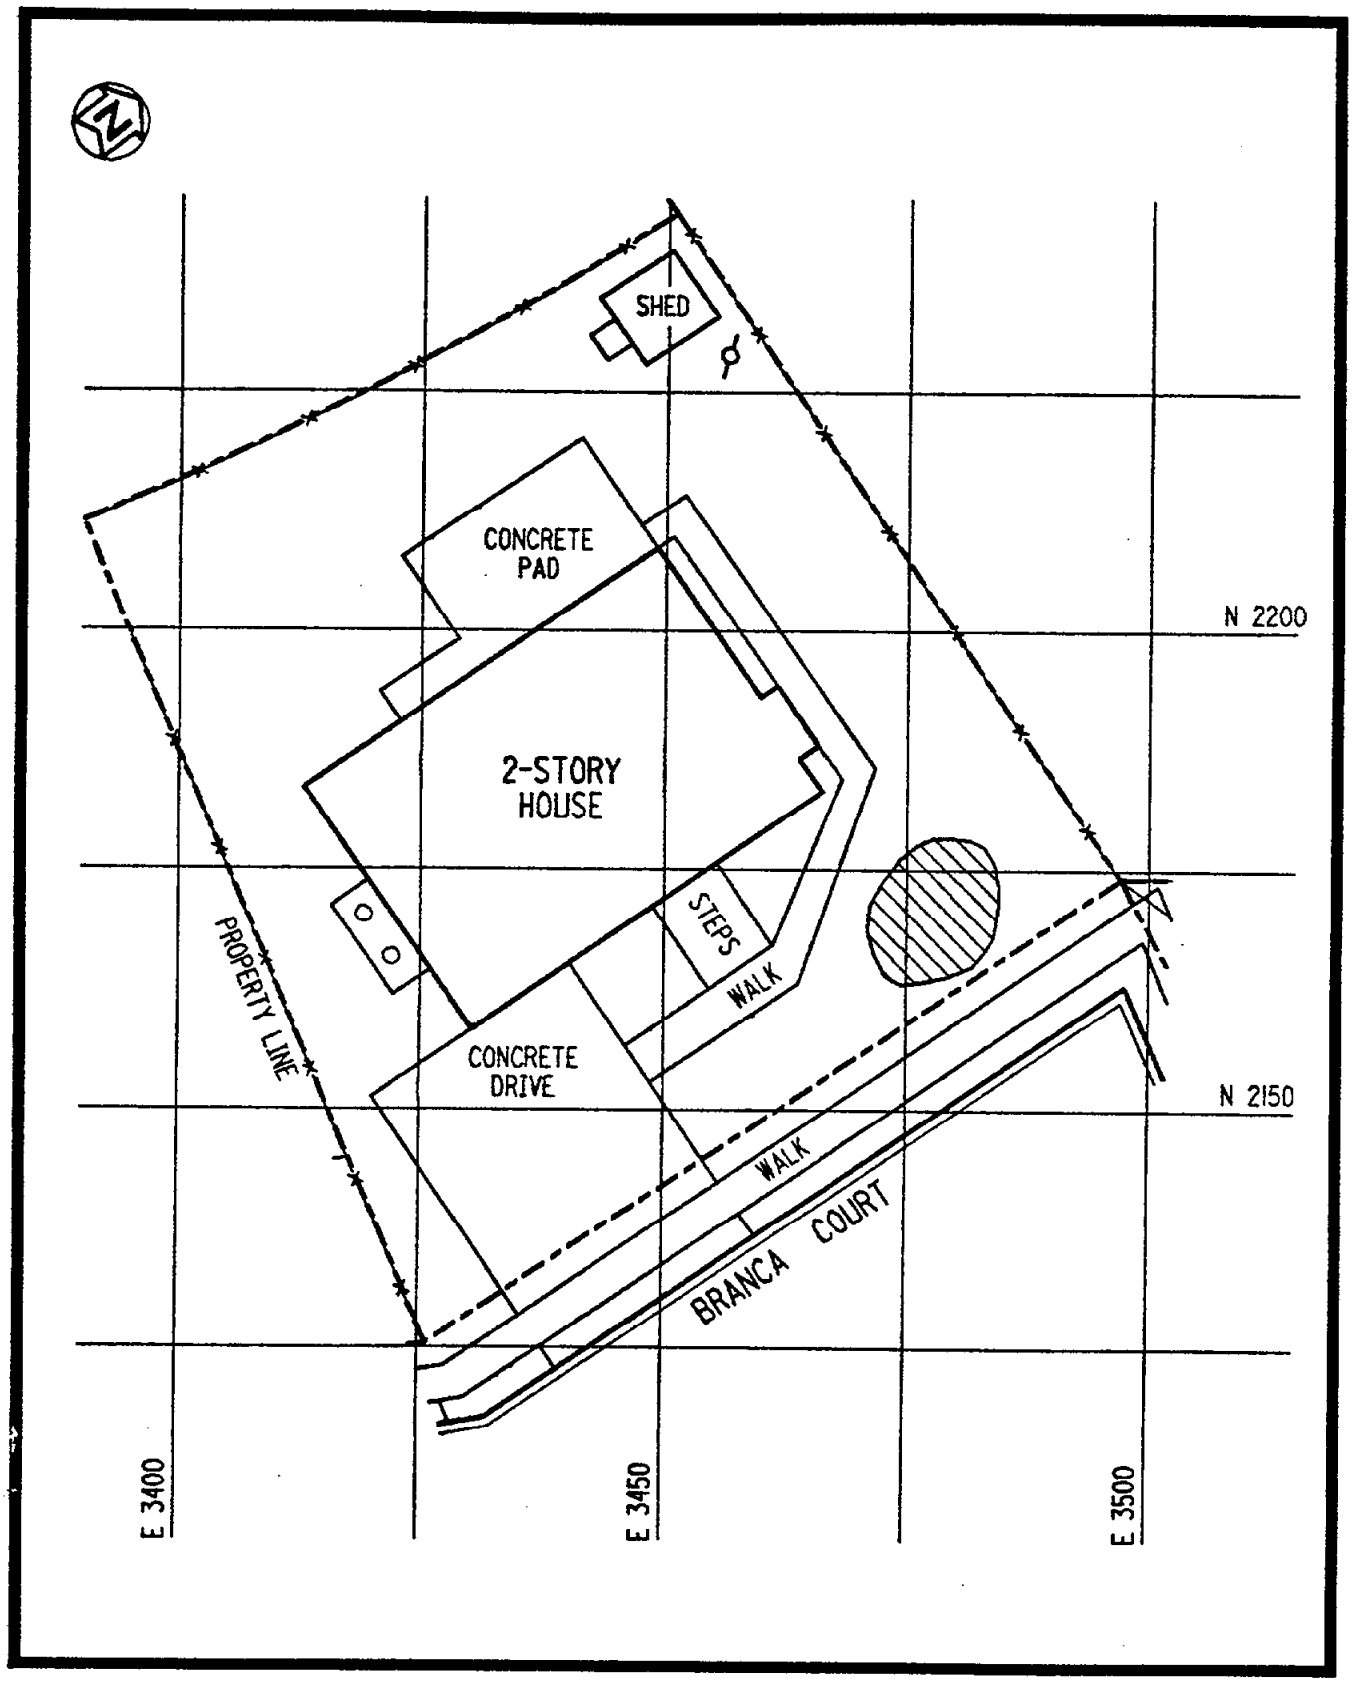
FIGURE 5-1 AREAS OF SURFACE CONTAMINATION AT 6 BRANCA COURT

Near-surface gamma radiation measurements on the property ranged from 3,000 cpm to approximately 6,000 cpm. The average background level for this area is 5,000 cpm. A measurement of 11,000 cpm is approximately equal to the DOE guideline for thorium-232 of 5 pCi/g above background for surface soil contamination. Using this correlation, the near-surface gamma measurements were used to determine the extent of surface contamination and the basis for selecting the locations of soil samples. Areas of surface contamination are shown in Figure 5-1.

On the basis of near-surface gamma radiation measurements, surface and subsurface soil sample analyses, and downhole gamma logging, contamination on this property is believed to consist primarily of subsurface contamination at depths ranging from 15.2 cm (0.5 in.) to 2.28 m (7.5 ft). The areas of subsurface contamination are shown in Figure 5-2. The subsurface contamination appears to extend beneath the northeast corner of the residence as well as into the street in front of the property.

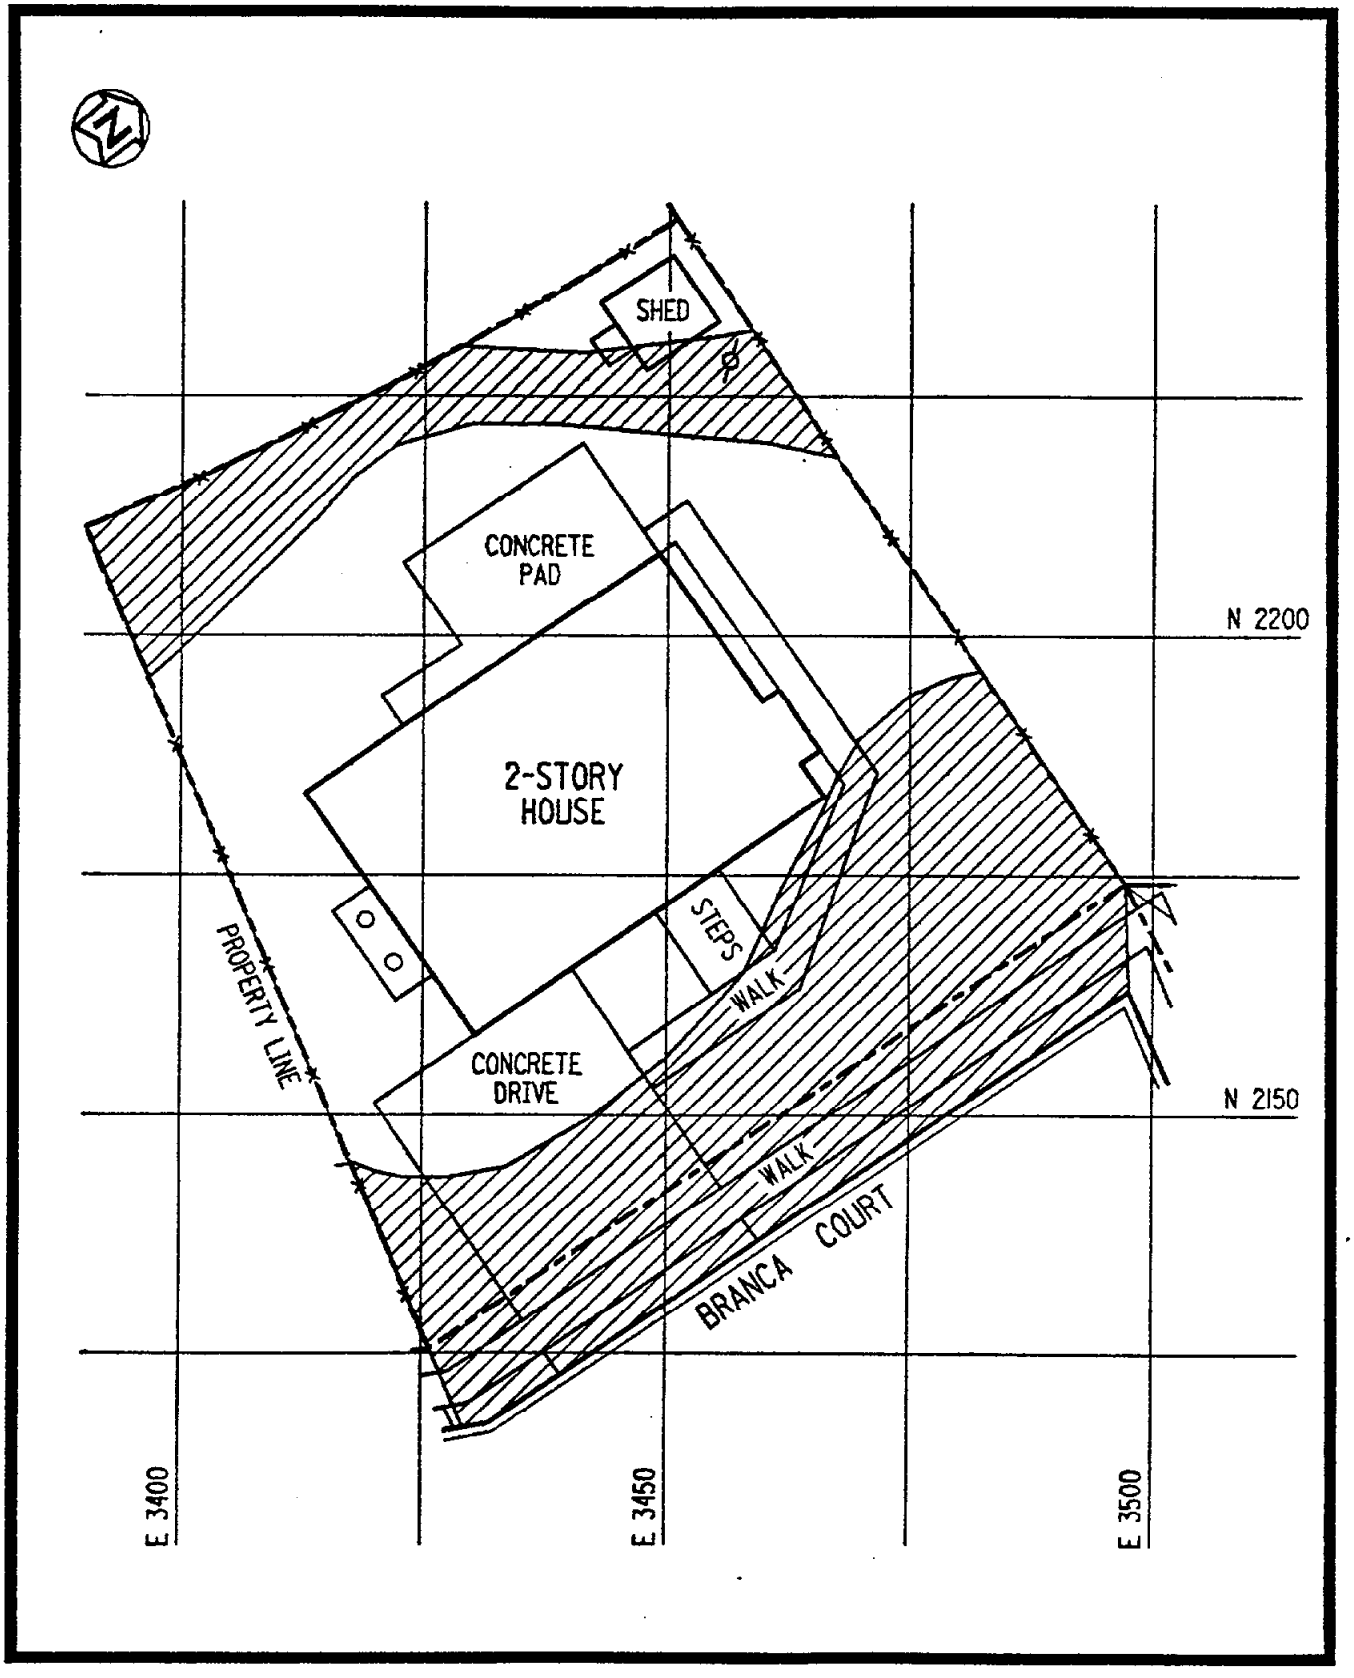
FIGURE 5-2 AREAS OF SUBSURFACE CONTAMINATION AT 6 BRANCA COURT

Soil analysis data for this property indicated an isolated area of surface contamination. Subsurface investigation by gamma logging indicated contamination to a depth of 2.28 m (7.5 ft).

The contamination on this property is similar to contamination found on residential properties in close proximity to this property. It has been established that the Lodi Brook channel through these adjacent properties once occupied locations connecting to those where stream sediments were found at 6 Branca Court. Thus, the elevated gamma readings shown on gamma logs from boreholes drilled on this property serve as further indication of the suspected mechanism of transport for radiological contamination (i.e., stream deposition from Lodi Brook).
