RADIOLOGICAL CHARACTERIZATION REPORT FOR THE RESIDENTIAL PROPERTY AT 17 REDSTONE LANE

Lodi, New Jersey

September 1989

Bechtel National, Inc.

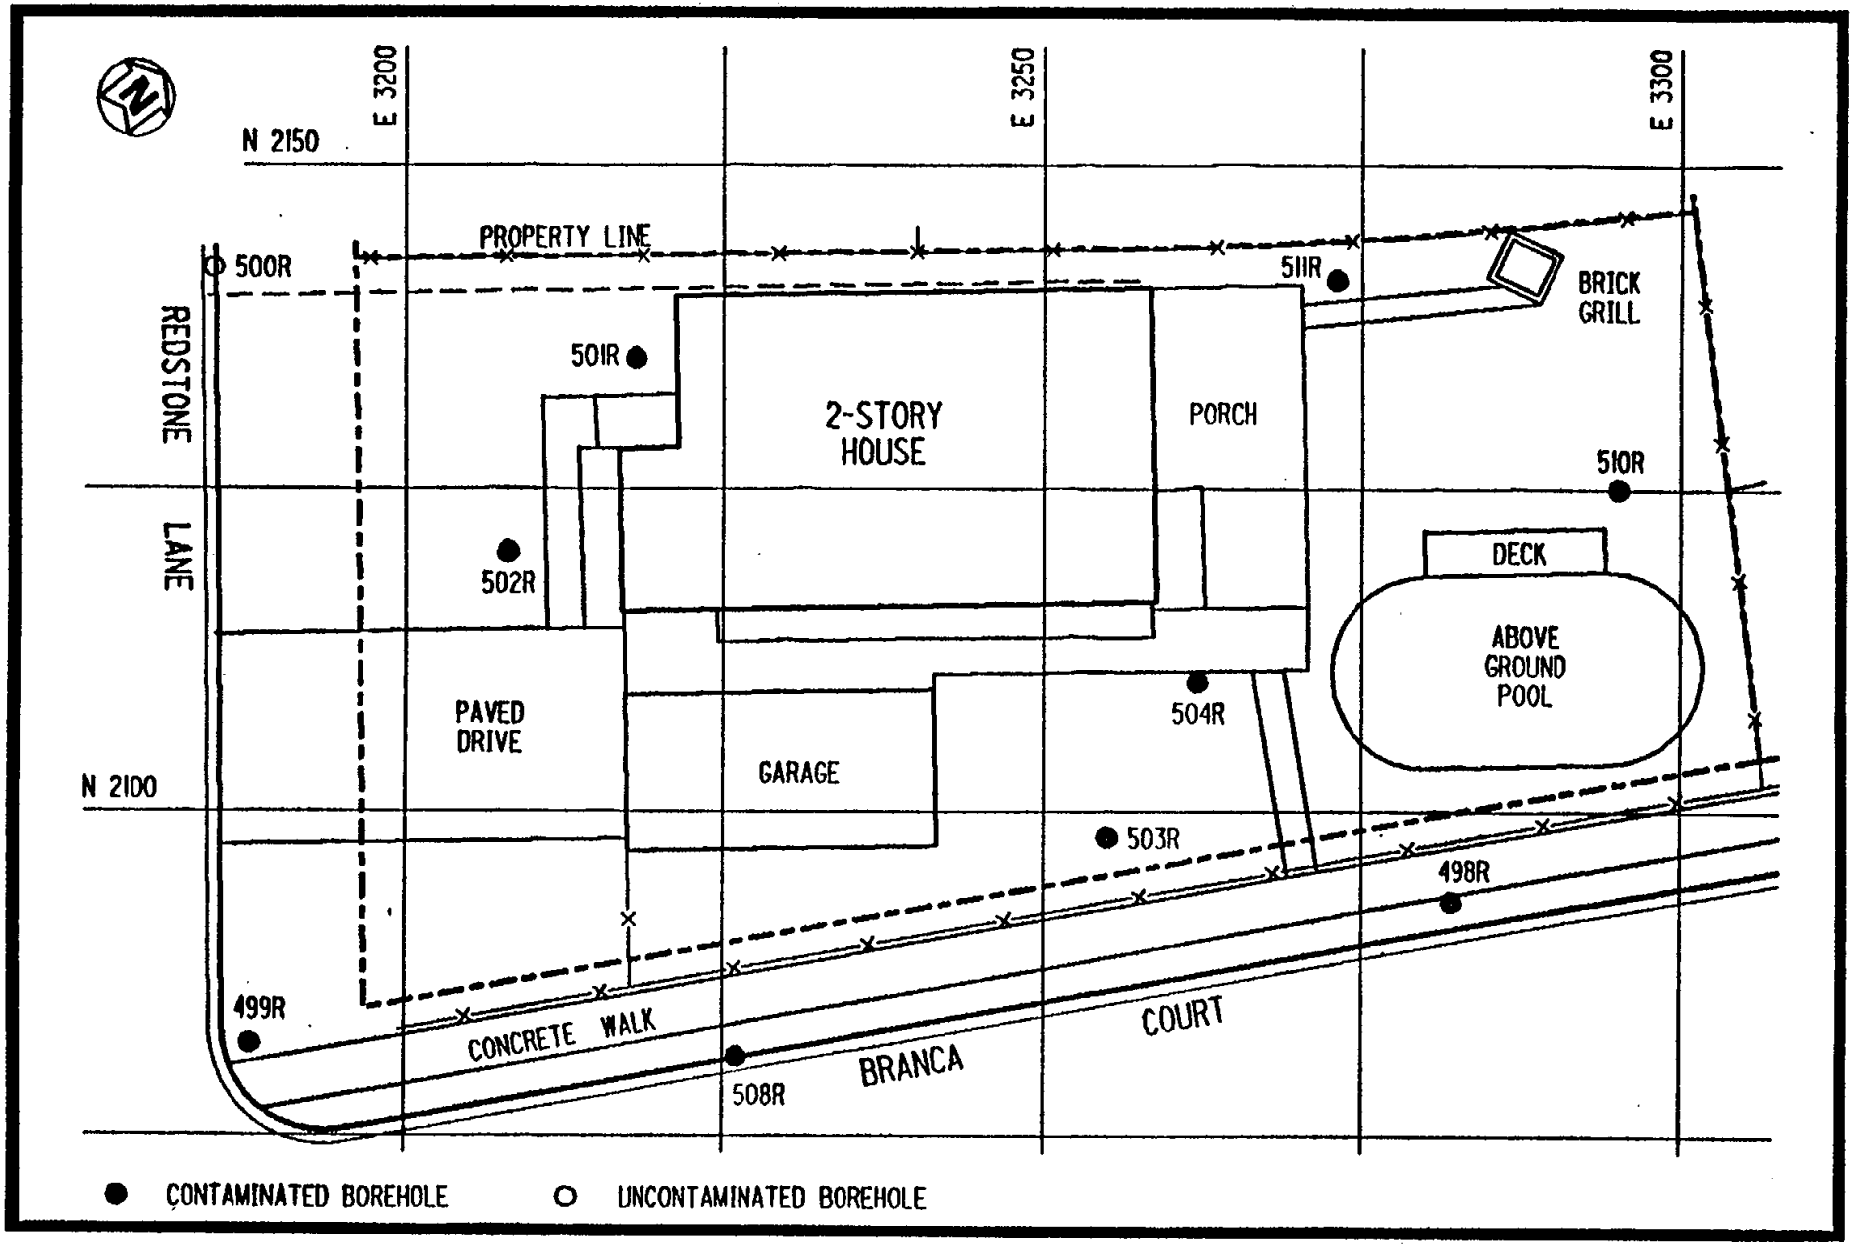
FIGURE 4-1 BOREHOLE LOCATIONS AT 17 REDSTONE LANE

Gamma radiation measurements were taken at 15.2-cm (6-in.) vertical intervals to determine the depth and concentration of the contamination. The gamma-logging data were reviewed

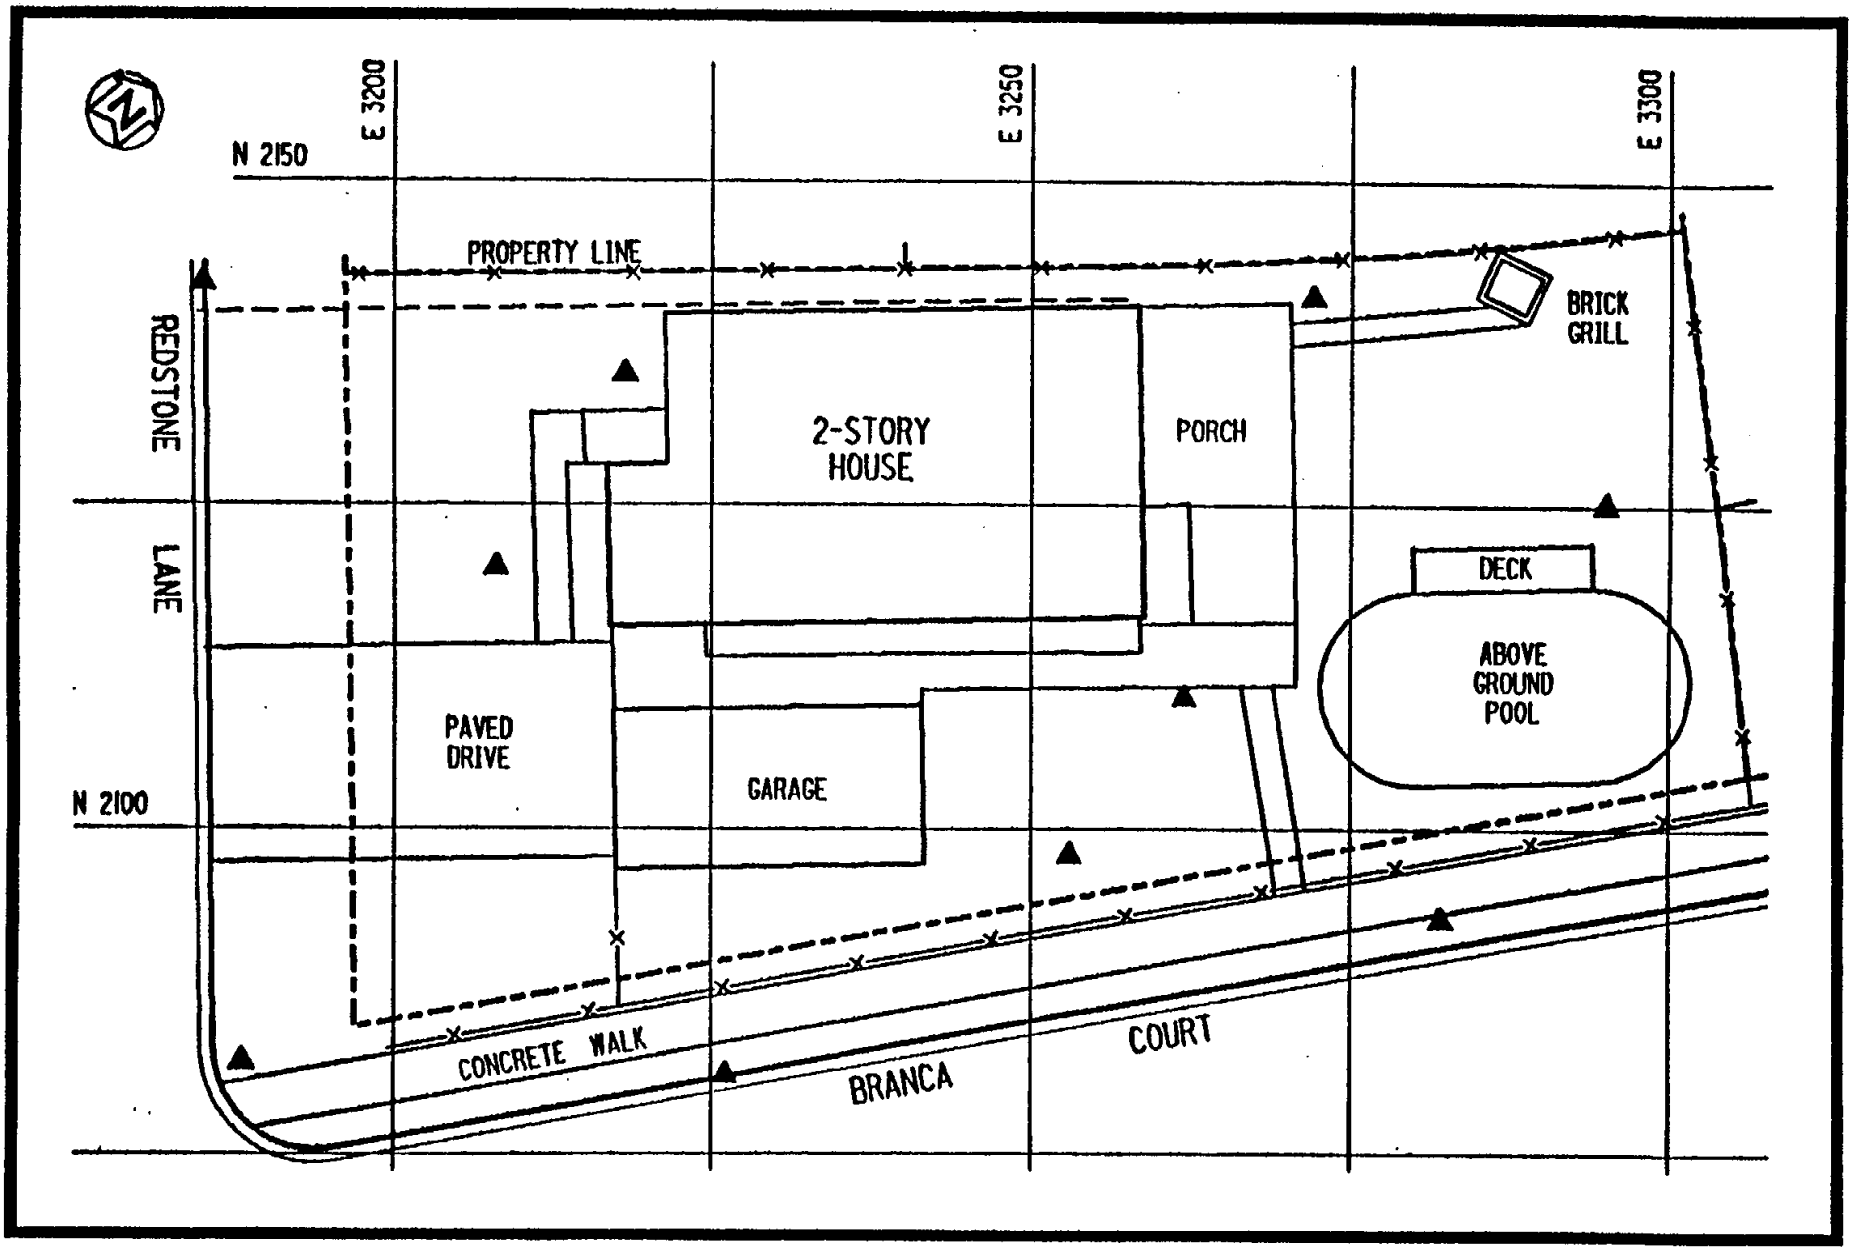
FIGURE 4-2 SURFACE AND SUBSURFACE SOIL SAMPLING LOCATIONS AT 17 REDSTONE LANE

Subsurface soil samples were collected from ten locations (Figure 4-2) using the side-wall sampling method and were analyzed to compare laboratory soil sample results to downhole gamma radiation measurements. A cup or can attached to a steel pipe or wooden stake was inserted into the borehole and used to scrape samples off the side of the borehole at a specified depth. The subsurface soil samples were analyzed for radium-226, uranium-238, and thorium-232 in the same manner as the surface soil samples.

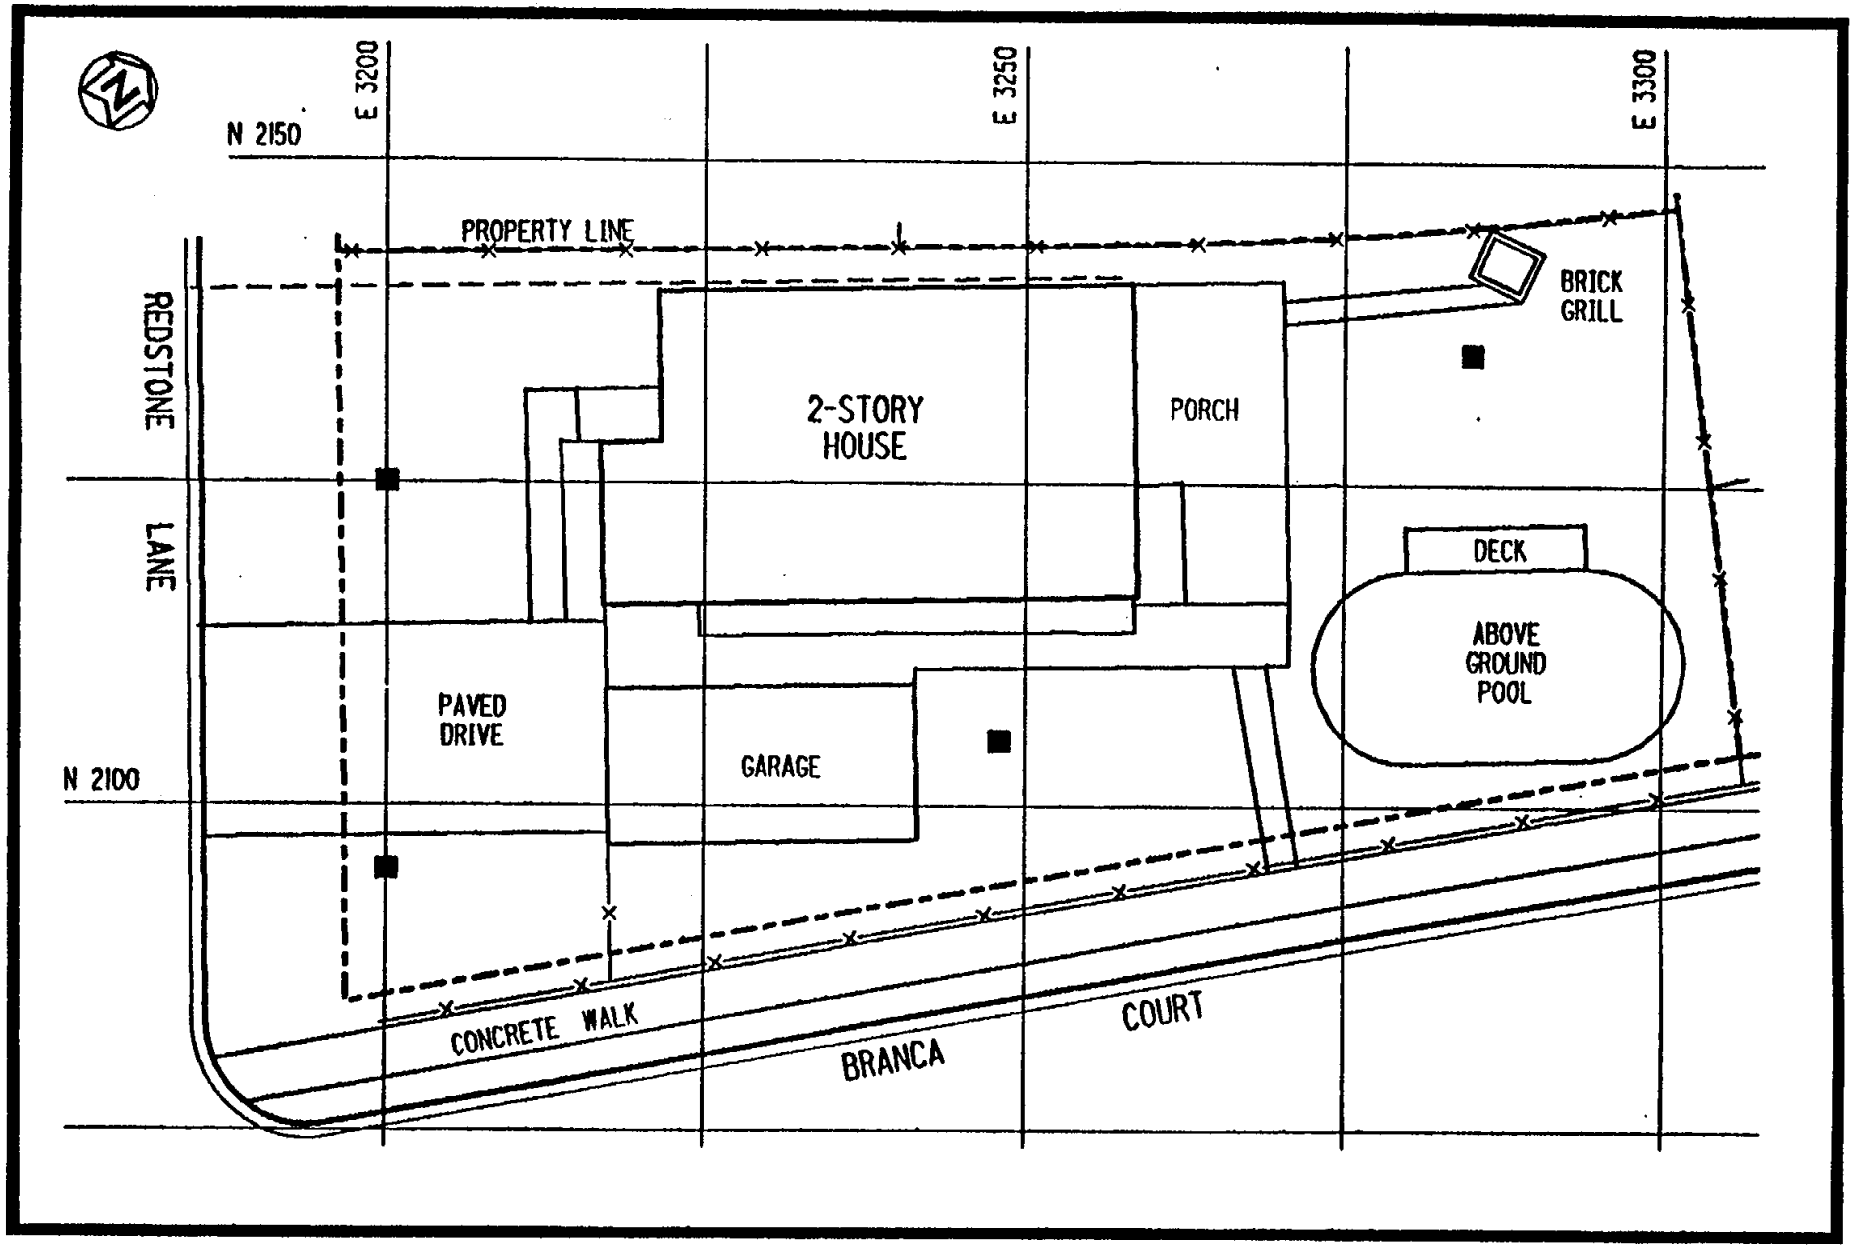
FIGURE 4-3 GAMMA EXPOSURE RATE MEASUREMENT LOCATIONS AT 17 REDSTONE LANE

Exterior gamma exposure rate measurements were made at four locations throughout the property grid system and at one location inside the residence. To obtain these measurements, either a 5.0- by 5.0-cm (2- by 2-in.) thallium-activated sodium iodide gamma scintillation detector designed to detect gamma radiation only or a pressurized ionization chamber (PIC) was used. Measurement locations are shown in Figure 4-3. The PIC instrument has a response to gamma radiation that is proportional to exposure in roentgens. A conversion factor for gamma scintillation to the PIC was established through a correlation of these two measurements at four locations in the vicinity of the property. The unshielded gamma scintillation detector readings were then used to estimate gamma exposure rates for each location. These measurements were taken 1 m (3 ft) above the ground. The locations were determined to be representative of the entire property. Interior measurements are generally obtained with the gamma scintillation instrument rather than the PIC because of its smaller size and the desire to minimize the technician's time inside the residence.

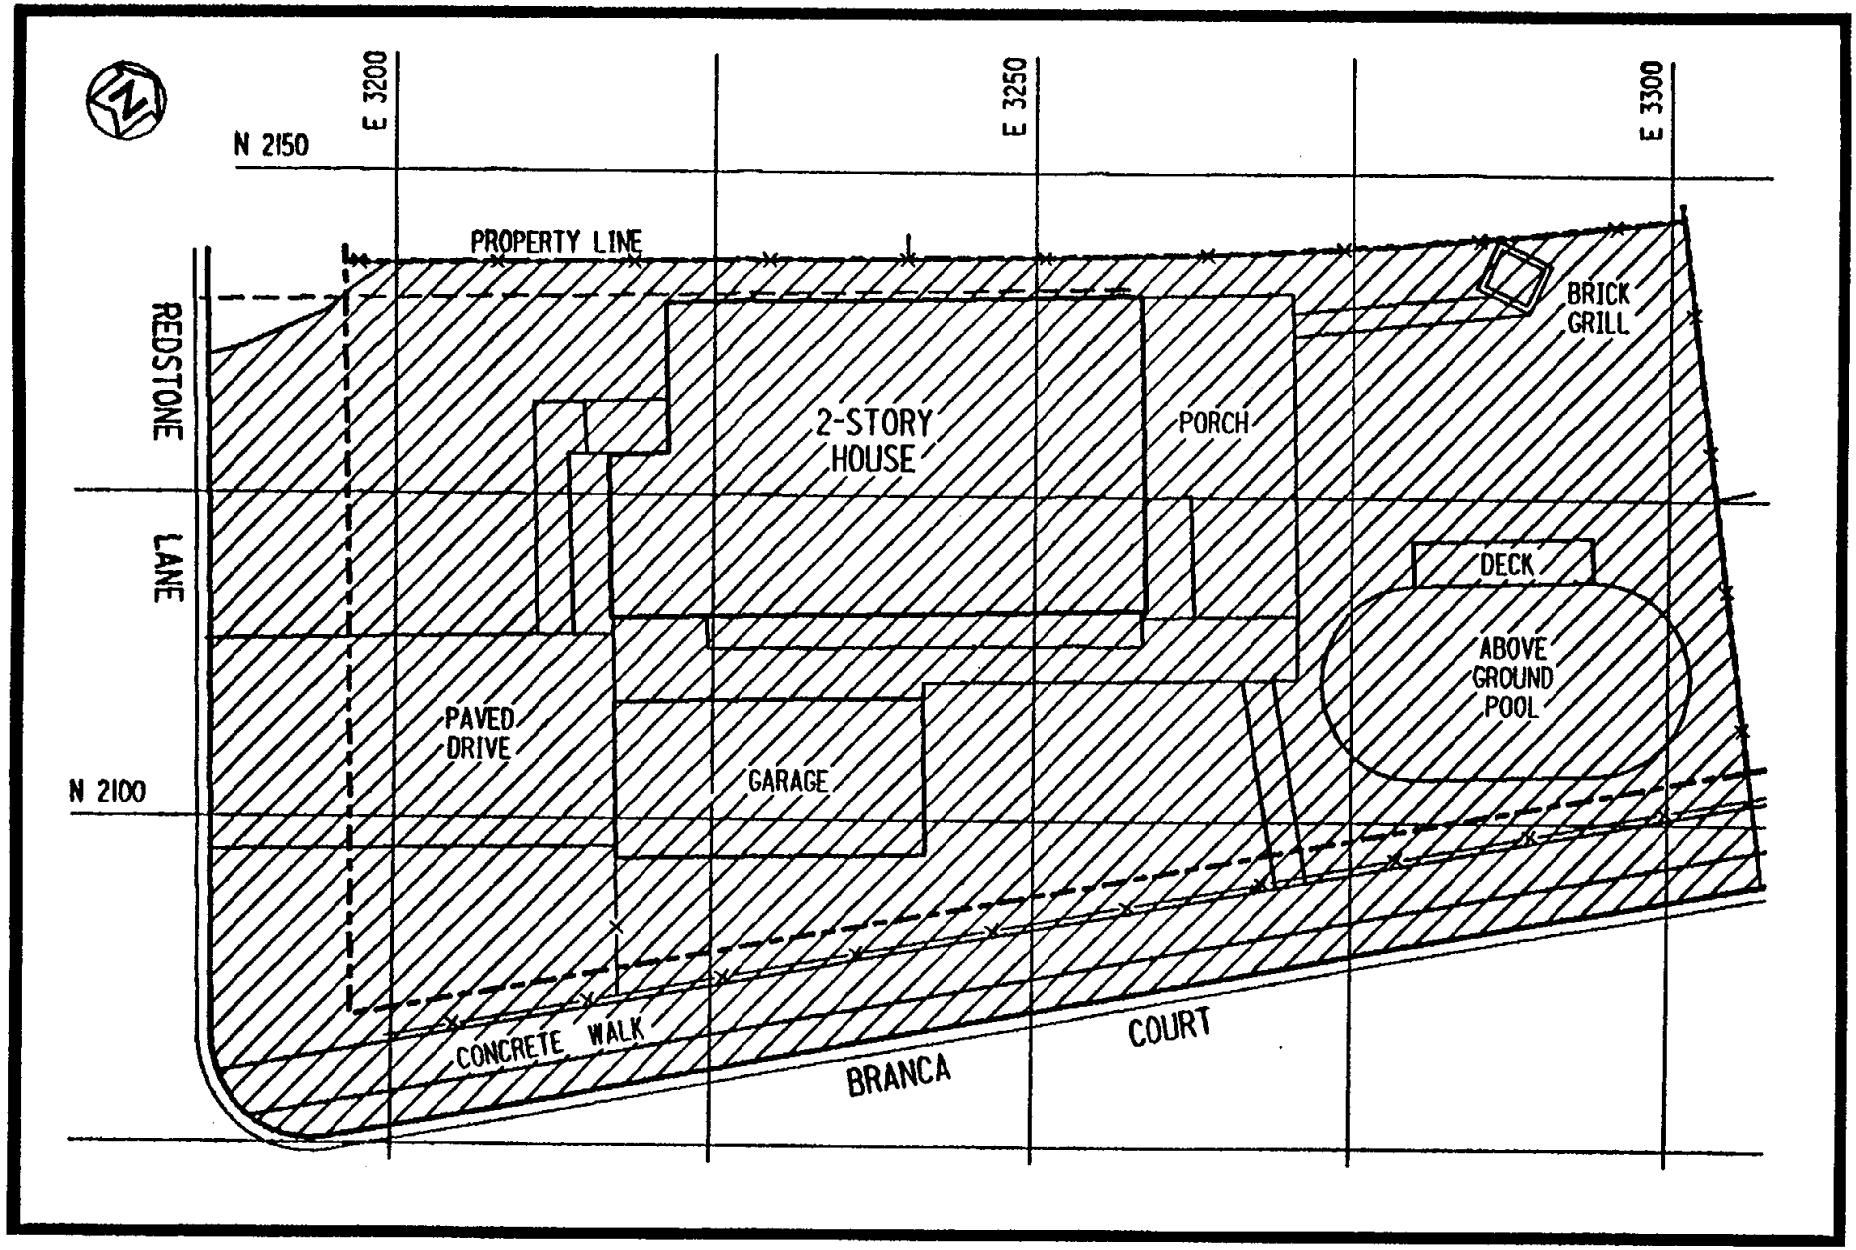
FIGURE 5-1 AREAS OF SUBSURFACE CONTAMINATION
AT 17 REDSTONE LANE

On the basis of near-surface gamma radiation measurements, surface and subsurface soil sample analyses, and downhole gamma logging, contamination on this property is believed to consist primarily of subsurface contamination at depths ranging from 0.60 m (2.0 ft) to 2.59 m (8.5 ft). The areas of subsurface contamination are shown in Figure 5-1. The subsurface contamination appears to extend beneath the residence as well as into the street in front of the property.

It is apparent from review of historical documentation (e.g., aerial photographs of the area, interviews with local residents, and previous radiological surveys) that the subsurface contamination on this property lies along the former channel of Lodi Brook and its associated floodplain.

The contamination on this property is similar to contamination found on residential properties in close proximity to this property. It has been established that the Lodi Brook channel through these neighboring properties once occupied locations connecting to those where stream sediments were found at 17 Redstone Lane. Thus, the elevated gamma readings shown on gamma logs from boreholes drilled on this property serve as further indication of the suspected mechanism of transport for radiological contamination (i.e., stream deposition from Lodi Brook).
