RADIOLOGICAL CHARACTERIZATION REPORT FOR THE RESIDENTIAL PROPERTY AT 60 TRUDY DRIVE

Lodi, New Jersey

September 1989

RADIOLOGICAL CHARACTERIZATION REPORT FOR THE RESIDENTIAL PROPERTY AT 60 TRUDY DRIVE LODI, NEW JERSEY

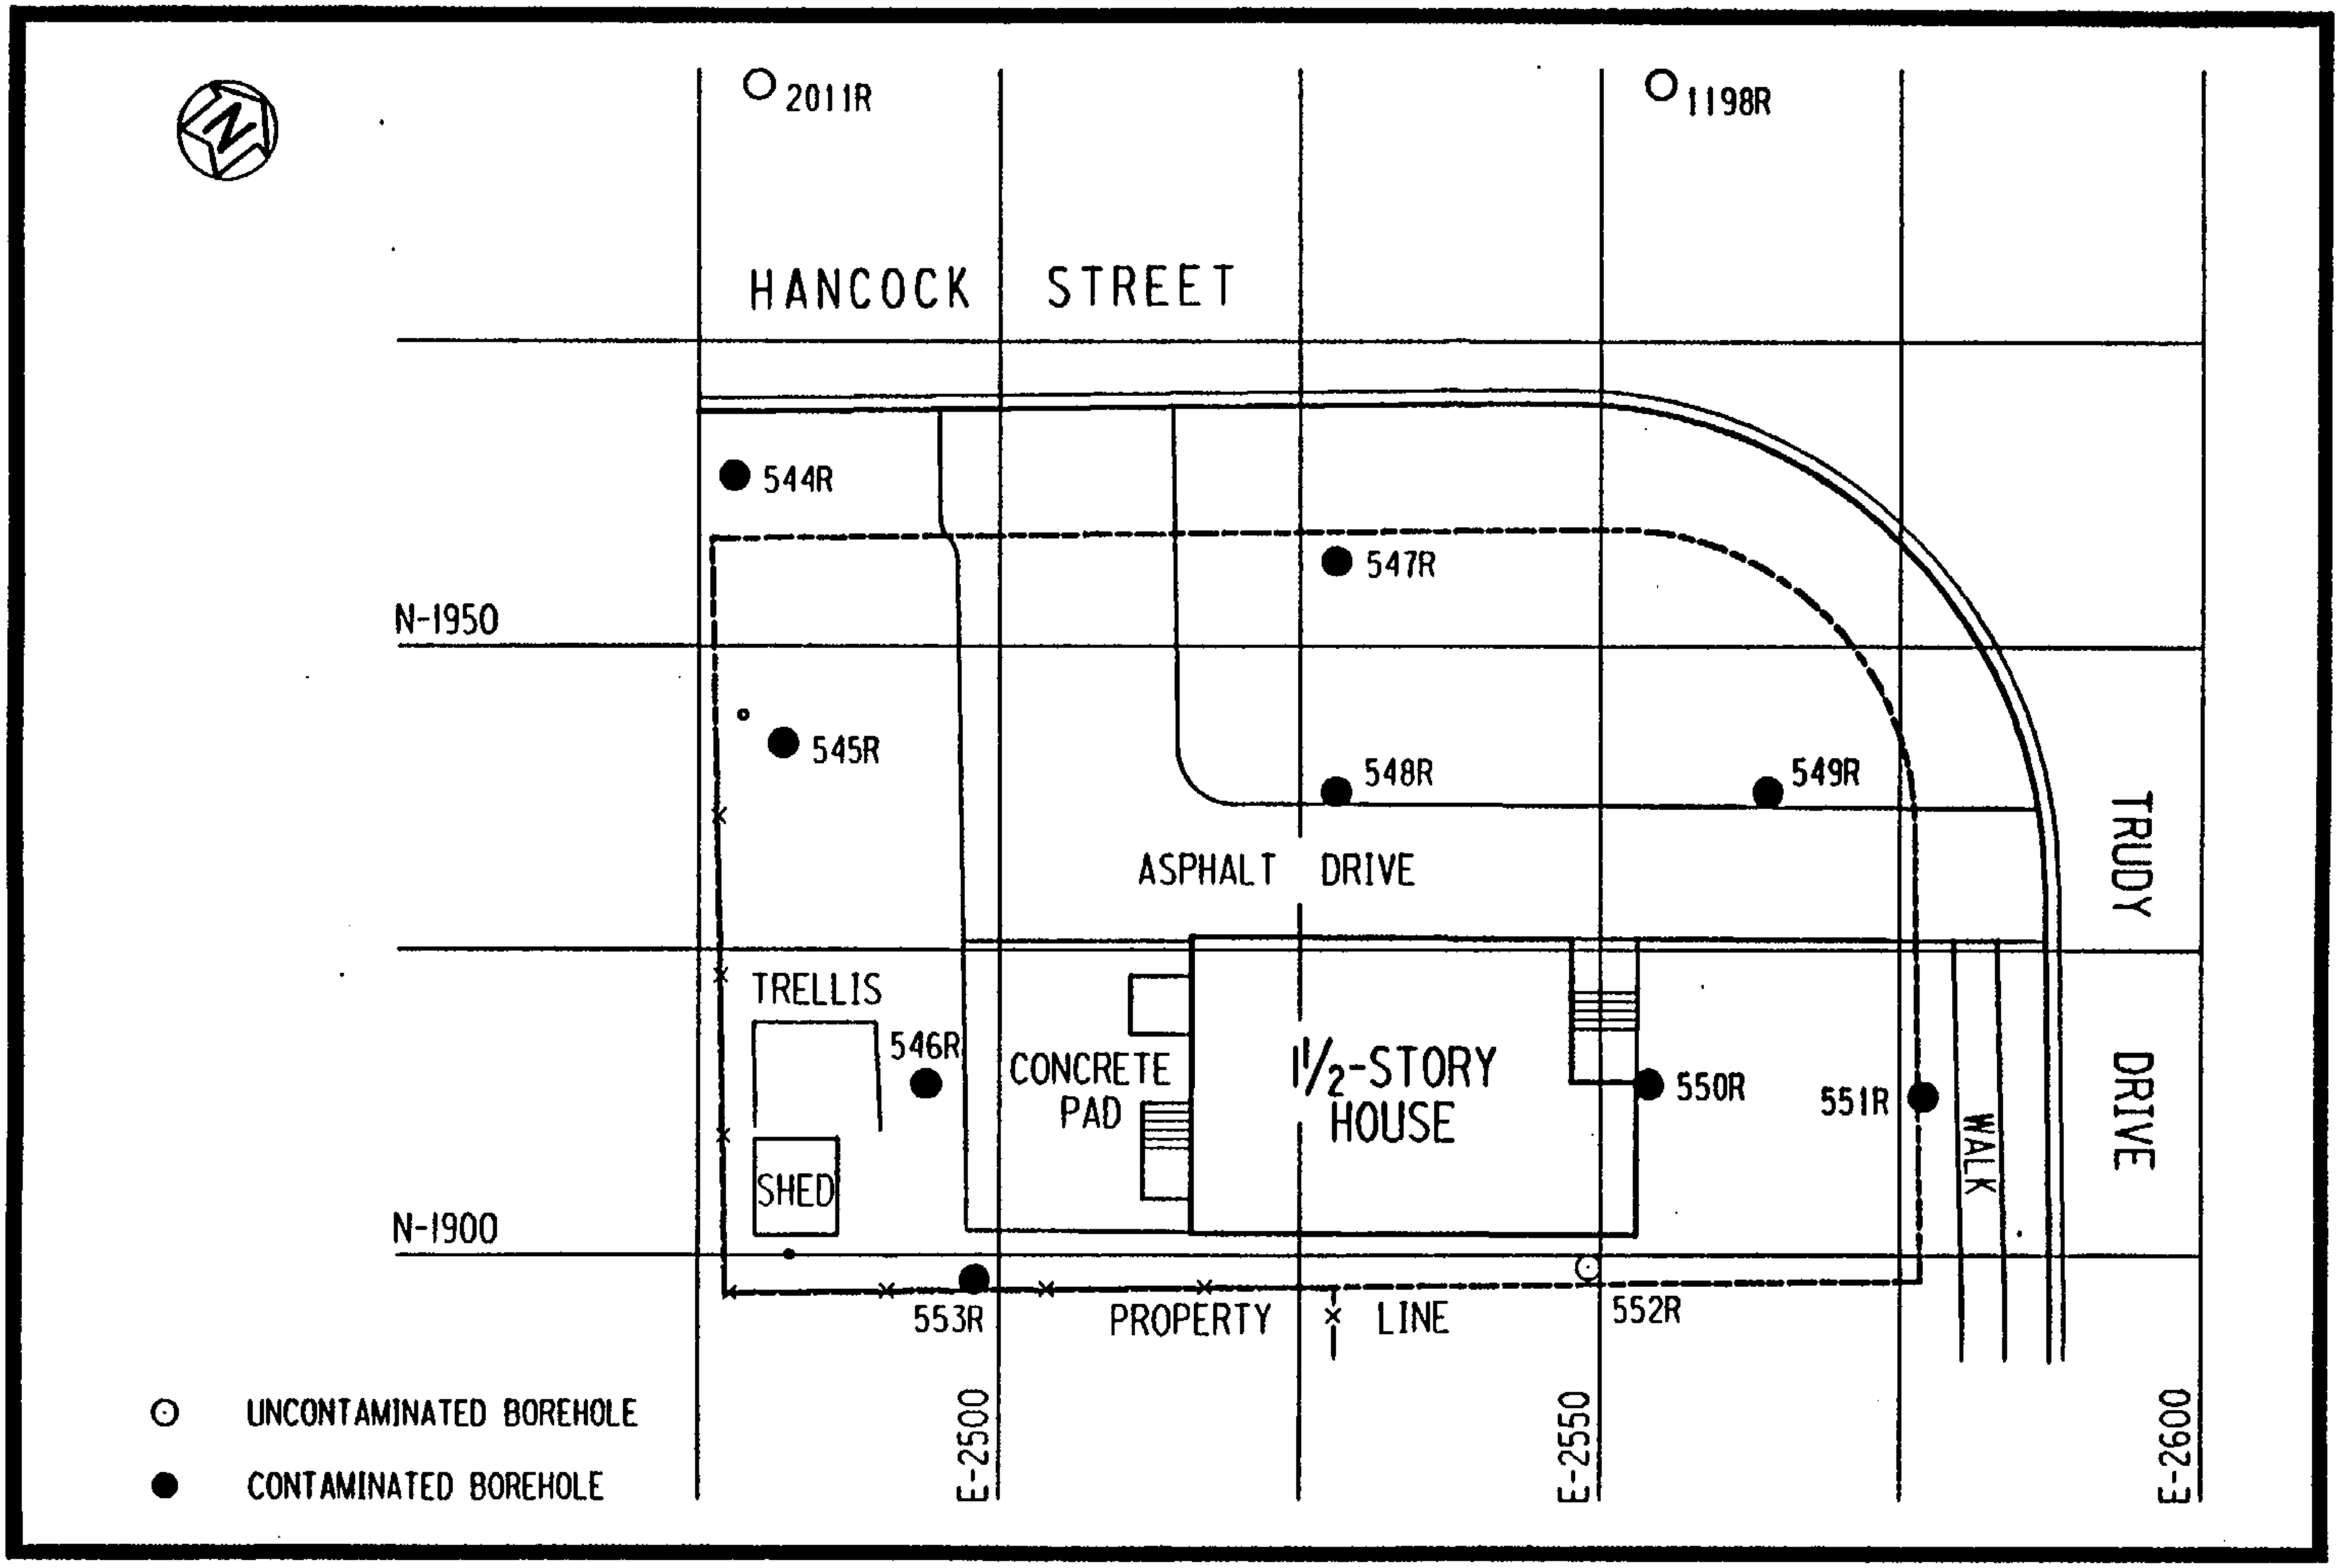
FIGURE 4-1 BOREHOLE LOCATIONS AT 60 TRUDY DRIVE

A subsurface investigation was conducted to determine the depth to which the previously identified surface contamination extended and to locate subsurface contamination where there was no surface manifestation. The subsurface characterization consisted of drilling ten boreholes on the property and two boreholes in Hancock Street on the northeast side (Figure 4-1) [using either a 7.6-cm- (3-in.-) or 15.2-cm- (6-in.-) diameter auger bit], and gamma logging them. The boreholes were drilled to depths determined in the field by the radiological and geological support representatives.

[a]Borehole locations are shown in Figure 4-1.

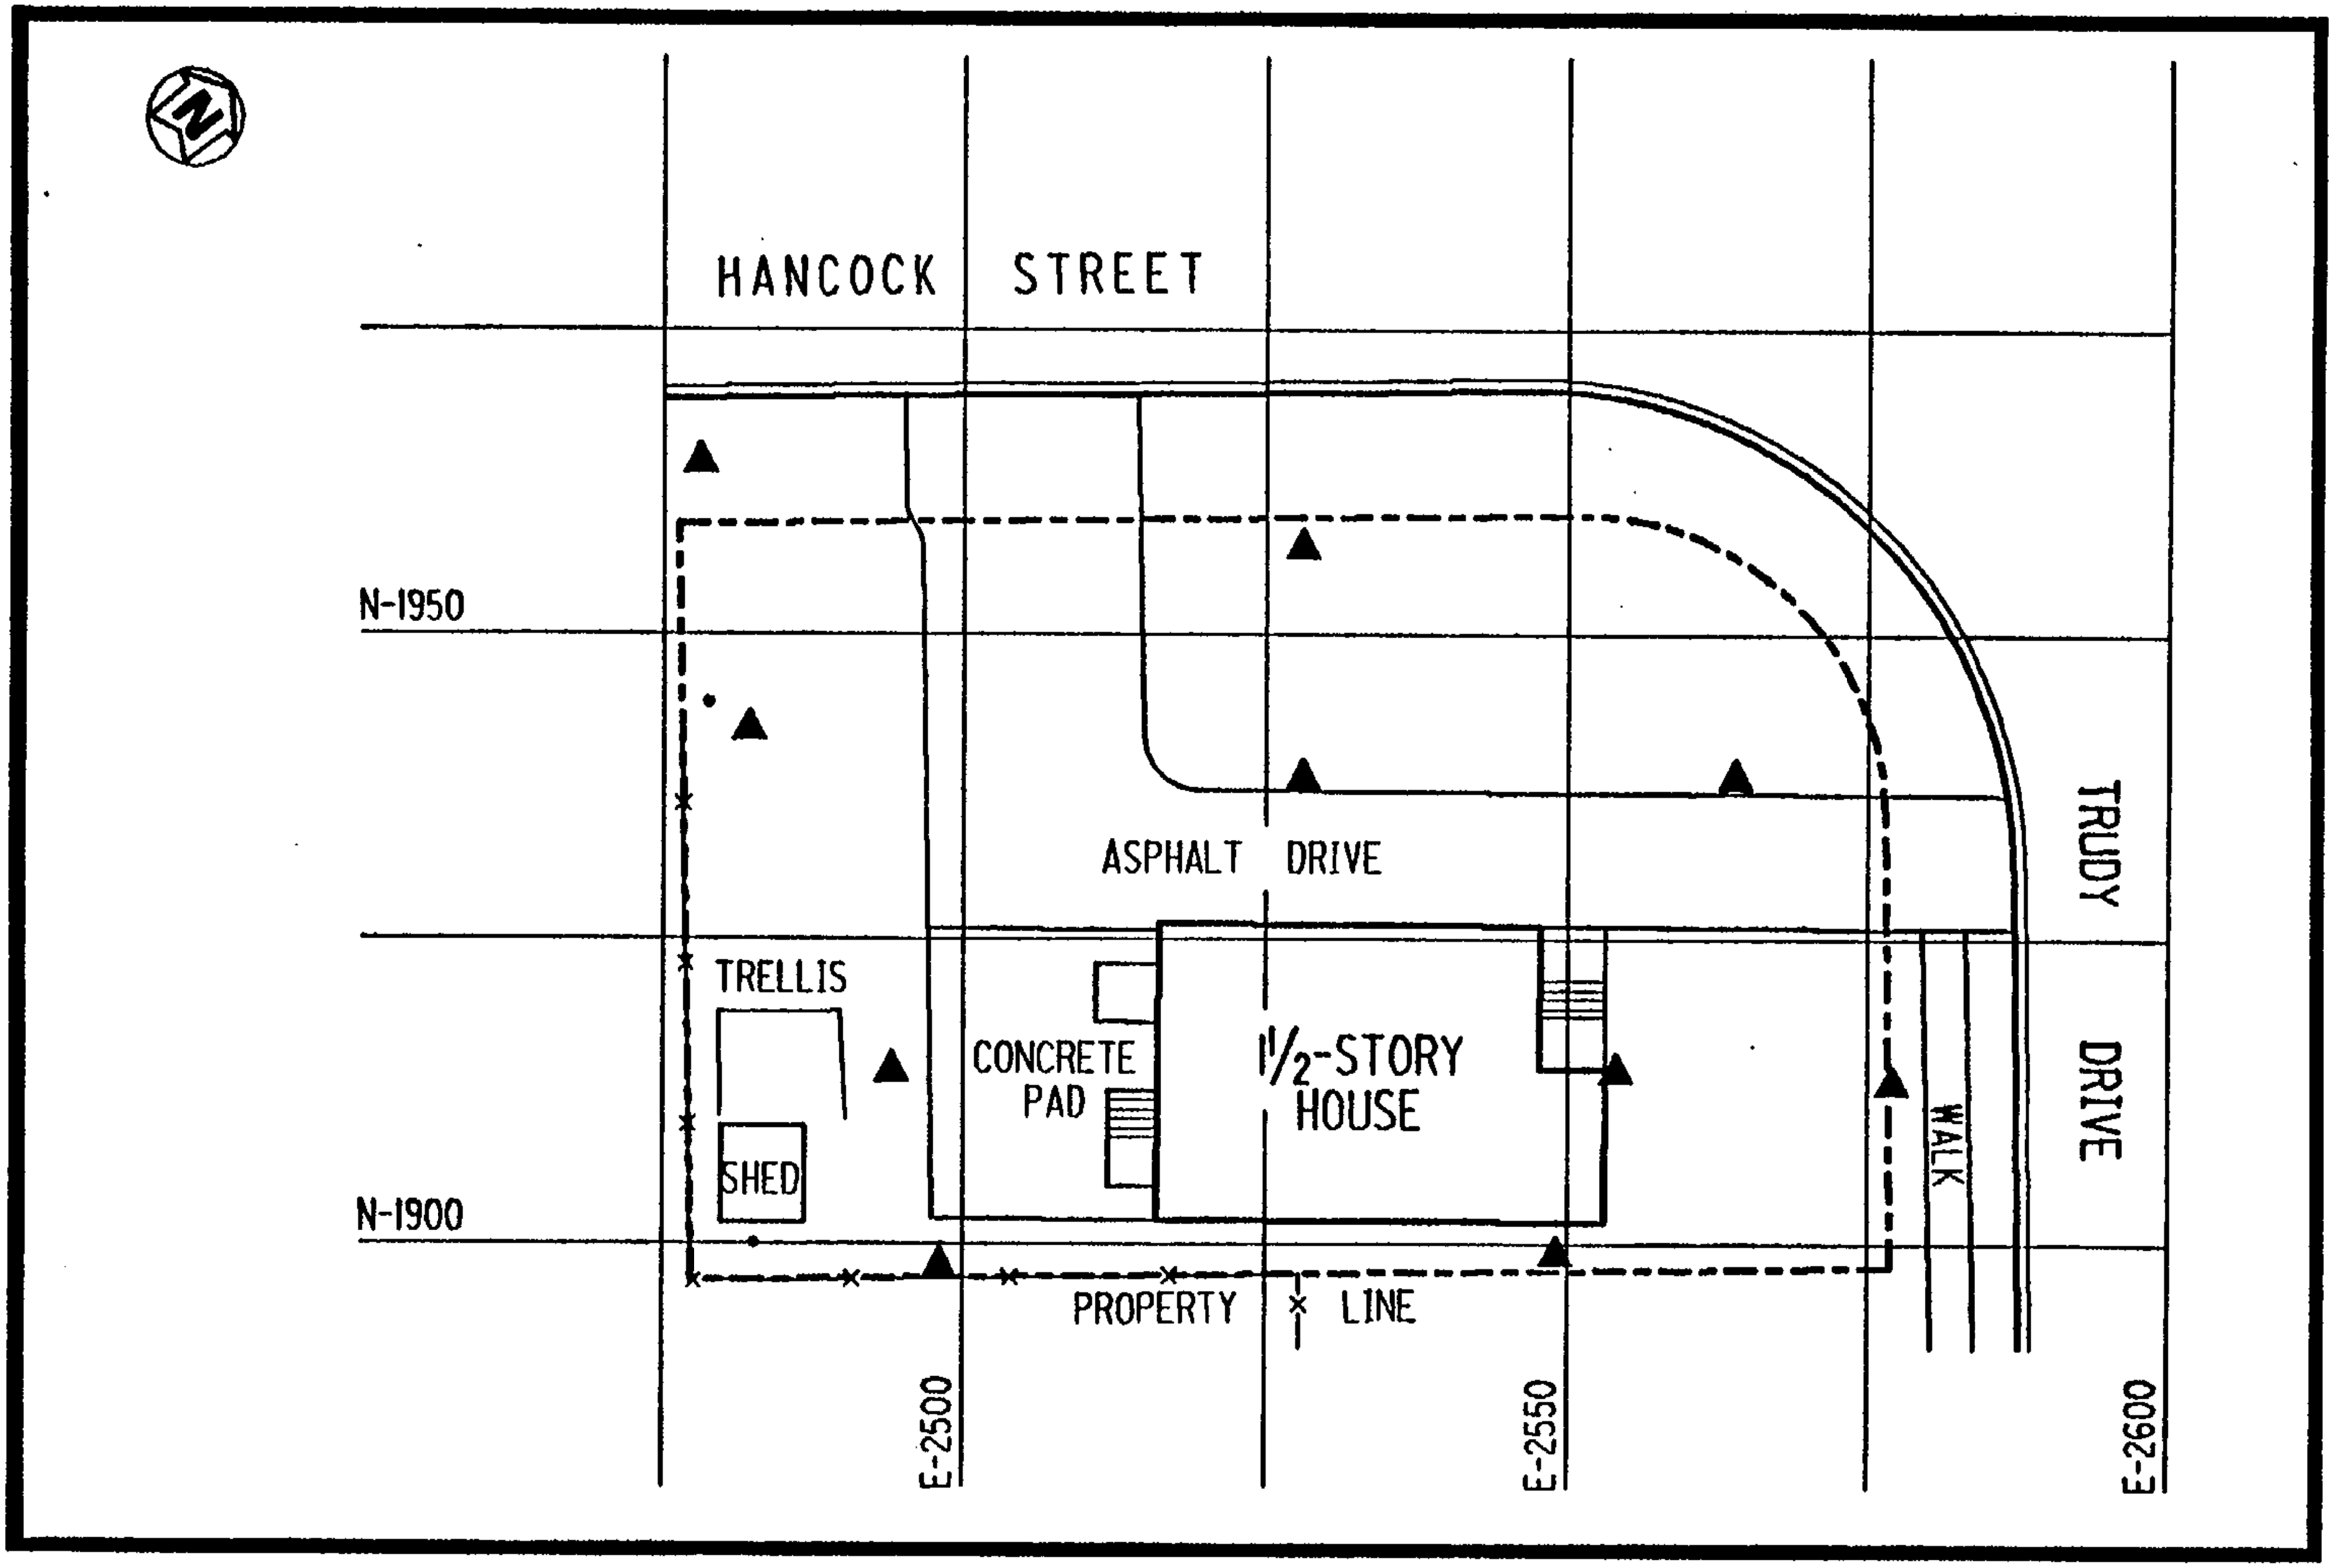
FIGURE 4-2 SURFACE AND SUBSURFACE SOIL SAMPLING LOCATIONS AT 60 TRUDY DRIVE

Subsurface soil samples were collected from ten locations (Figure 4-2) using the side-wall sampling method and were analyzed to compare laboratory soil sample results to downhole gamma radiation measurements. A cup or can attached to a steel pipe or wooden stake was inserted into the borehole and used to scrape samples off the side of the borehole at a specified depth. The subsurface soil samples were analyzed for radium-226, uranium-238, and thorium-232 in the same manner as the surface soil samples. The subsurface soil samples from two locations on the northeast side

Surface soil samples [depths from 0.0 to 15.2 cm (0.5 in.)] were taken at ten locations on the property (Figure 4-2). These samples were analyzed for thorium-232, uranium-238, and radium-226. The concentrations in these samples ranged from 1.1 to less than 11.6 pCi/g for uranium-238, from 1.3 to 11.2 pCi/g for thorium-232, and from 0.6 to 1.9 pCi/g for radium-226. Analytical results for surface soils are provided in Table 5-1; these data showed concentrations of thorium-232 in excess of DOE guidelines (5 pCi/g plus background of 1 pCi/g for surface soils) with a maximum concentration of 11.2 pCi/g. Use of the "less than" (<) notation in reporting results indicates that the radionuclide was not present in concentrations that are quantitative with the instruments and techniques used. The "less than" value represents the lower bound of the

[a]Sampling locations are shown in Figure 4-2.

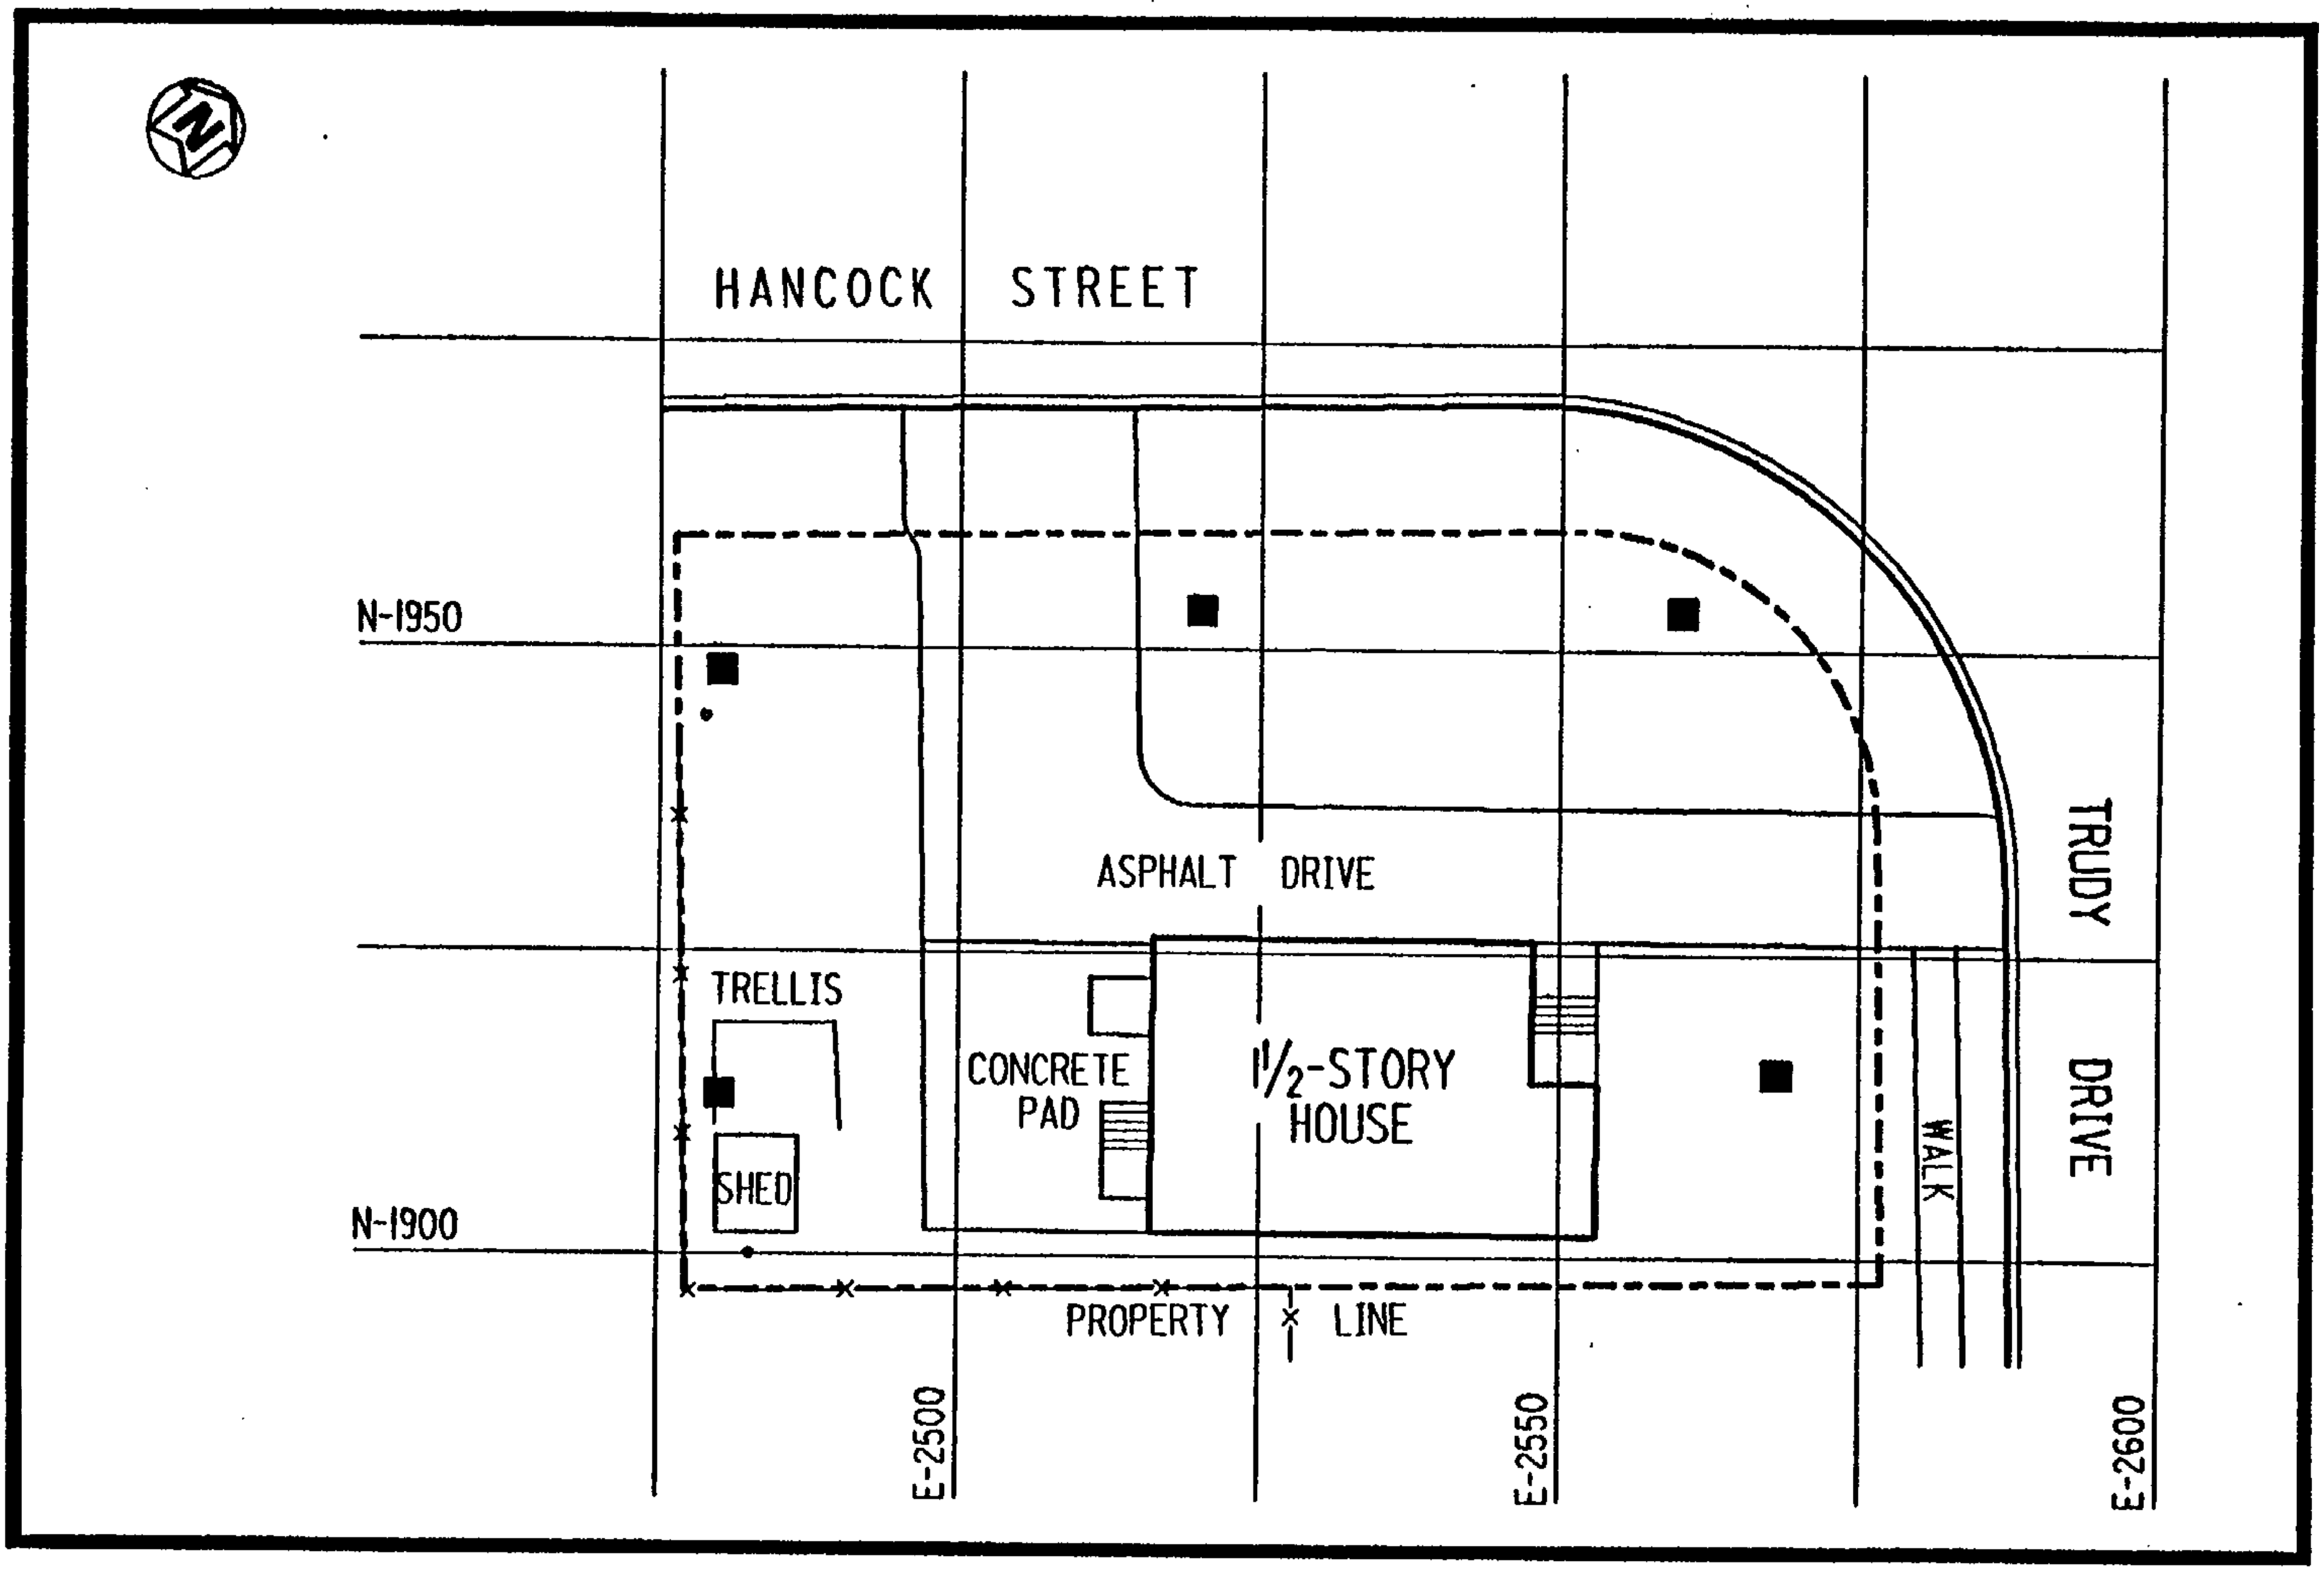
FIGURE 4-3 GAMMA EXPOSURE RATE MEASUREMENT LOCATIONS AT 60 TRUDY DRIVE

Exterior gamma exposure rate measurements were made at five locations throughout the property grid system and at two locations inside the residence. To obtain these measurements, either a 5.0- by 5.0-cm (2- by 2-in.) thallium-activated sodium iodide gamma scintillation detector designed to detect gamma radiation only or a pressurized ionization chamber (PIC) was used. Measurement locations are shown in Figure 4-3. The PIC instrument has a response to gamma radiation that is proportional to exposure in roentgens. A conversion factor for gamma scintillation to the PIC was established through a correlation of these two measurements at four locations in the vicinity of the property. The unshielded gamma scintillation detector readings were then used to estimate gamma exposure rates for each location. These measurements were taken 1 m (3 ft) above the ground. The locations were determined to be representative of the entire property. Interior measurements are generally obtained with the gamma scintillation instrument rather than the PIC because of its smaller size and the desire to minimize the technician's time inside the residence.

[a]Measurement locations are shown in Figure 4-3.

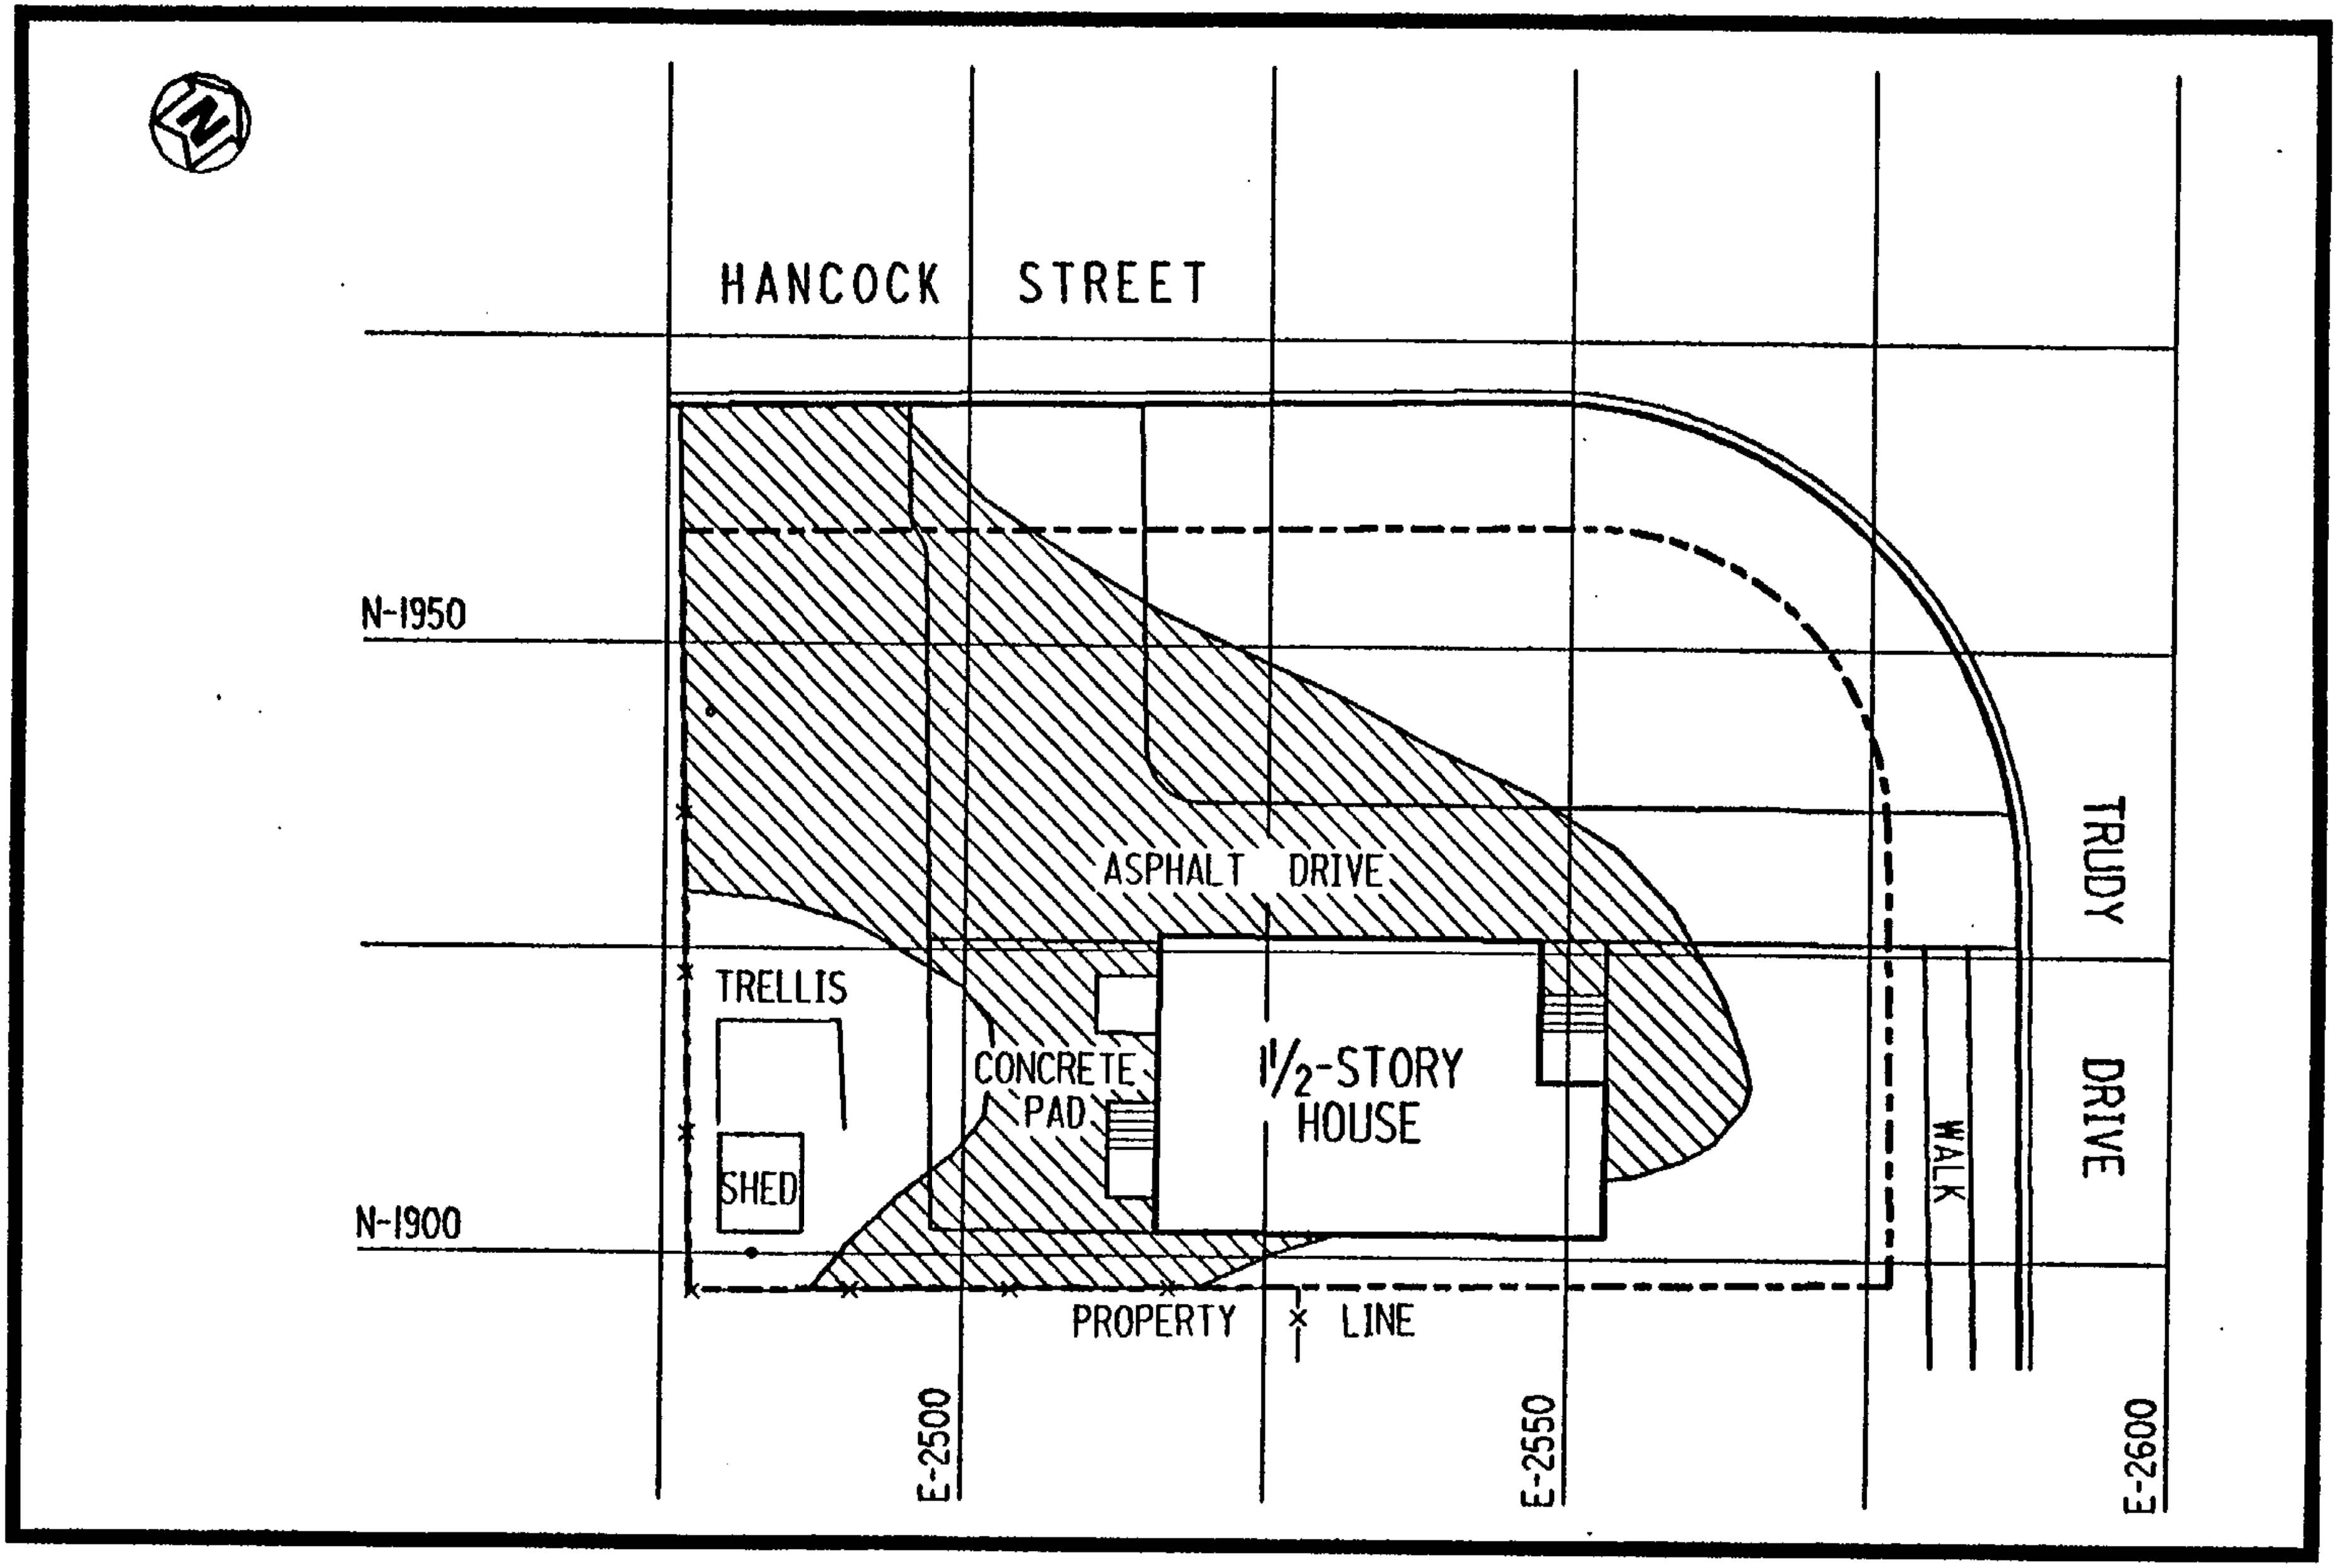
FIGURE 5-1 AREAS OF SURFACE CONTAMINATION AT 60 TRUDY DRIVE

Near-surface gamma radiation measurements on the property ranged from 3,000 cpm to approximately 13,000 cpm. The average background level for this area is 5,000 cpm. A measurement of 11,000 cpm is approximately equal to the DOE guideline for thorium-232 of 5 pCi/g above background for surface soil contamination. Using this correlation, the near-surface gamma measurements were used to determine the extent of surface contamination and the basis for selecting the locations of soil samples. Areas of surface contamination are shown in Figure 5-1.

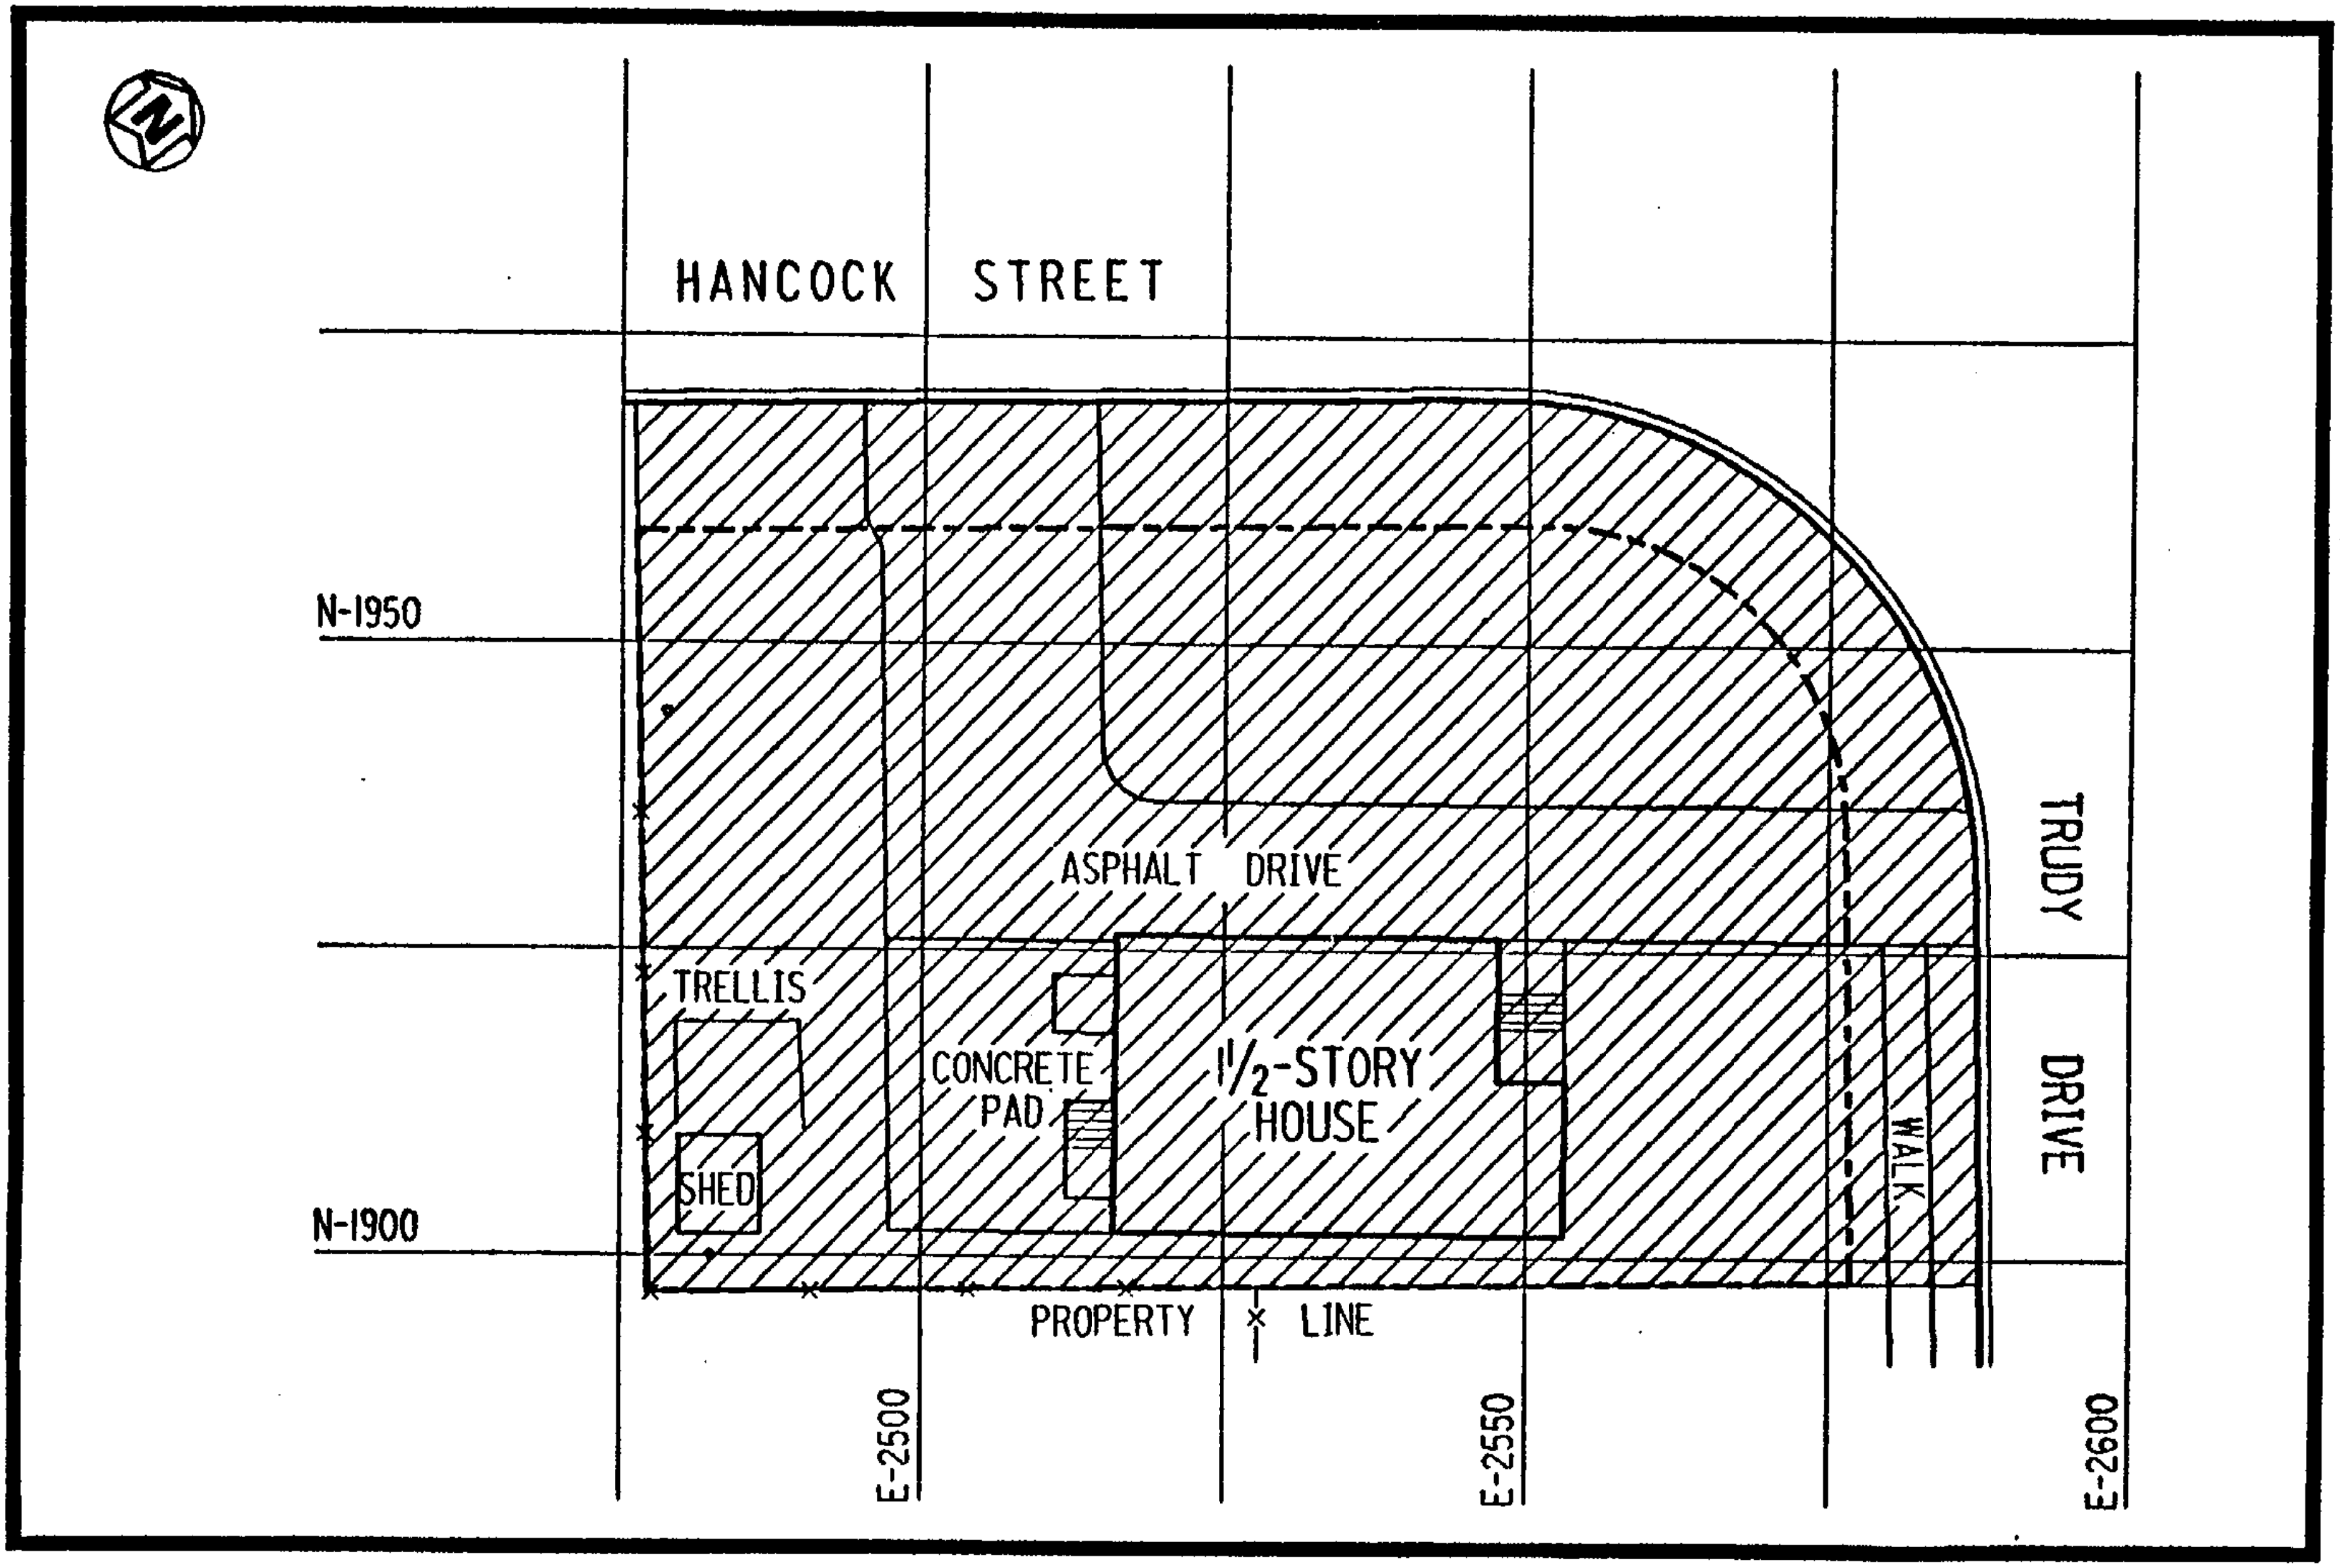
FIGURE 5-2 AREAS OF SUBSURFACE CONTAMINATION AT 60 TRUDY DRIVE

On the basis of near-surface gamma radiation measurements, surface and subsurface soil sample analyses, and downhole gamma logging, contamination on this property is believed to consist of both surface and subsurface contamination. The subsurface contamination at depths ranging from 15.2 cm (0.5 in.) to 2.89 m (9.5 ft). The areas of subsurface contamination are shown in Figure 5-2. The subsurface contamination appears to extend beneath the residence as well as into the street in front of the property (Trudy Drive).

It is apparent from review of historical documentation (e.g., aerial photographs of the area, interviews with local residents, and previous radiological surveys) that the subsurface contamination on this property lies along the former channel of Lodi Brook and its associated floodplain.

The contamination on this property is similar to contamination found on residential properties in close proximity to this property. It has been established that the Lodi Brook channel through these neighboring properties once occupied locations connecting to those where stream sediments were found at 60 Trudy Drive. Thus, the elevated gamma readings shown on gamma logs from boreholes drilled on this property serve as further indication of the suspected mechanism of transport for radiological contamination (i.e., stream deposition from Lodi Brook).
