RADIOLOGICAL CHARACTERIZATION REPORT FOR THE GULF STATION PROPERTY

Maywood, New Jersey

September 1989

Bechtel National, Inc.

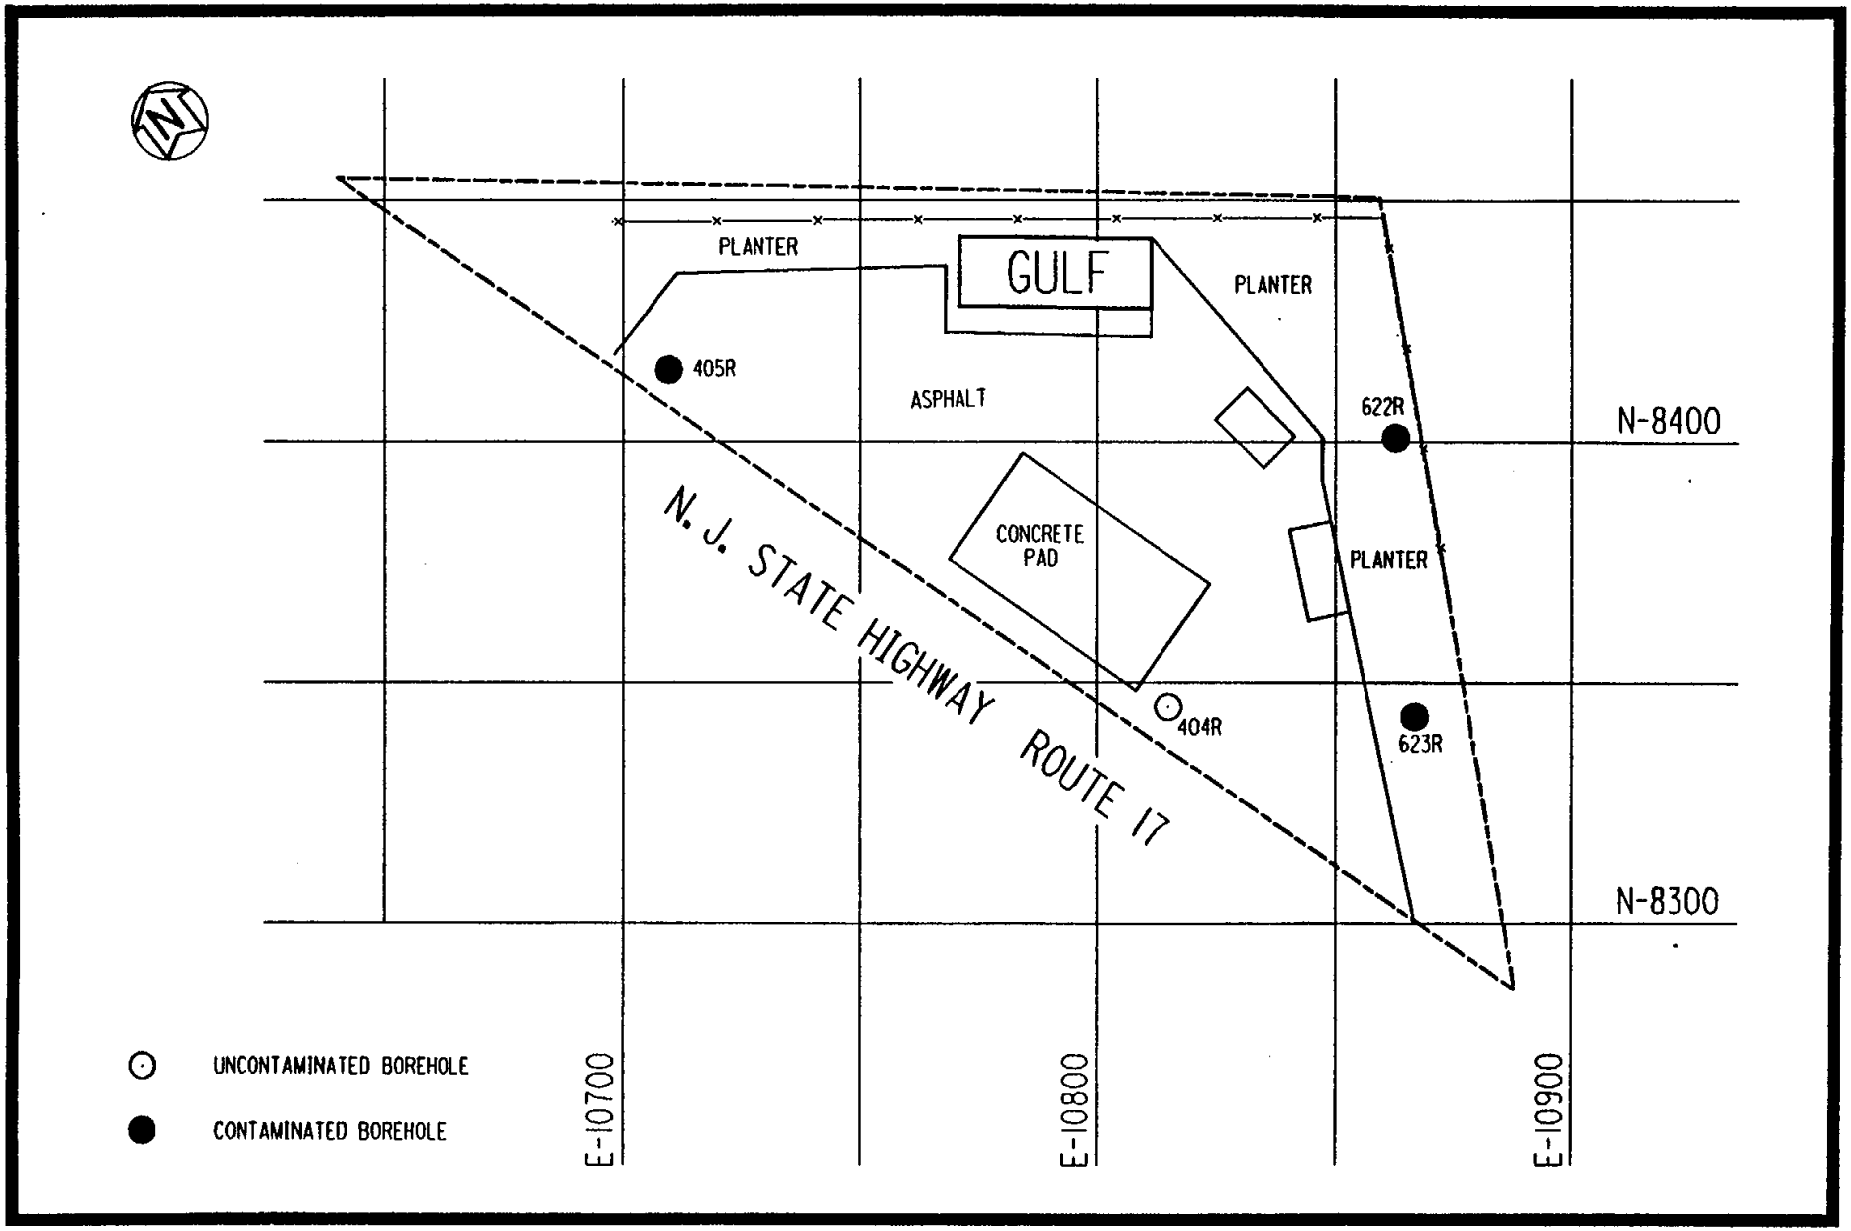
FIGURE 4-1 BOREHOLE LOCATIONS AT THE GULF STATION

A subsurface investigation was conducted to determine the depth to which the previously identified surface contamination extended and to locate subsurface contamination where there was no surface manifestation. The subsurface characterization consisted of drilling five boreholes (Figure 4-1), using either a 7.6-cm- (3-in.-) or 15.2-cm- (6-in.-) diameter auger bit, and gamma logging them. The boreholes were drilled to depths determined in the field by the radiological and geological support representatives. Because of limited accessibility, only five boreholes were drilled during the subsurface investigation. Four of the boreholes were gamma logged to determine the depths and concentrations of radiological contamination; the remaining borehole collapsed (E10820, N8425). Subsurface soil samples were collected from the borehole, however, before it collapsed.

[a]Borehole locations are shown in Figure 4-1.

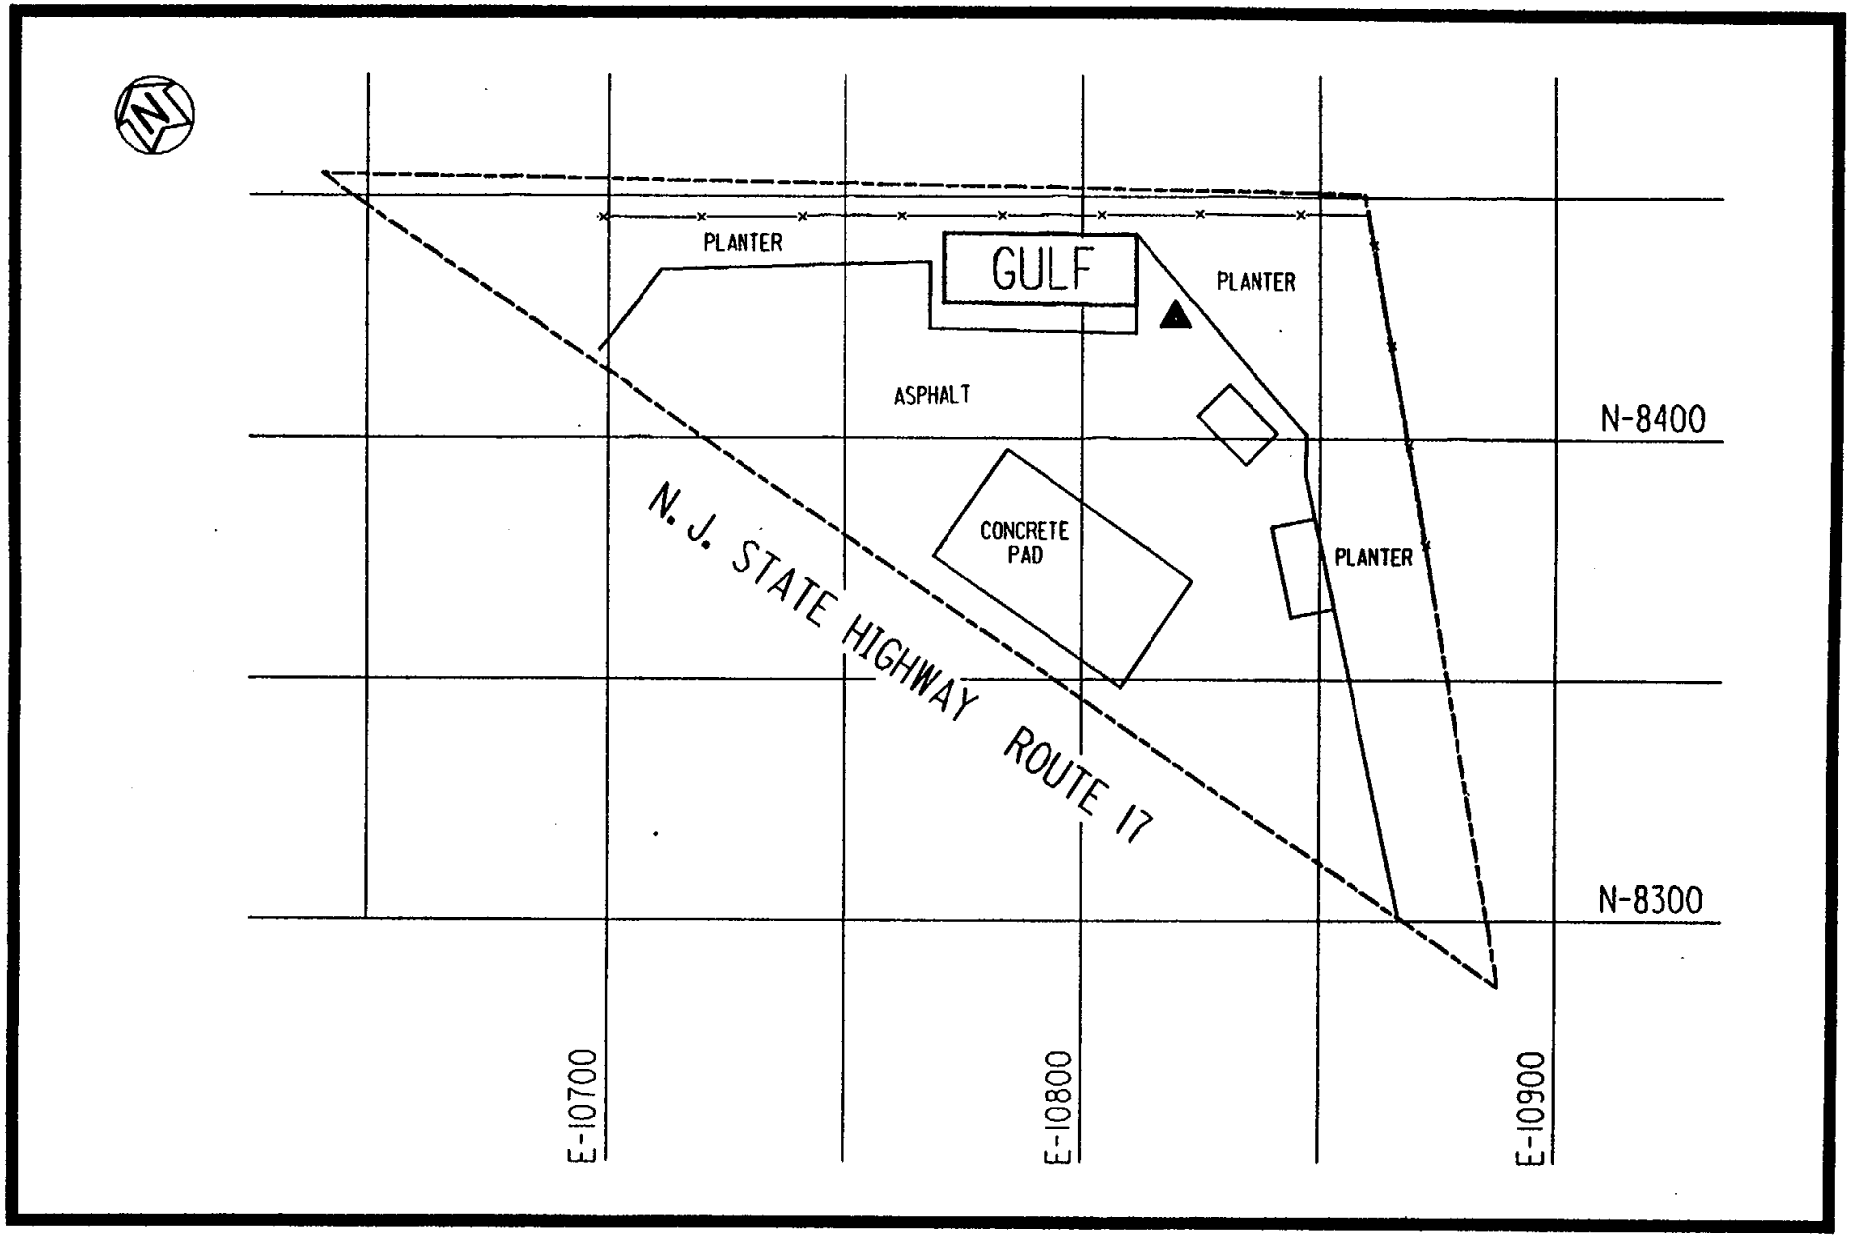
FIGURE 4-2 SURFACE AND SUBSURFACE SOIL SAMPLING LOCATION AT THE GULF STATION

[a]Sample locations are shown in Figure 4-2.

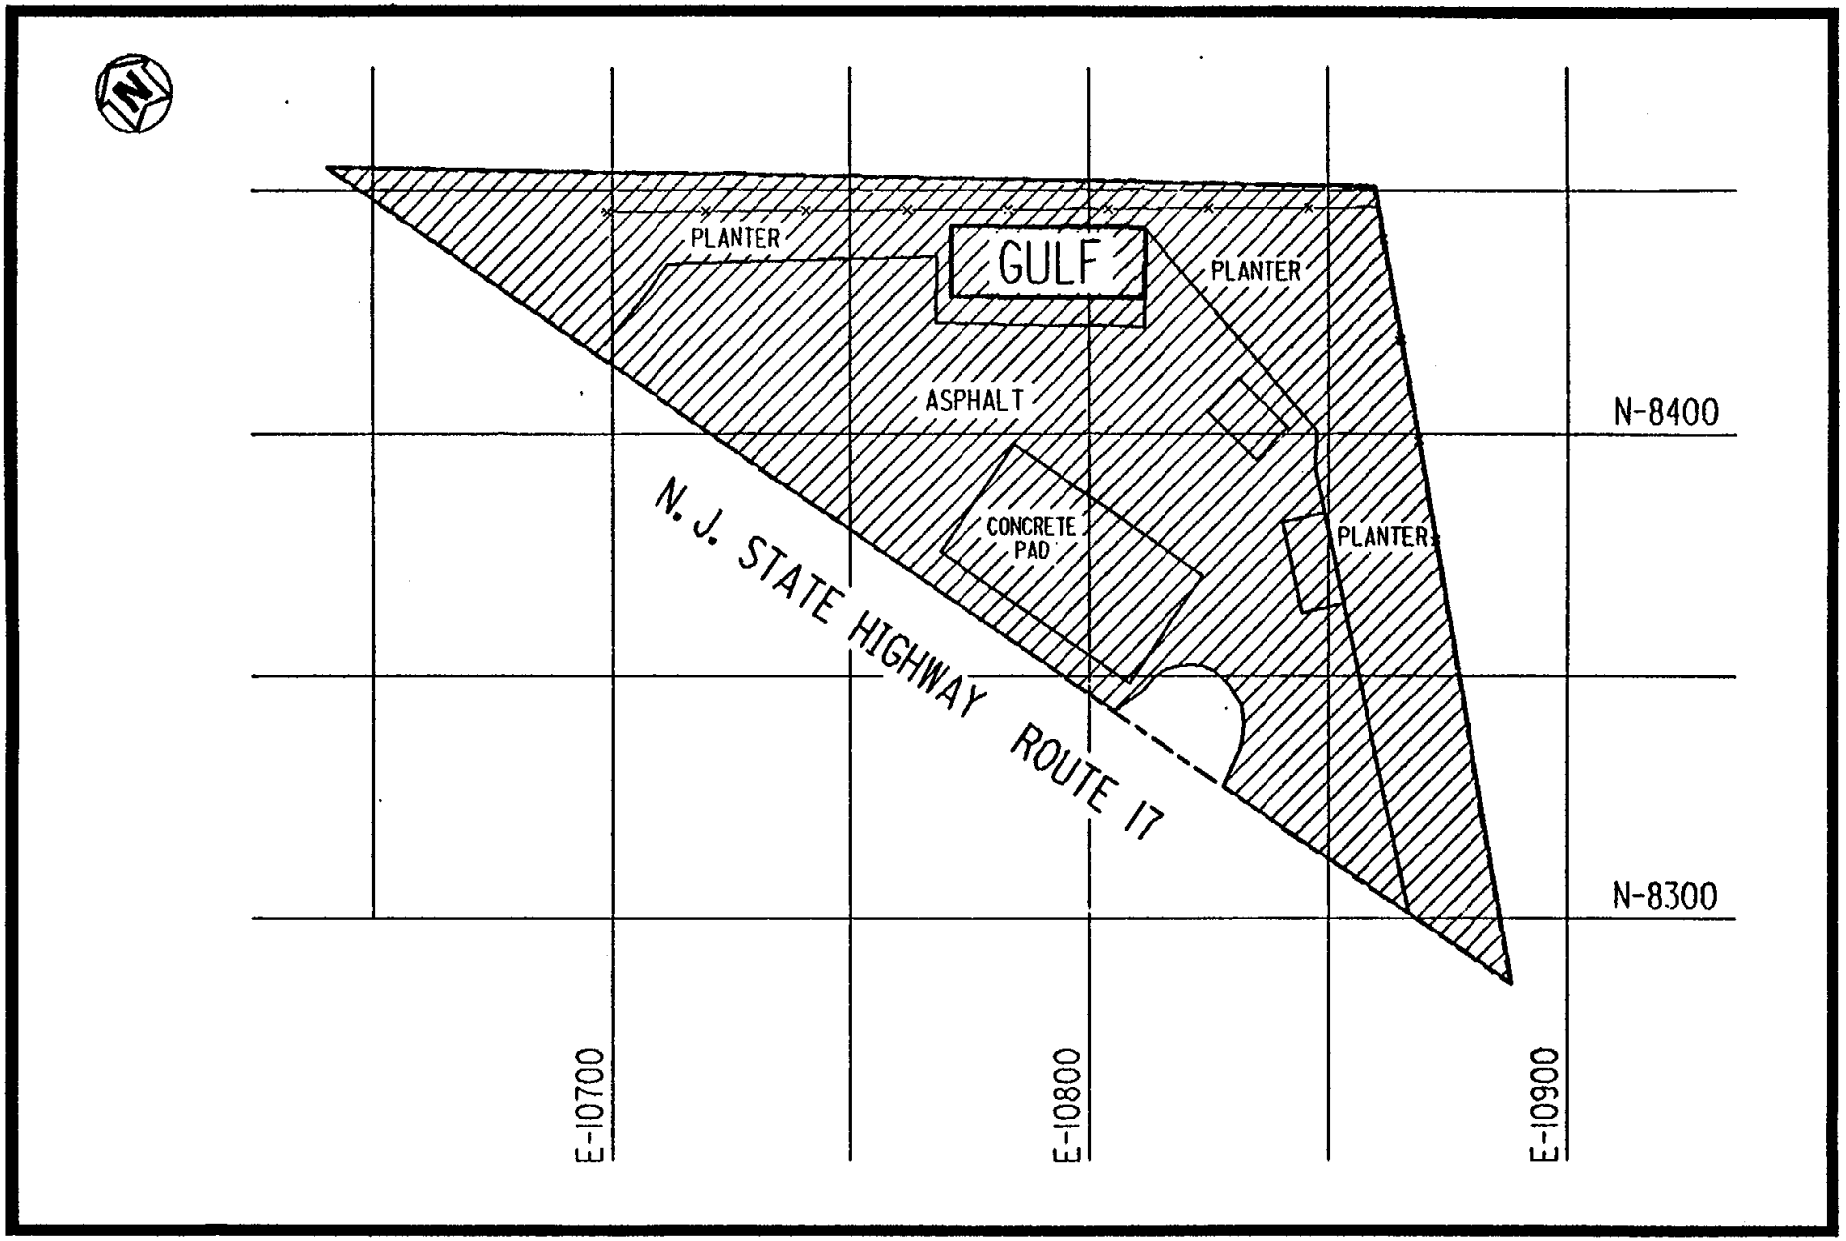
FIGURE 5-1 AREAS OF SUBSURFACE CONTAMINATION AT THE GULF STATION

On the basis of near-surface gamma radiation measurements, surface and subsurface soil sample analyses, and downhole gamma logging, contamination on this property is believed to consist primarily of subsurface contamination at depths ranging from 15.2 cm (6.0 in.) to 2.13 m (7.0 ft). The areas of subsurface contamination are shown in Figure 5-1. The subsurface contamination appears to extend beneath the building, and there is a high probability that it extends beneath New Jersey Route 17 that is adjacent to the property.
