RADIOLOGICAL CHARACTERIZATION REPORT FOR THE RESIDENTIAL PROPERTY AT 14 LONG VALLEY ROAD

Lodi, New Jersey

September 1989

Bechtel National, Inc.

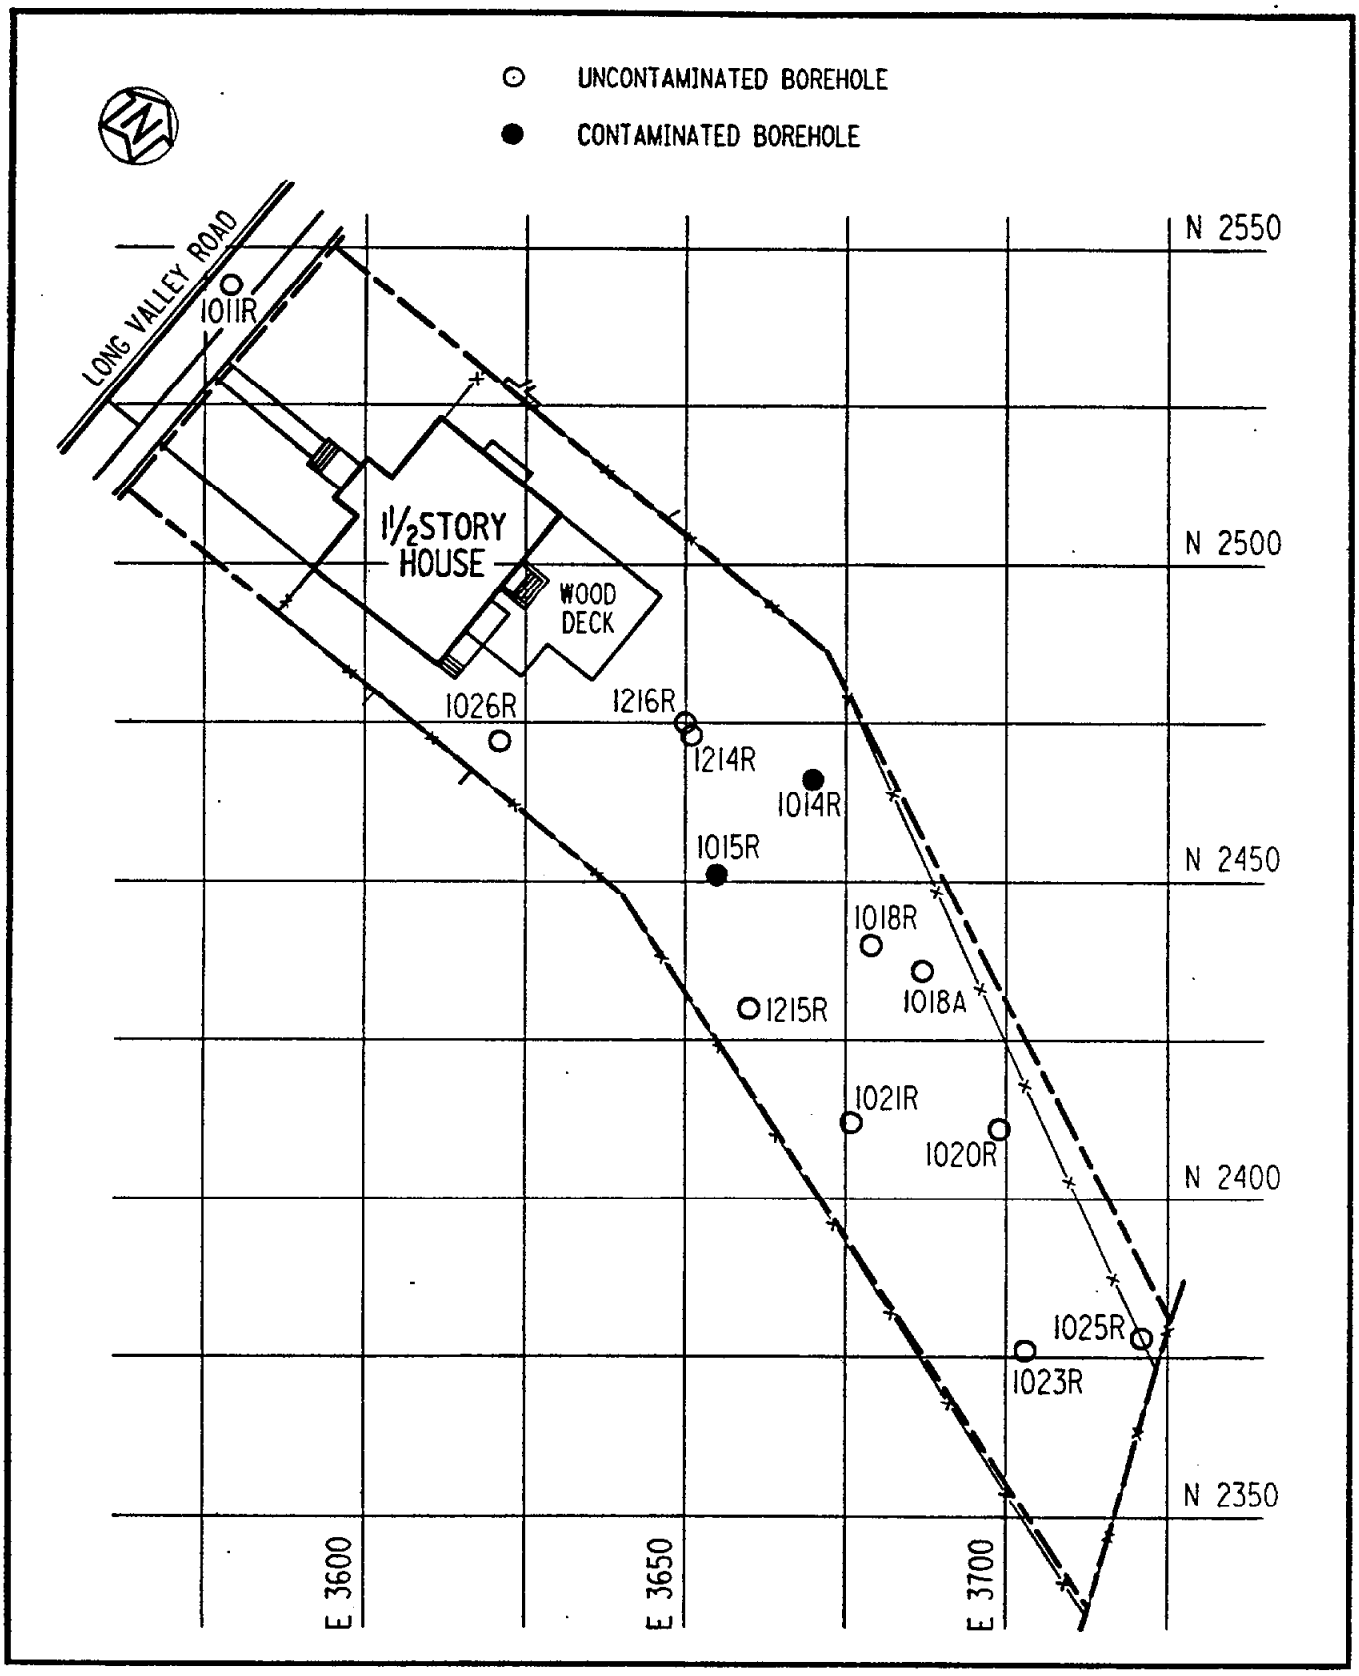
FIGURE 4-1 BOREHOLE LOCATIONS AT 14 LONG VALLEY ROAD

Analytical results for subsurface soil samples are given in Table 5-1, and gamma logging data are given in Table 5-2. The results in Table 5-2 showed a range from 7,000 cpm to 45,000 cpm. A measurement of 40,000 cpm is approximately equal to the DOE guideline for subsurface contamination of 15 pCi/g. Analyses of subsurface soil samples indicated uranium-238 concentrations ranging from 1.7 to 32.8 pCi/g, thorium-232 concentrations ranging from less than 0.8 to 8.7 pCi/g, and radium-226 concentrations ranging from less than 0.5 to less than 2.1 pCi/g.

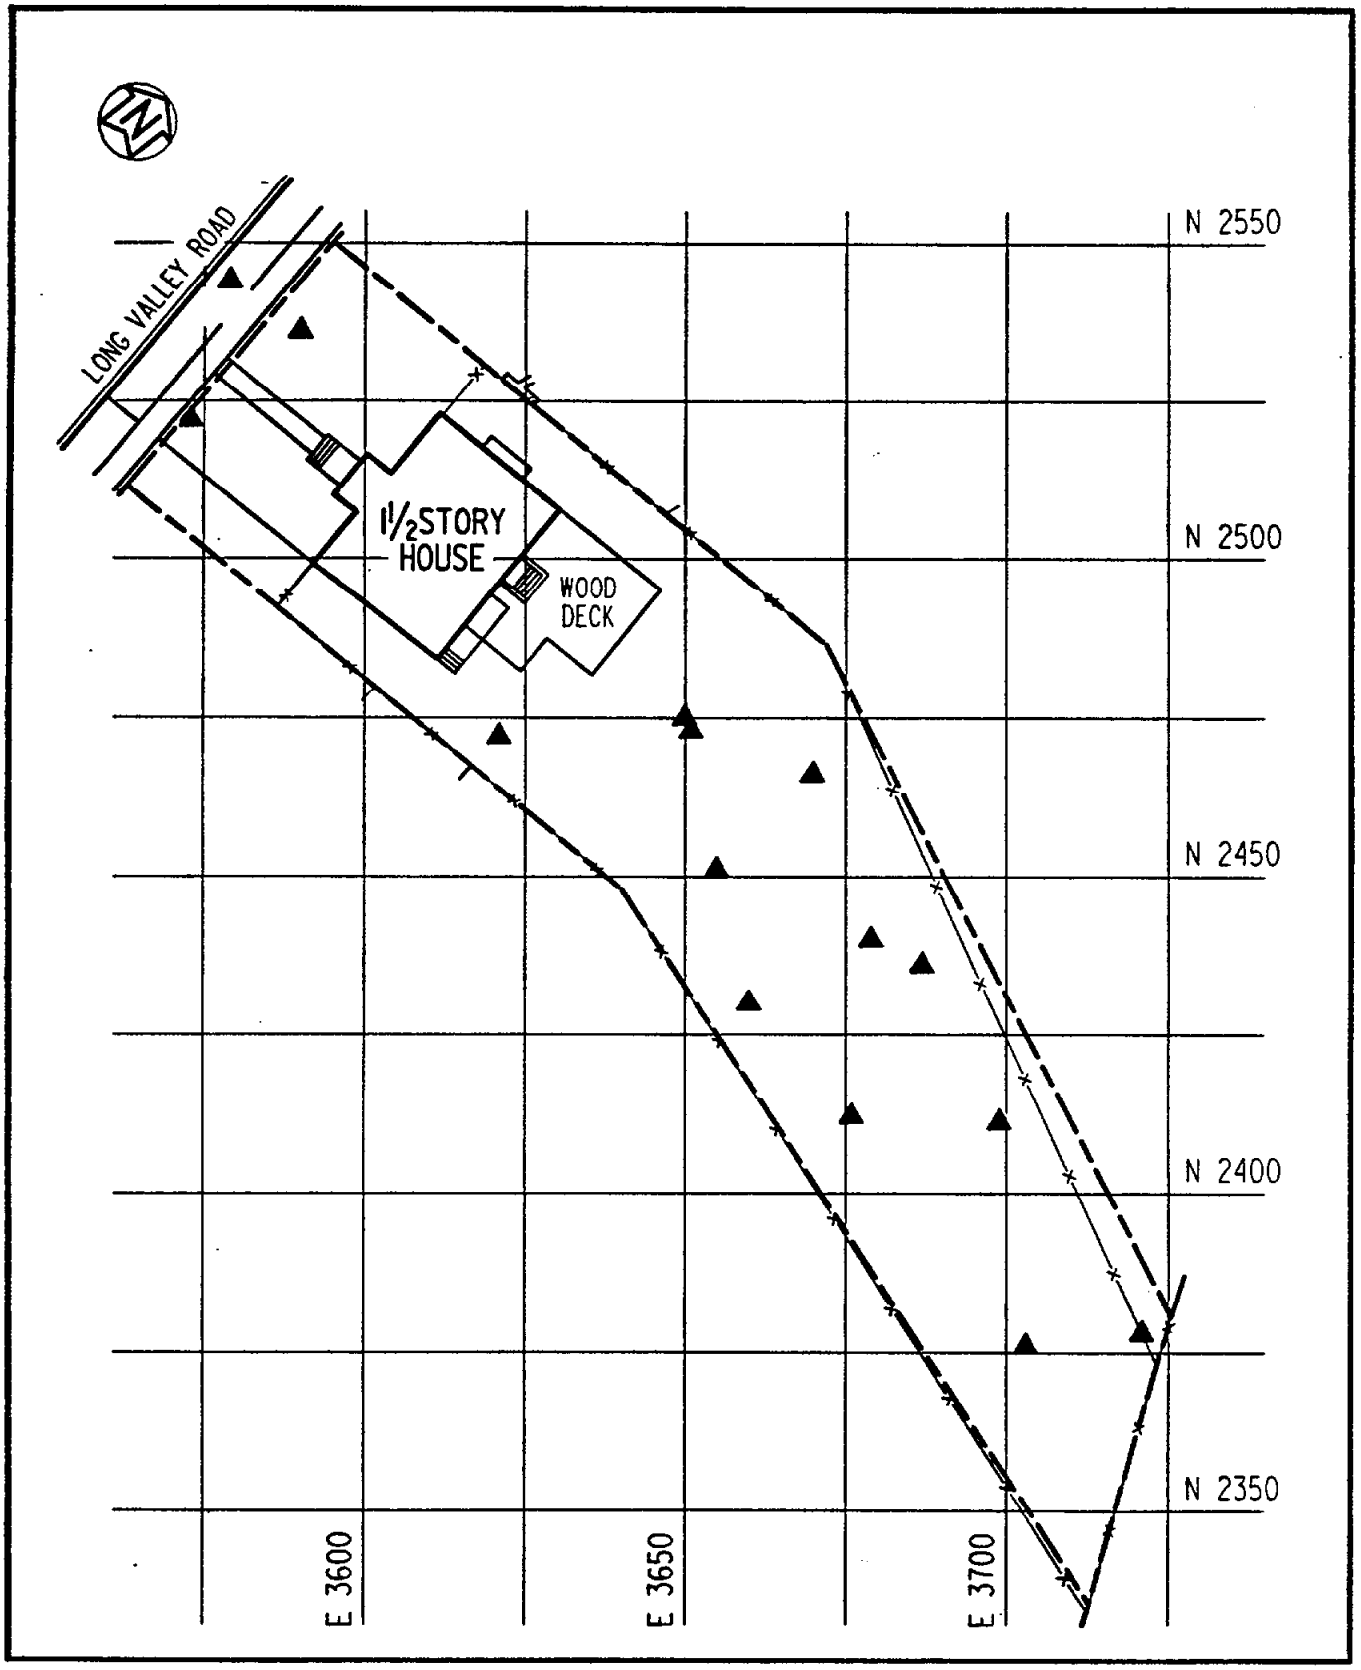
FIGURE 4-2 SURFACE AND SUBSURFACE SOIL SAMPLING LOCATIONS AT 14 LONG VALLEY ROAD

Surface soil samples [depths from 0.0 to 15.2 cm (6.0 in.)] were taken at seven locations on the property (Figure 4-2). These samples were analyzed for thorium-232, uranium-238, and radium-226. The concentrations in these samples ranged from less than 4.5 to less than 10.3 pCi/g for uranium-238, from less than 1.5 to 14.4 pCi/g for thorium-232, and from less than 0.9 to 1.7 pCi/g for radium-226. Analytical results for surface soils are provided in Table 5-1; these data showed that concentrations of thorium-232 exceeded DOE guidelines (5 pCi/g plus background of 1 pCi/g for surface soils) with a maximum concentration of 14.4 pCi/g. Use of the "less than" (<) notation in reporting results indicates that the radionuclide was not present in concentrations that are quantitative with the instruments and techniques used. The "less than" value represents the lower bound of the

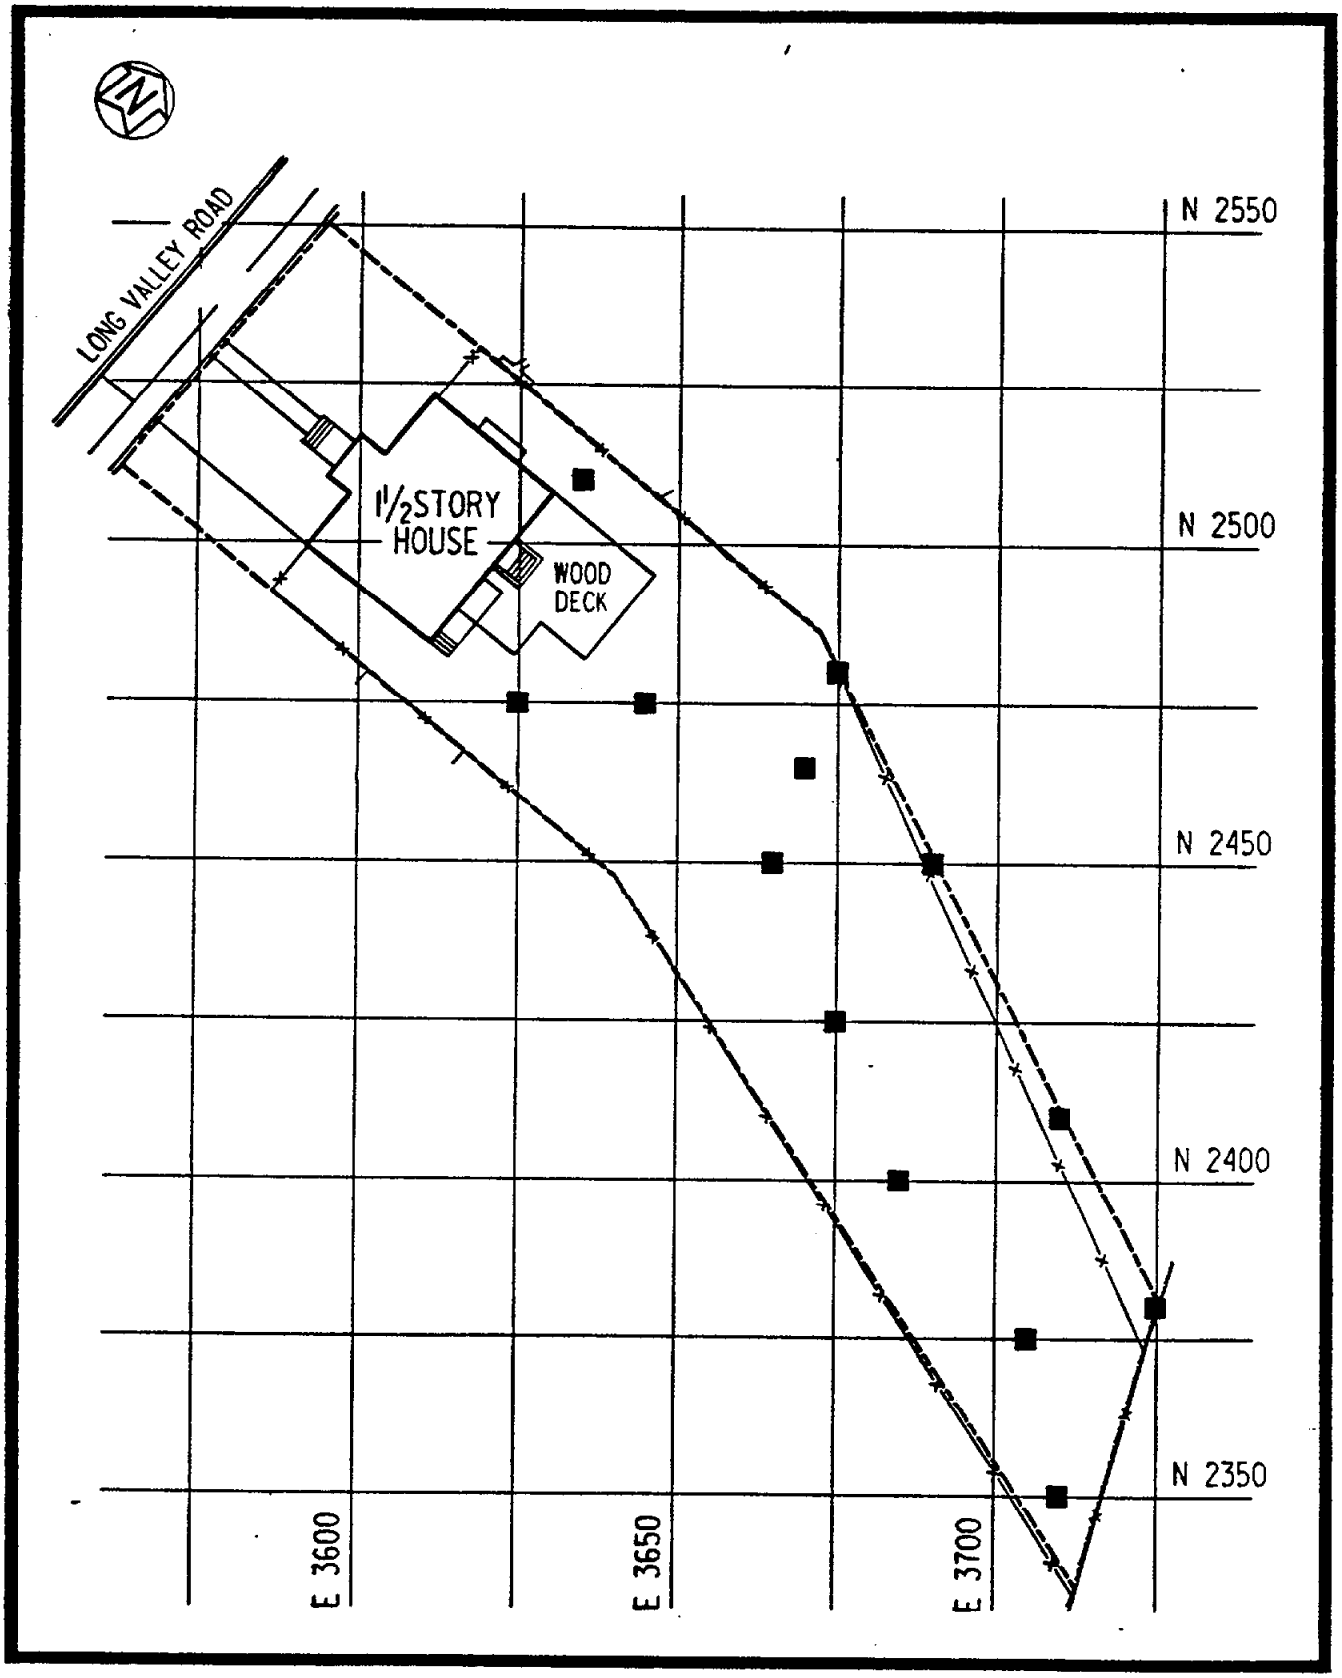
FIGURE 4-3 GAMMA EXPOSURE RATE MEASUREMENT LOCATIONS AT 14 LONG VALLEY ROAD

Exterior gamma exposure rate measurements were made at 13 locations throughout the property grid system. To obtain exterior measurements, either a 5.0- by 5.0-cm (2- by 2-in.) thallium-activated sodium iodide gamma scintillation detector designed to detect gamma radiation only or a pressurized ionization chamber (PIC) was used. Measurement locations are shown in Figure 4-3. The PIC instrument has a response to gamma radiation that is proportional to exposure in roentgens. A conversion factor for gamma scintillation to the PIC was established through a correlation of these two measurements at four locations in the vicinity of the property. The unshielded gamma scintillation detector readings were then used to estimate gamma exposure rates for each location. These measurements were taken 1 m (3 ft) above the ground. The locations were determined to be representative of the entire property.

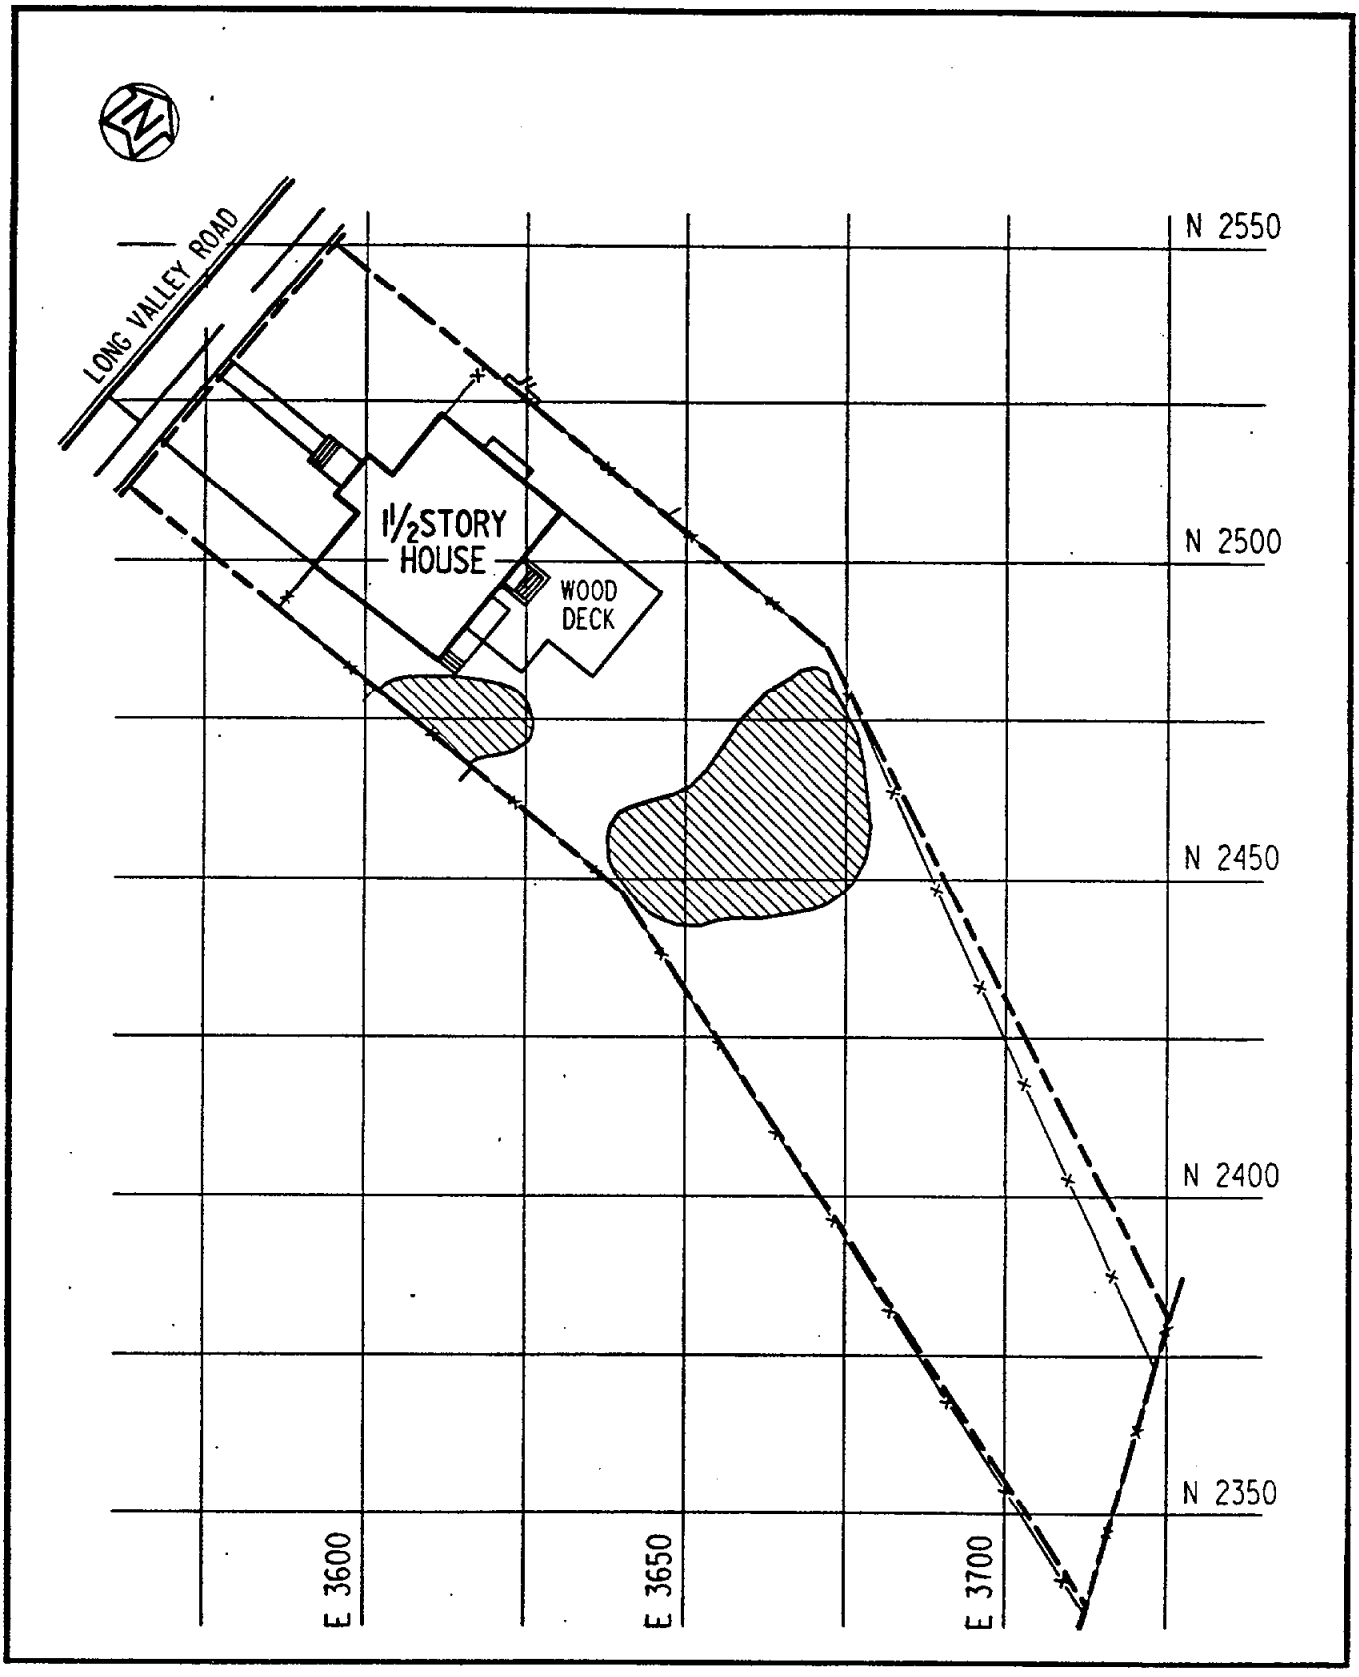
FIGURE 5-1 AREAS OF SURFACE CONTAMINATION AT 14 LONG VALLEY ROAD

Near-surface gamma radiation measurements on the property ranged from 5,000 cpm to approximately 88,000 cpm. The average background level for this area is 5,000 cpm. A measurement of 11,000 cpm is approximately equal to the DOE guideline for thorium-232 of 5 pCi/g above background for surface soil contamination. Using this correlation, the near-surface gamma measurements were used to determine the extent of surface contamination and the basis for selecting the locations of soil samples. Areas of surface contamination are shown in Figure 5-1.

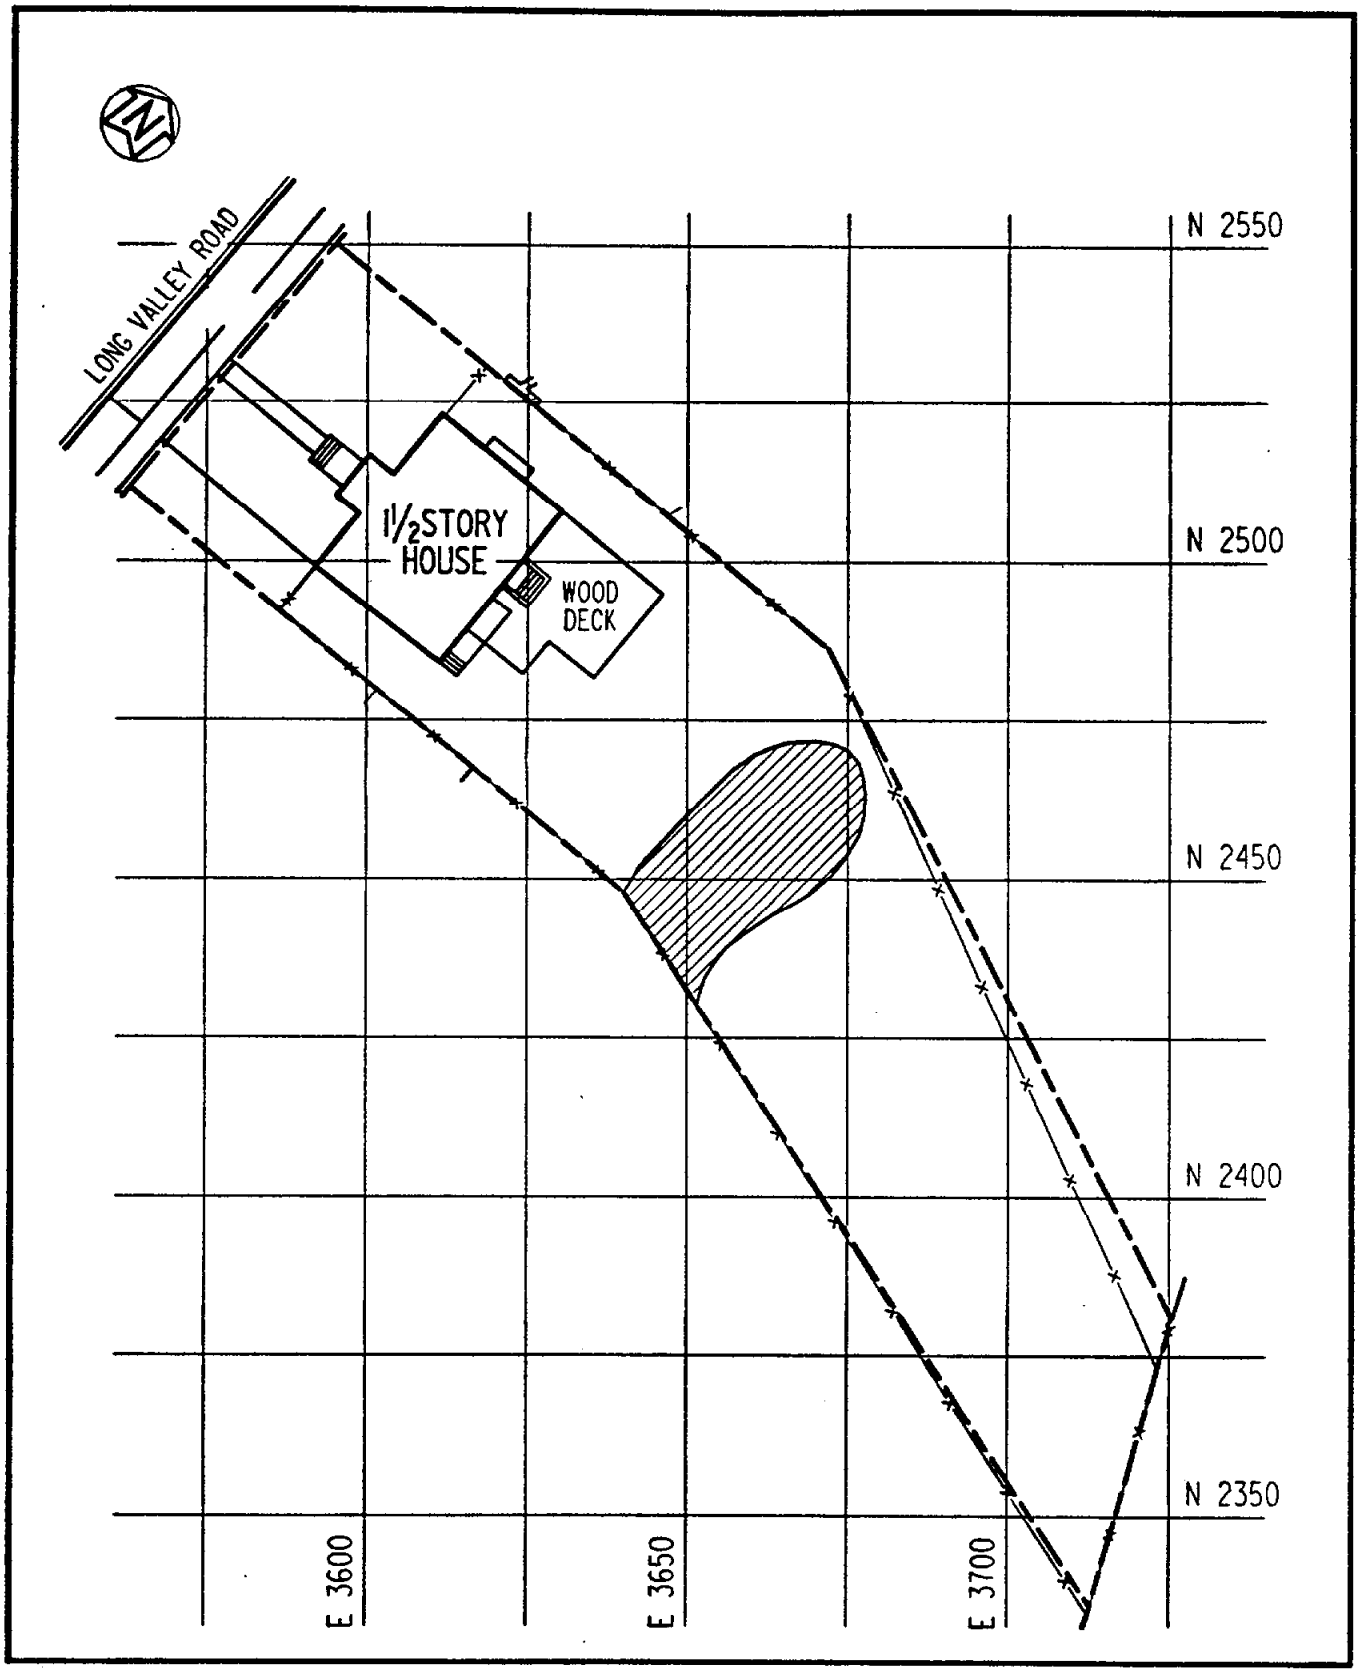
FIGURE 5-2 AREAS OF SUBSURFACE CONTAMINATION AT 14 LONG VALLEY ROAD

On the basis of near-surface gamma radiation measurements, surface and subsurface soil sample analyses, and downhole gamma logging, contamination on this property is believed to consist of surface contamination and subsurface contamination at depths ranging from 15.2 cm (6.0 in.) to 0.30 m (1.0 ft). The areas of subsurface contamination are shown in Figure 5-2.

It has been established that the Lodi Brook channel through these neighboring properties once occupied locations connecting to those where stream sediments were found at 14 Long Valley Road. Thus, the elevated gamma readings shown on gamma logs from boreholes drilled on this property serve as further indication of the suspected mechanism of transport for radiological contamination (i.e., stream deposition from Lodi Brook).
