RADIOLOGICAL CHARACTERIZATION REPORT FOR THE RESIDENTIAL PROPERTY AT 7 HANCOCK STREET

Lodi, New Jersey

September 1989

Bechtel National, Inc.

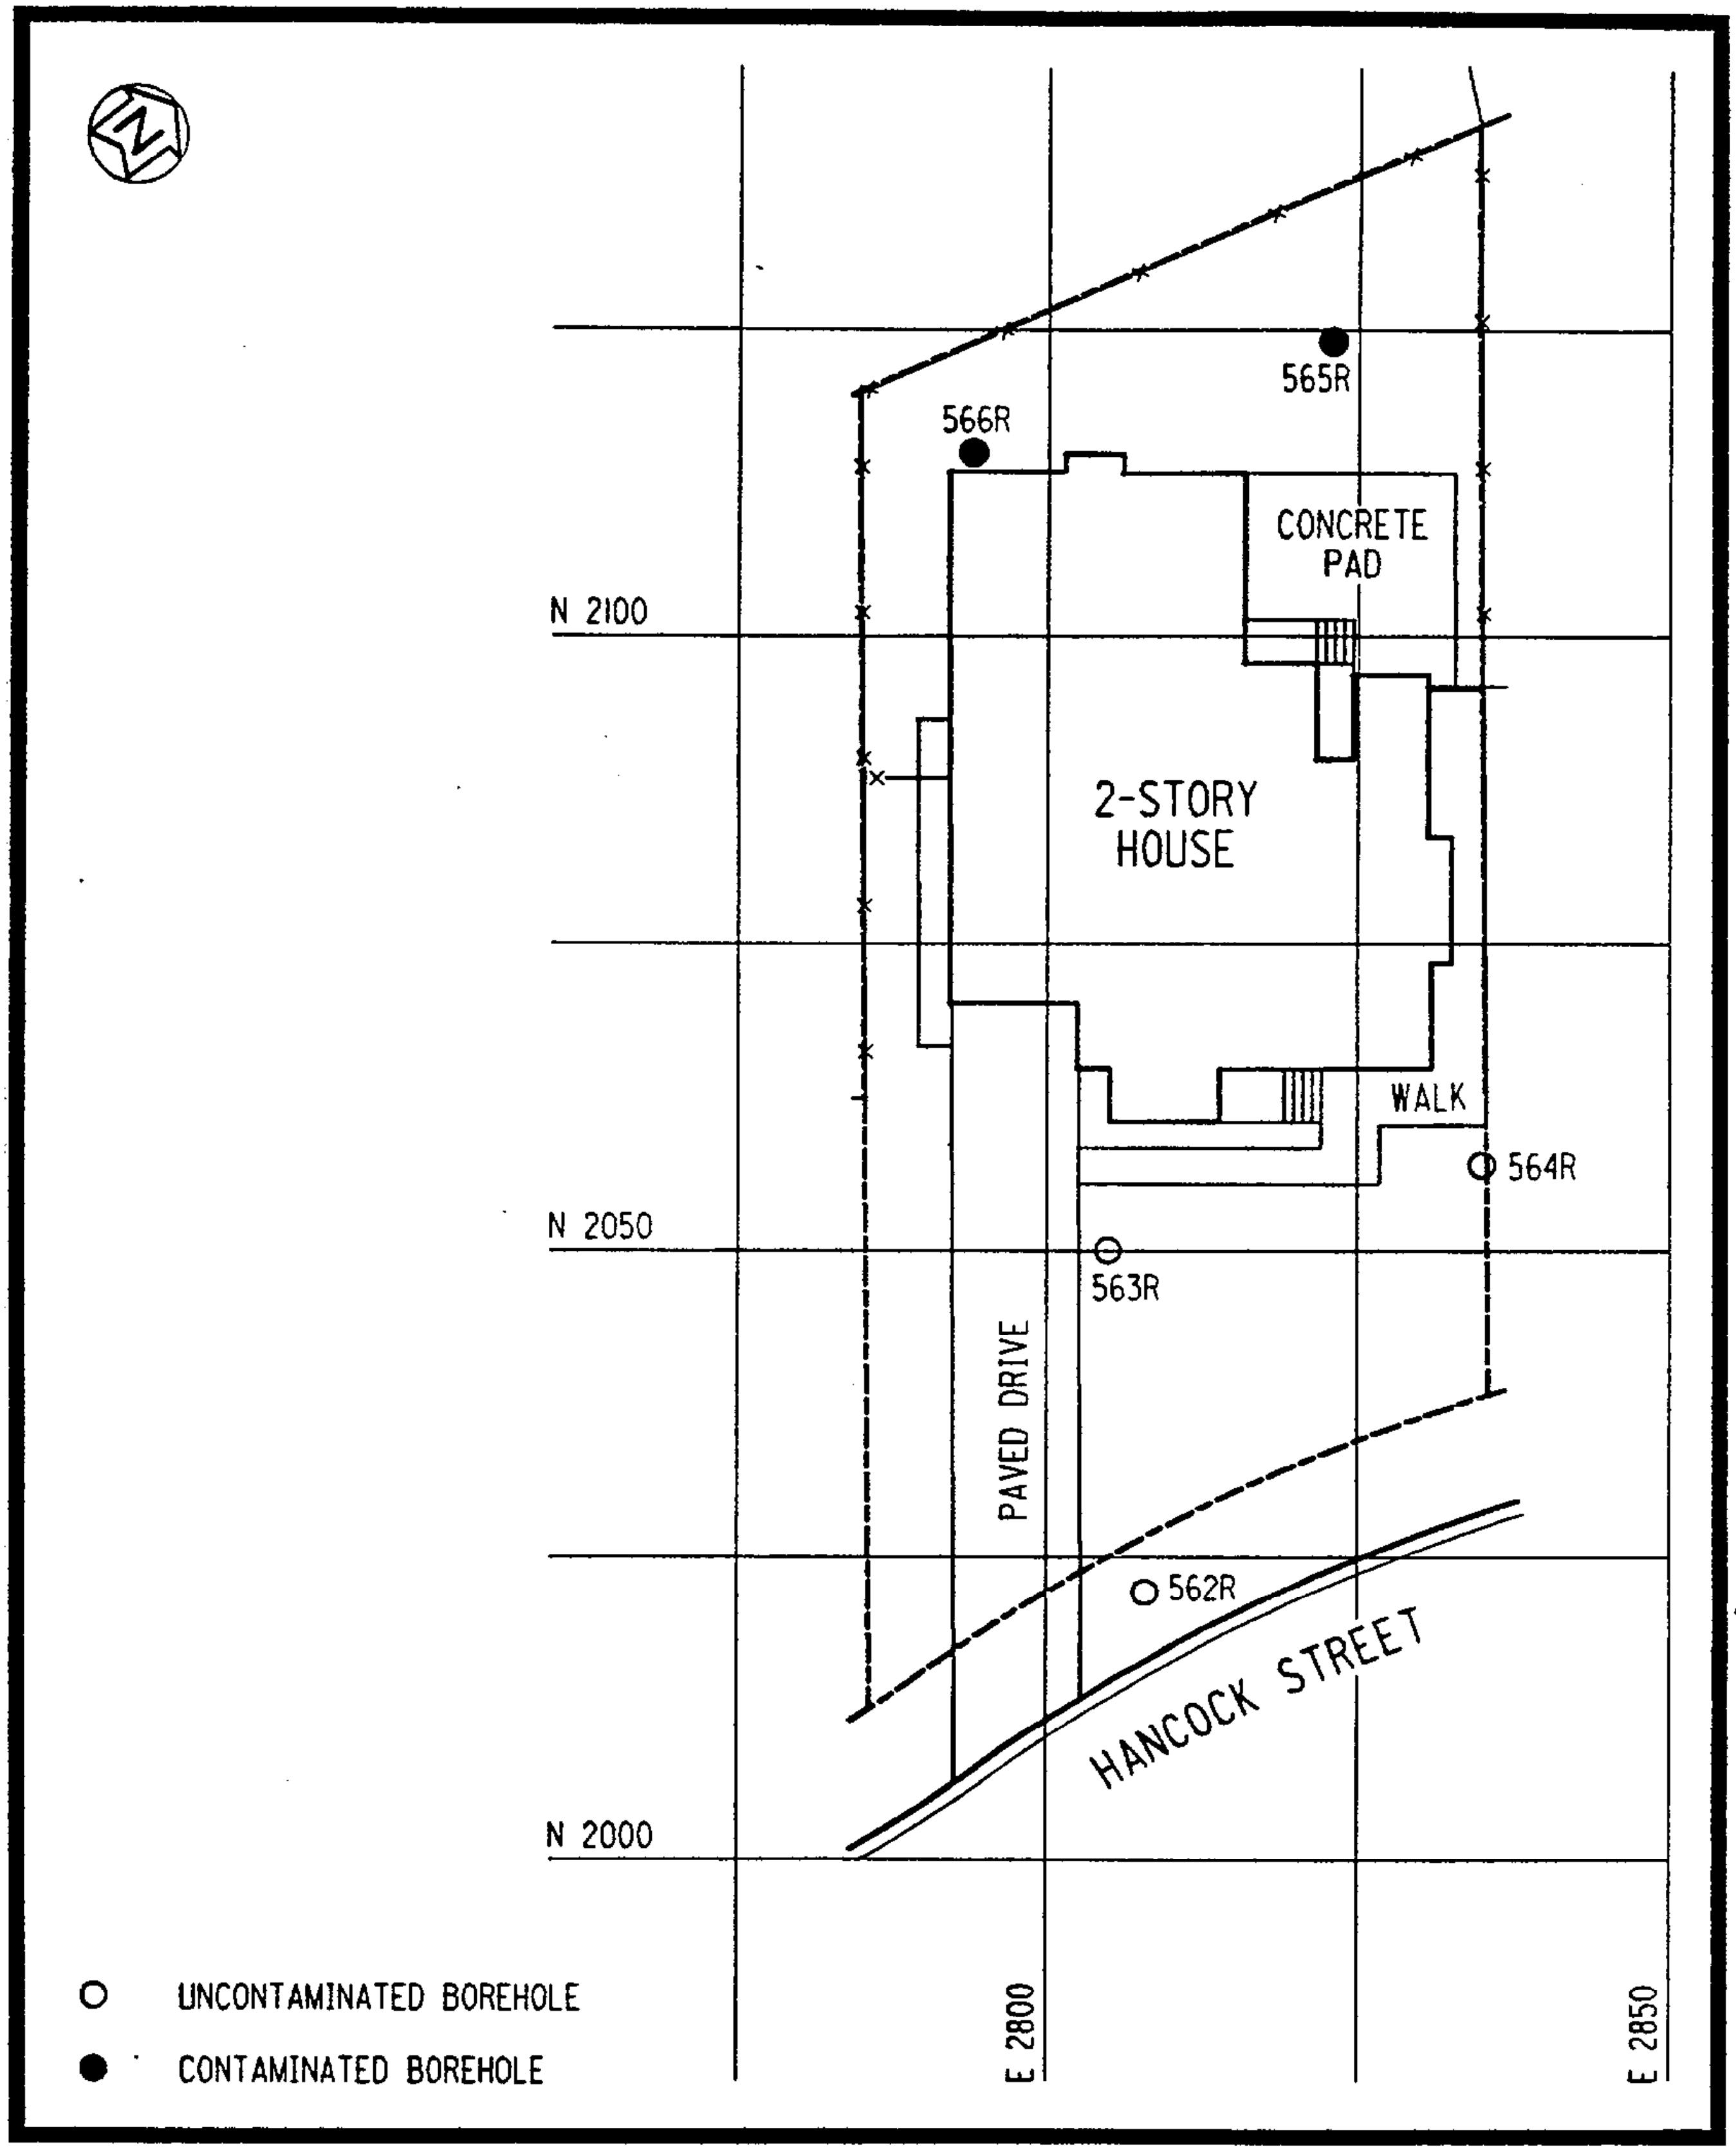
FIGURE 4-1 BOREHOLE LOCATIONS AT 7 HANCOCK STREET

A subsurface investigation was conducted to determine the depth to which the previously identified surface contamination extended and to locate subsurface contamination where there was no surface manifestation. The subsurface characterization consisted of drilling five boreholes (Figure 4-1) [using either a 7.6-cm- (3-in.-) or 15.2-cm- (6-in.-) diameter auger bit], and gamma logging them. The boreholes were drilled to depths determined in the field by the radiological and geological support representatives.

[a]Borehole locations are shown in Figure 4-1.

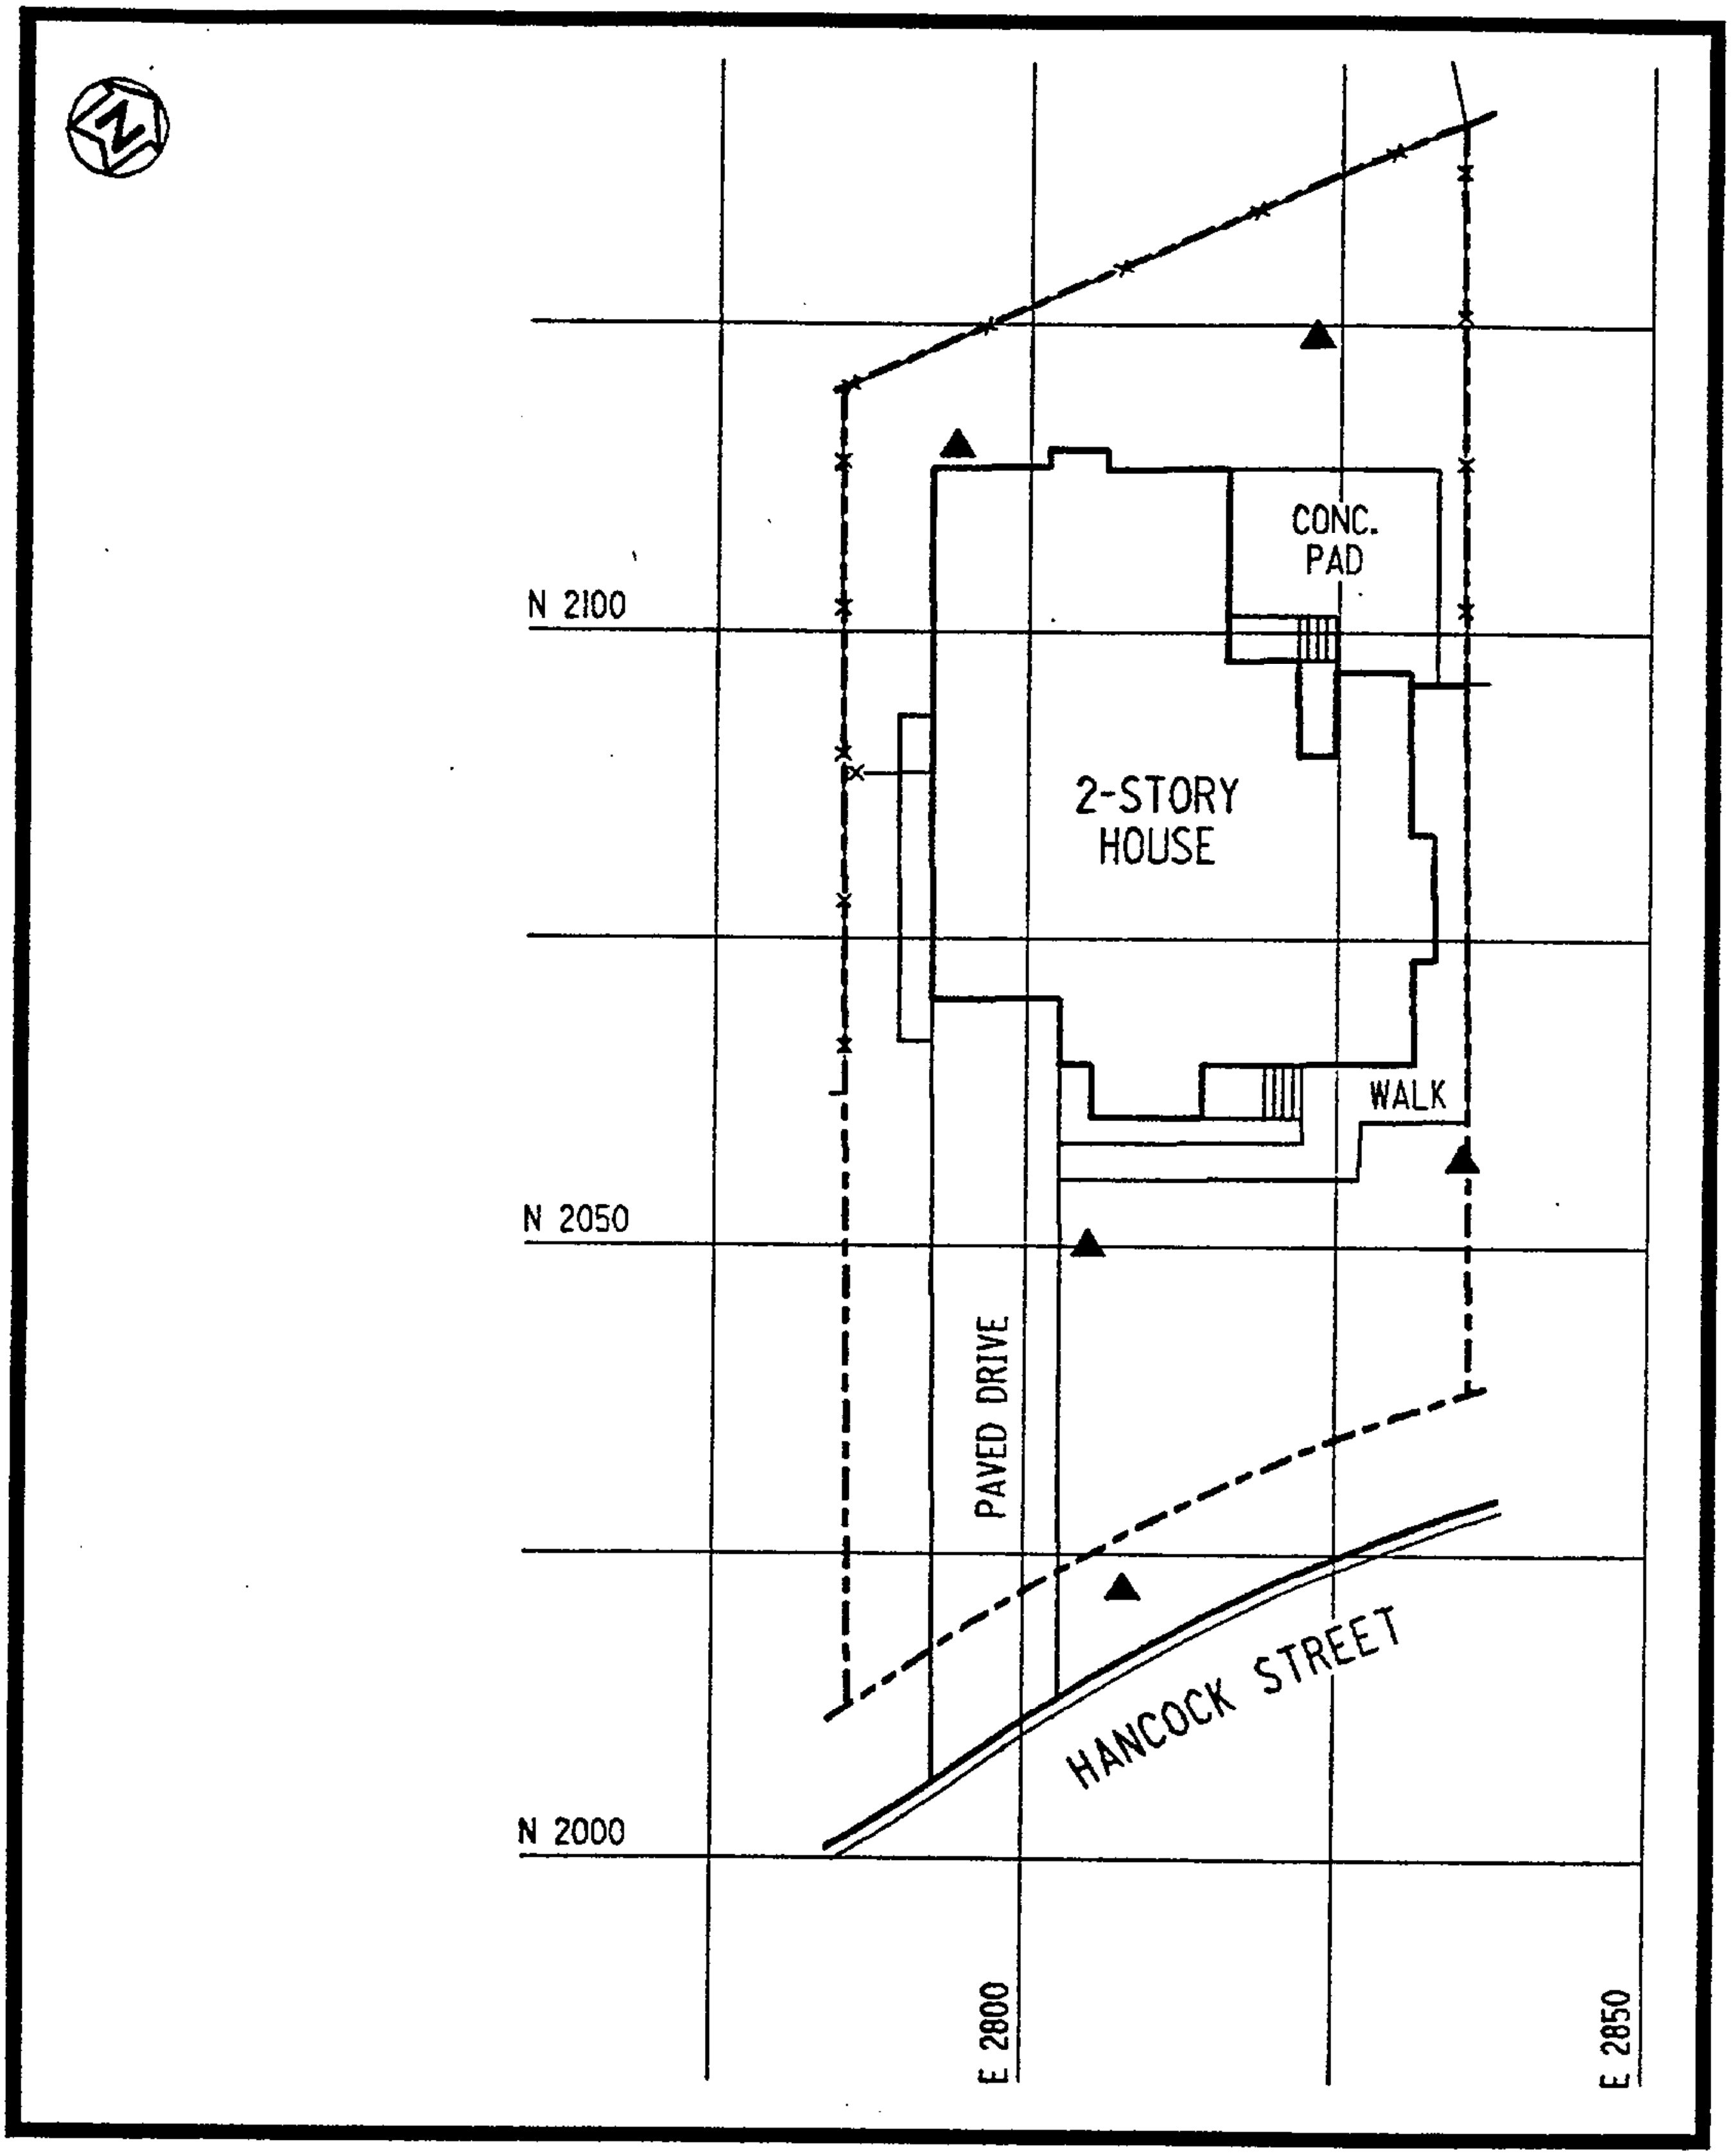
FIGURE 4-2 SURFACE AND SUBSURFACE SOIL SAMPLING LOCATIONS AT 7 HANCOCK STREET

Subsurface soil samples were collected from five locations (Figure 4-2) using the side-wall sampling method and were analyzed to compare laboratory soil sample results to downhole gamma radiation measurements. A cup or can attached to a steel pipe or wooden stake was inserted into the borehole and used to scrape samples off the side of the borehole at a specified depth. The subsurface soil samples were analyzed for radium-226, uranium-238, and thorium-232 in the same manner as the surface soil samples.

Surface soil samples [depths from 0.0 to 15.2 cm (0.5 in.)] were taken at five locations on the property (Figure 4-2). These samples were analyzed for thorium-232, uranium-238, and radium-226. The concentrations in these samples ranged from less than 6.2 to less than 8.1 pCi/g for uranium-238, from 1.3 to 3.5 pCi/g for thorium-232, and from 1.3 to 1.8 pCi/g for radium-226. Analytical results for surface soils are provided in Table 5-1; these data showed that concentrations of thorium-232 do not exceed DOE guidelines (5 pCi/g plus background of 1 pCi/g for surface soils) with a maximum concentration of 3.5 pCi/g. Use of the "less than" (<) notation in reporting results indicates that the radionuclide was not present in concentrations that are quantitative with the instruments and techniques used. The "less than" value represents the lower bound of the quantitative capacity of the instrument and technique used. The "less than" value is based on various factors, including the volume, size, and weight of the sample; the type of detector used; the counting time; and the background count rate. The actual concentration of the radionuclide is less than the value indicated. In addition, since radioactive decay is a random process, a correlation between the rate of disintegration and a given radionuclide concentration cannot be precisely established. For this reason, the exact concentration of the radionuclide cannot be determined. As such, each value that can be quantitatively determined has an associated uncertainty term ($\pm$), which represents the amount by which the actual concentration can be expected to differ from the value given in the table. The uncertainty term has an associated confidence level of 95 percent.

[a]Sampling locations are shown in Figure 4-2.

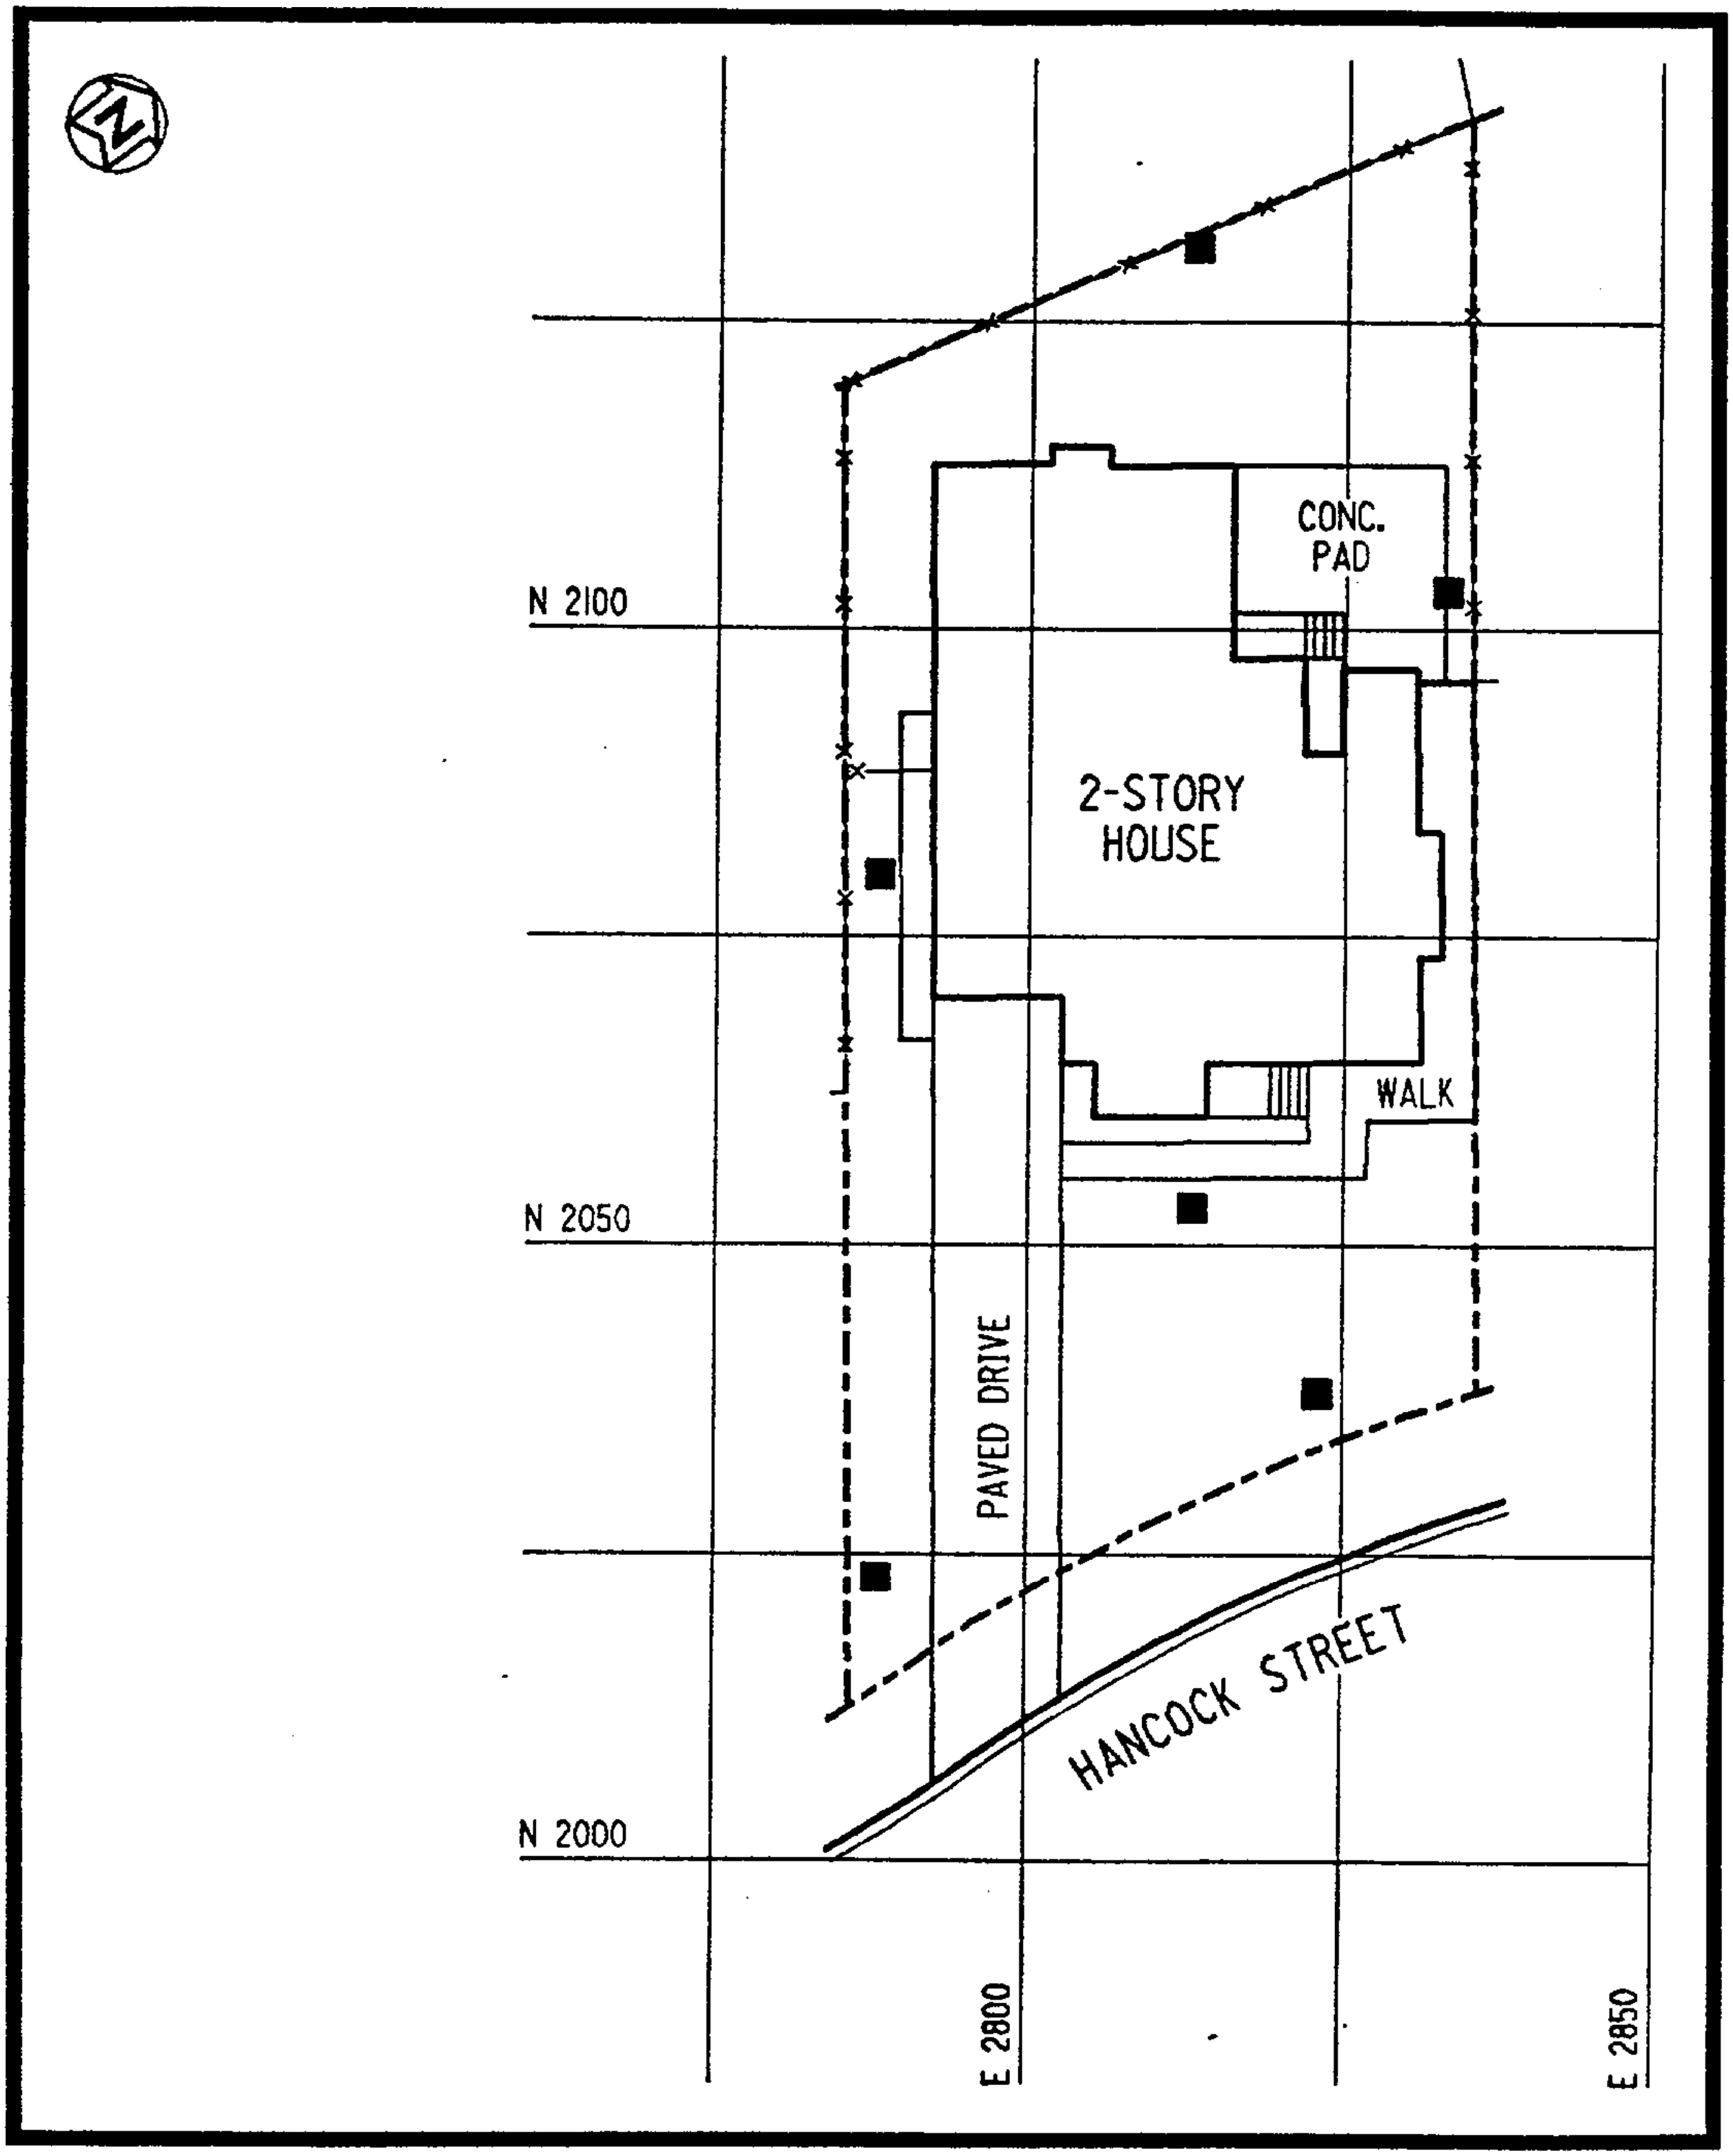
FIGURE 4-3 GAMMA EXPOSURE RATE MEASUREMENT LOCATIONS AT 7 HANCOCK STREET

Exterior gamma radiation exposure rate measurements ranged from 8 to 14 μR/h, including background. These results can be found in Table 5-3. Assuming the resident spends 36 hours per week for 52 weeks per year (1,872 hours or 8 hours per day for 2 days per week and 4 hours per day for 5 days per week) in the yard, the average exterior exposure rate of 22 μR/h would result in a yearly dose of 4 mrem above background (after subtracting average background of 9 μR/h; Ref. 12).

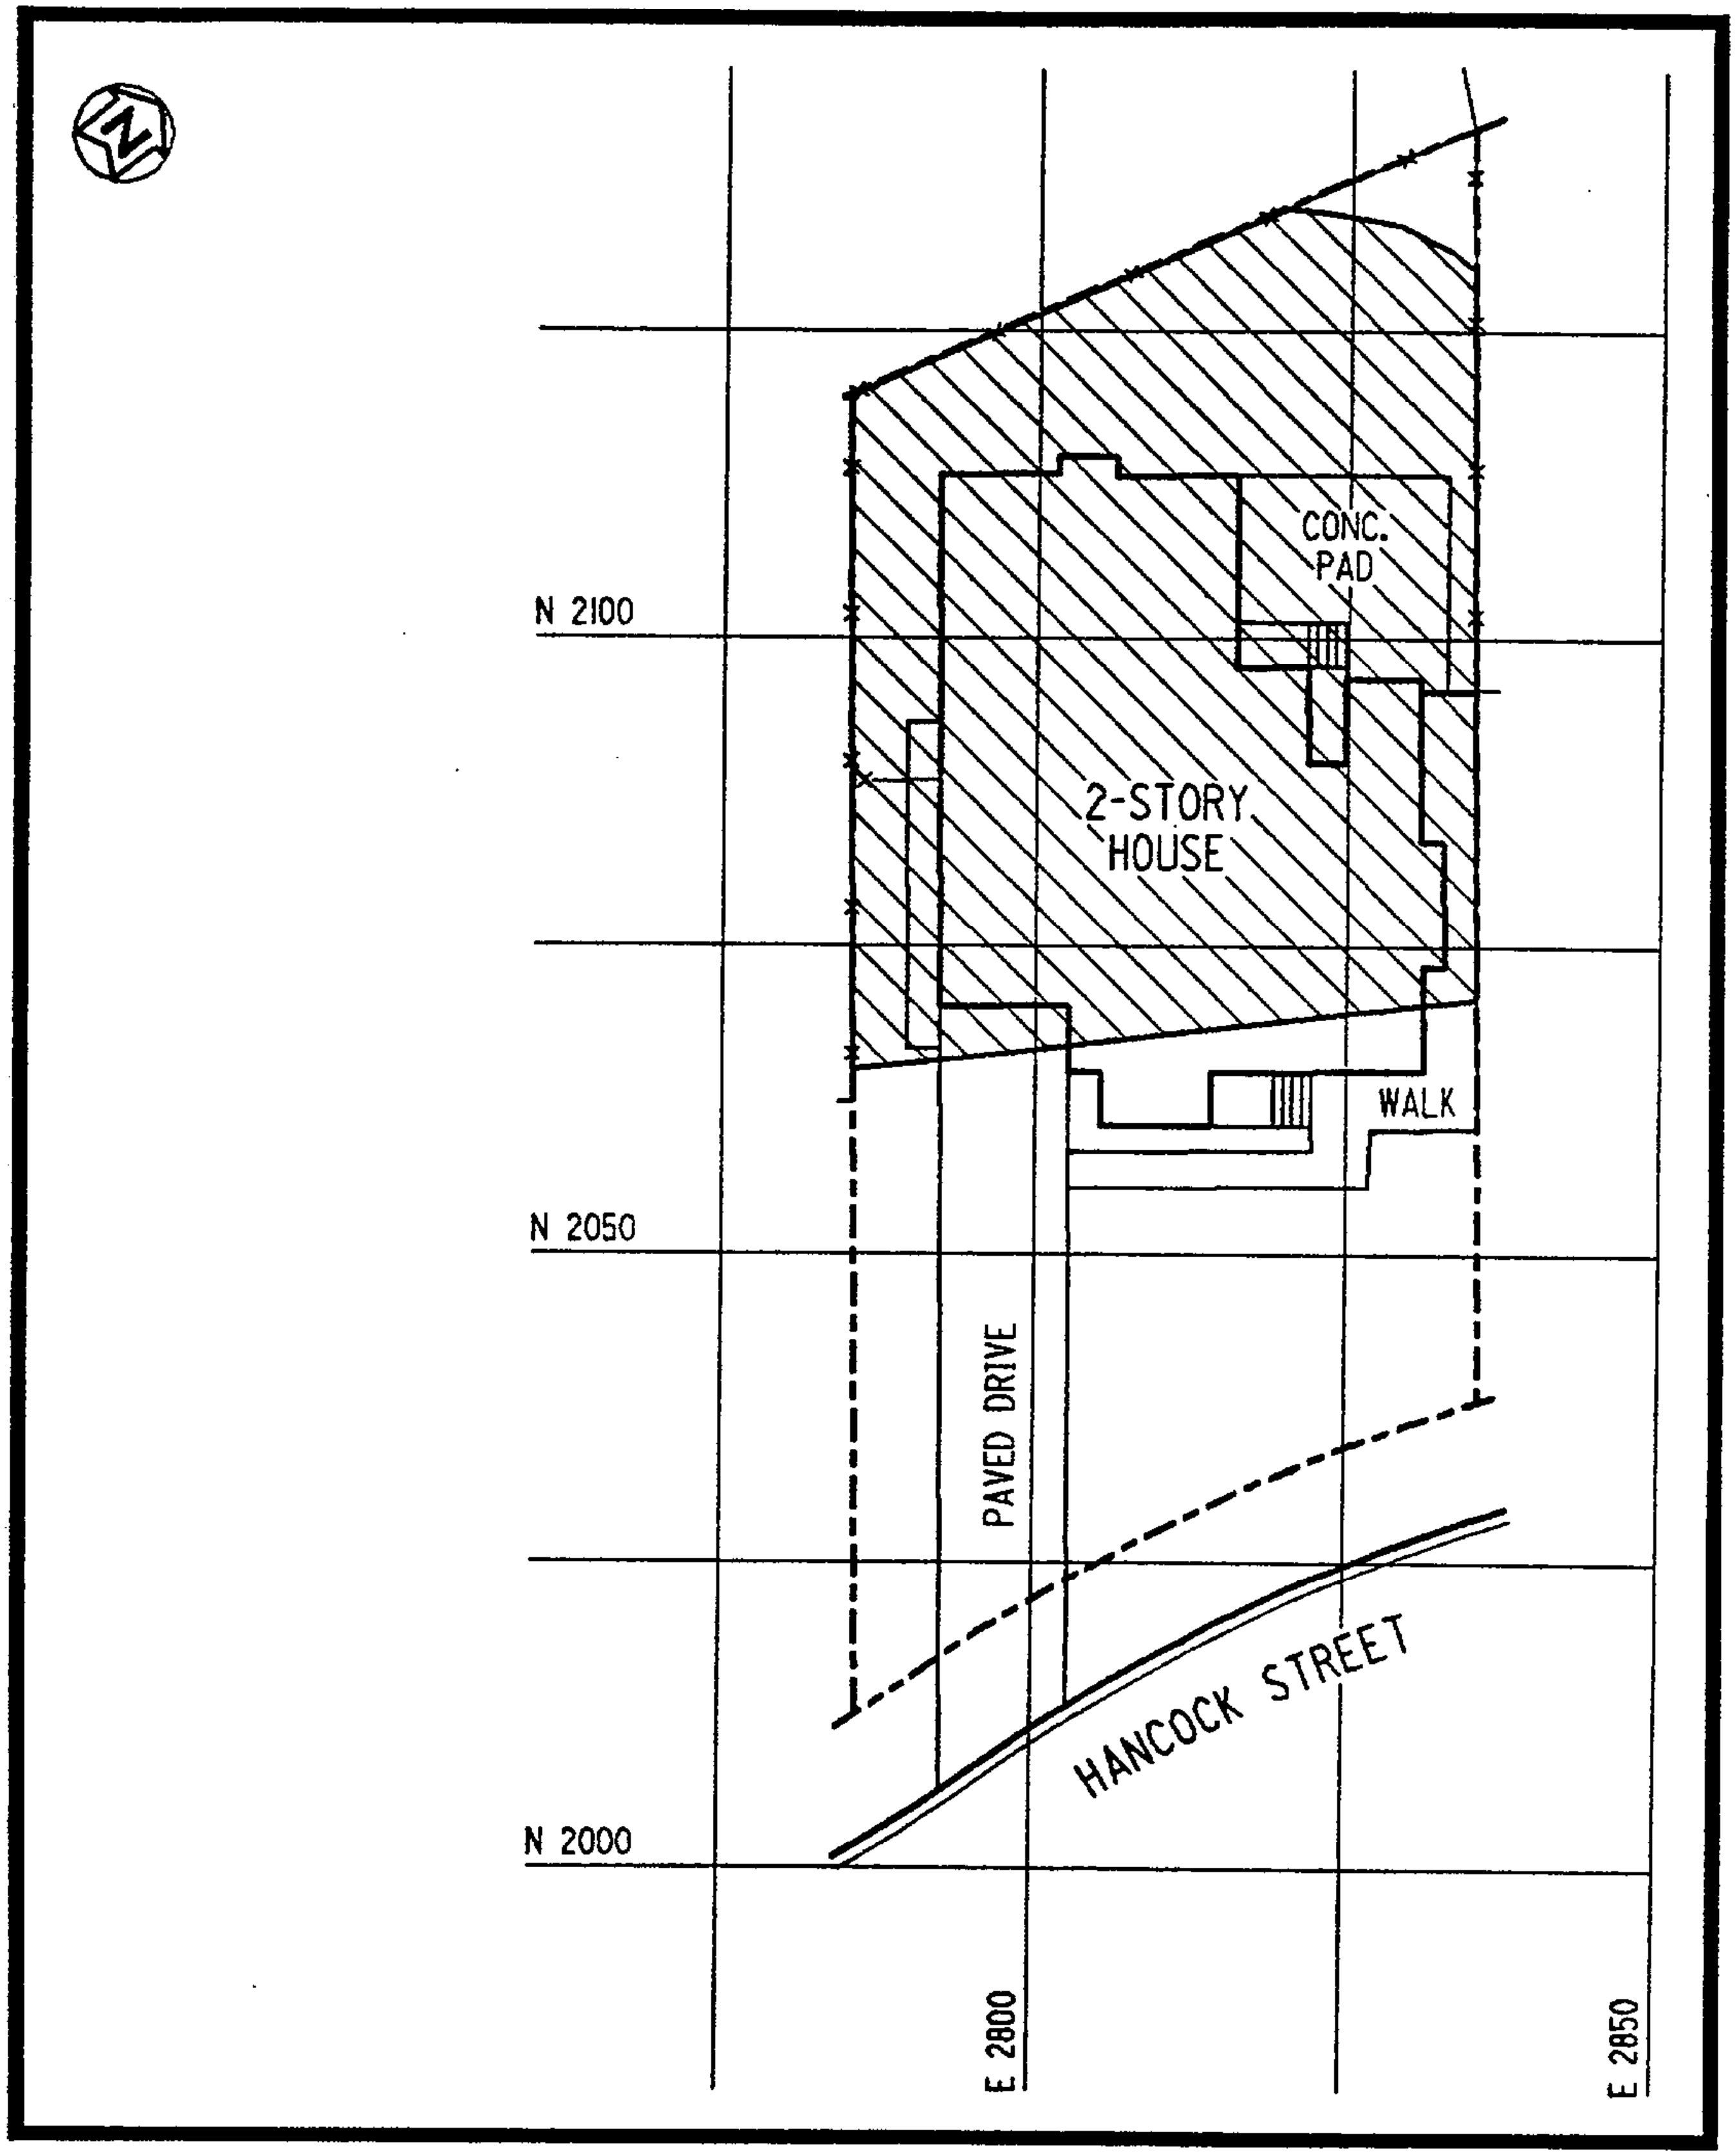
FIGURE 5-1 AREAS OF SUBSURFACE CONTAMINATION AT 7 HANCOCK STREET

Soil analysis data for this property did not indicate surface contamination. Subsurface investigation by gamma logging indicated contamination to a depth of 1.37 m (4.5 ft).

On the basis of near-surface gamma radiation measurements, surface and subsurface soil sample analyses, and downhole gamma logging, contamination on this property is believed to consist primarily of subsurface contamination at depths ranging from 0.76 m (2.5 ft) to 1.37 m (4.5 ft). The areas of subsurface contamination are shown in Figure 5-1. The subsurface contamination appears to extend beneath the residence.
