RADIOLOGICAL CHARACTERIZATION REPORT FOR THE COMMERCIAL PROPERTY AT 80 HANCOCK STREET (AIRCO)

Lodi, New Jersey

September 1989

RADIOLOGICAL CHARACTERIZATION REPORT FOR THE COMMERCIAL PROPERTY AT 80 HANCOCK STREET LODI, NEW JERSEY

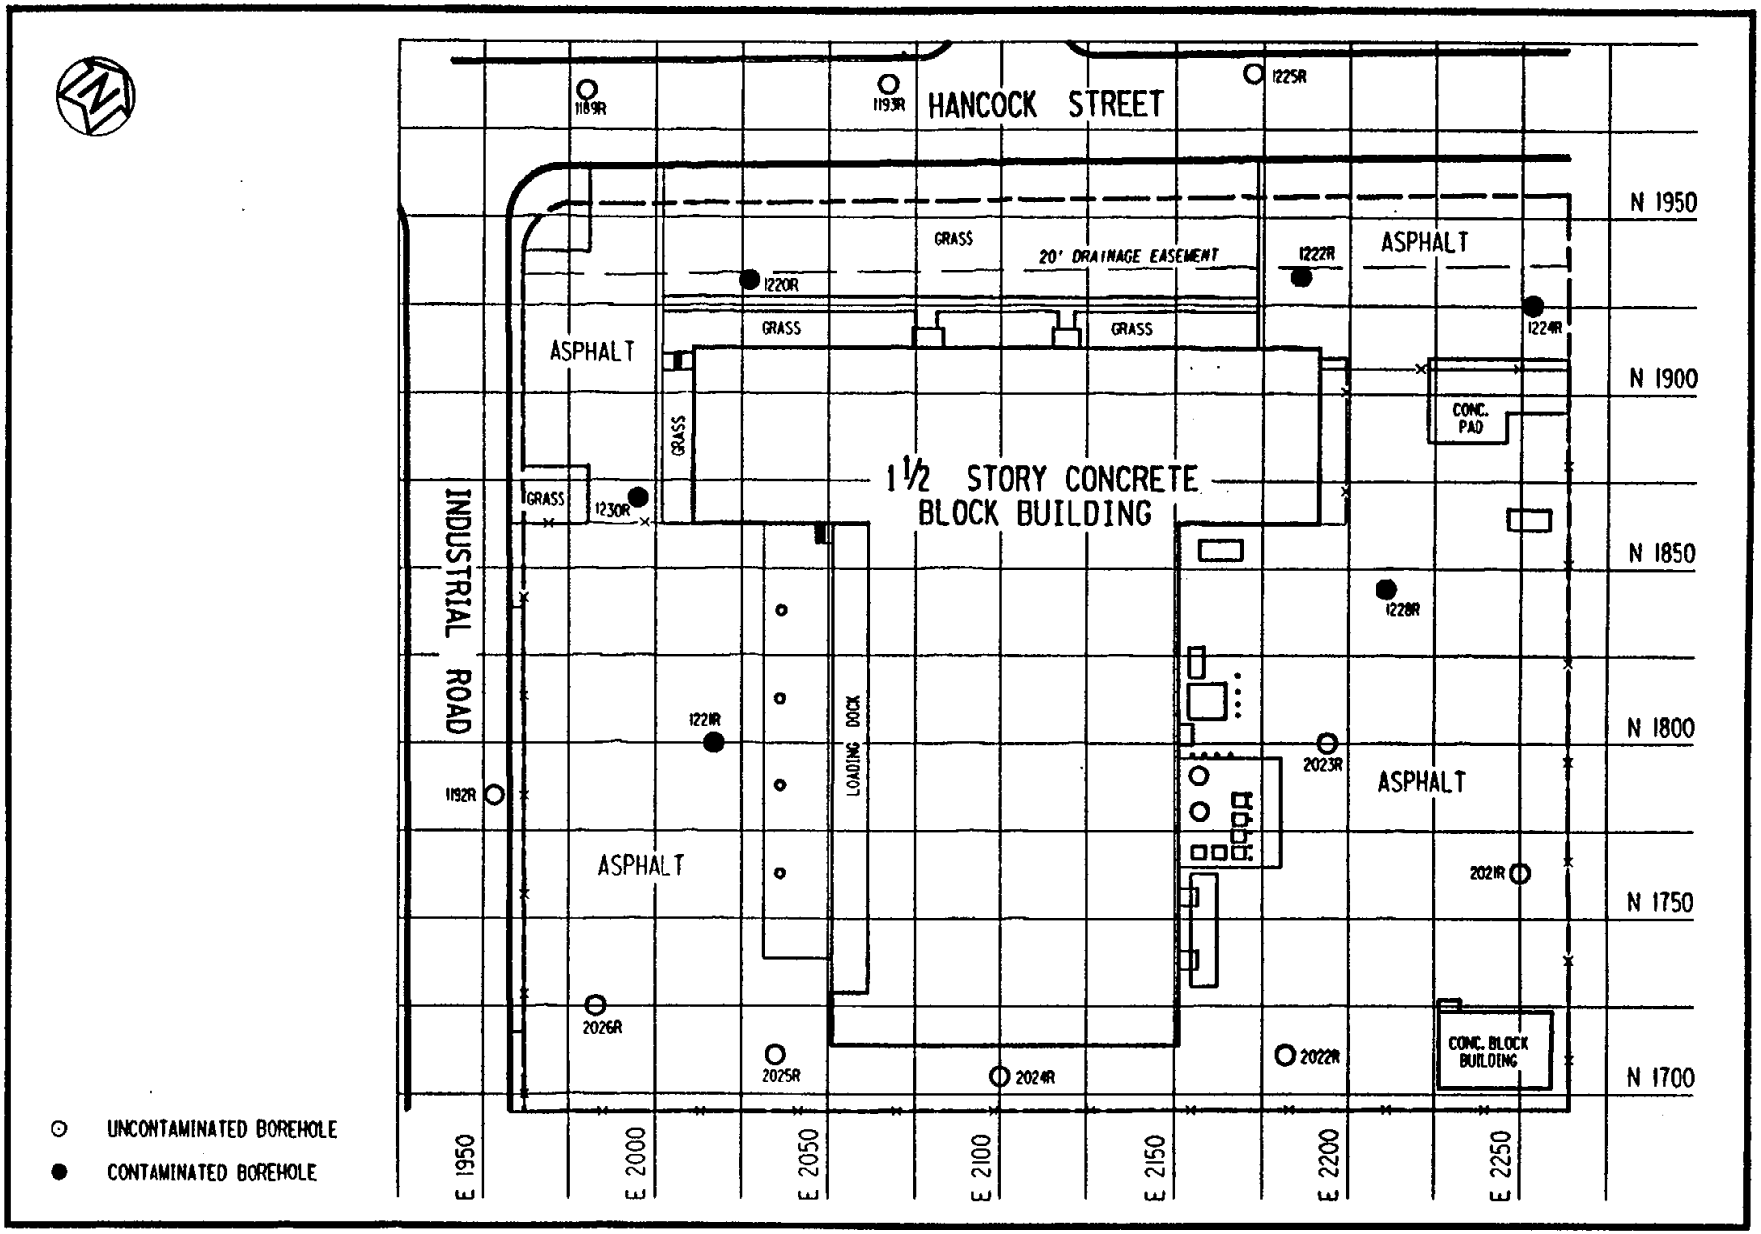
FIGURE 4-1 BOREHOLE LOCATIONS AT 80 HANCOCK STREET

Soil analysis data for this property indicated surface contamination. Subsurface investigation by gamma logging indicated contamination to a depth of 1.83 m (6.0 ft).

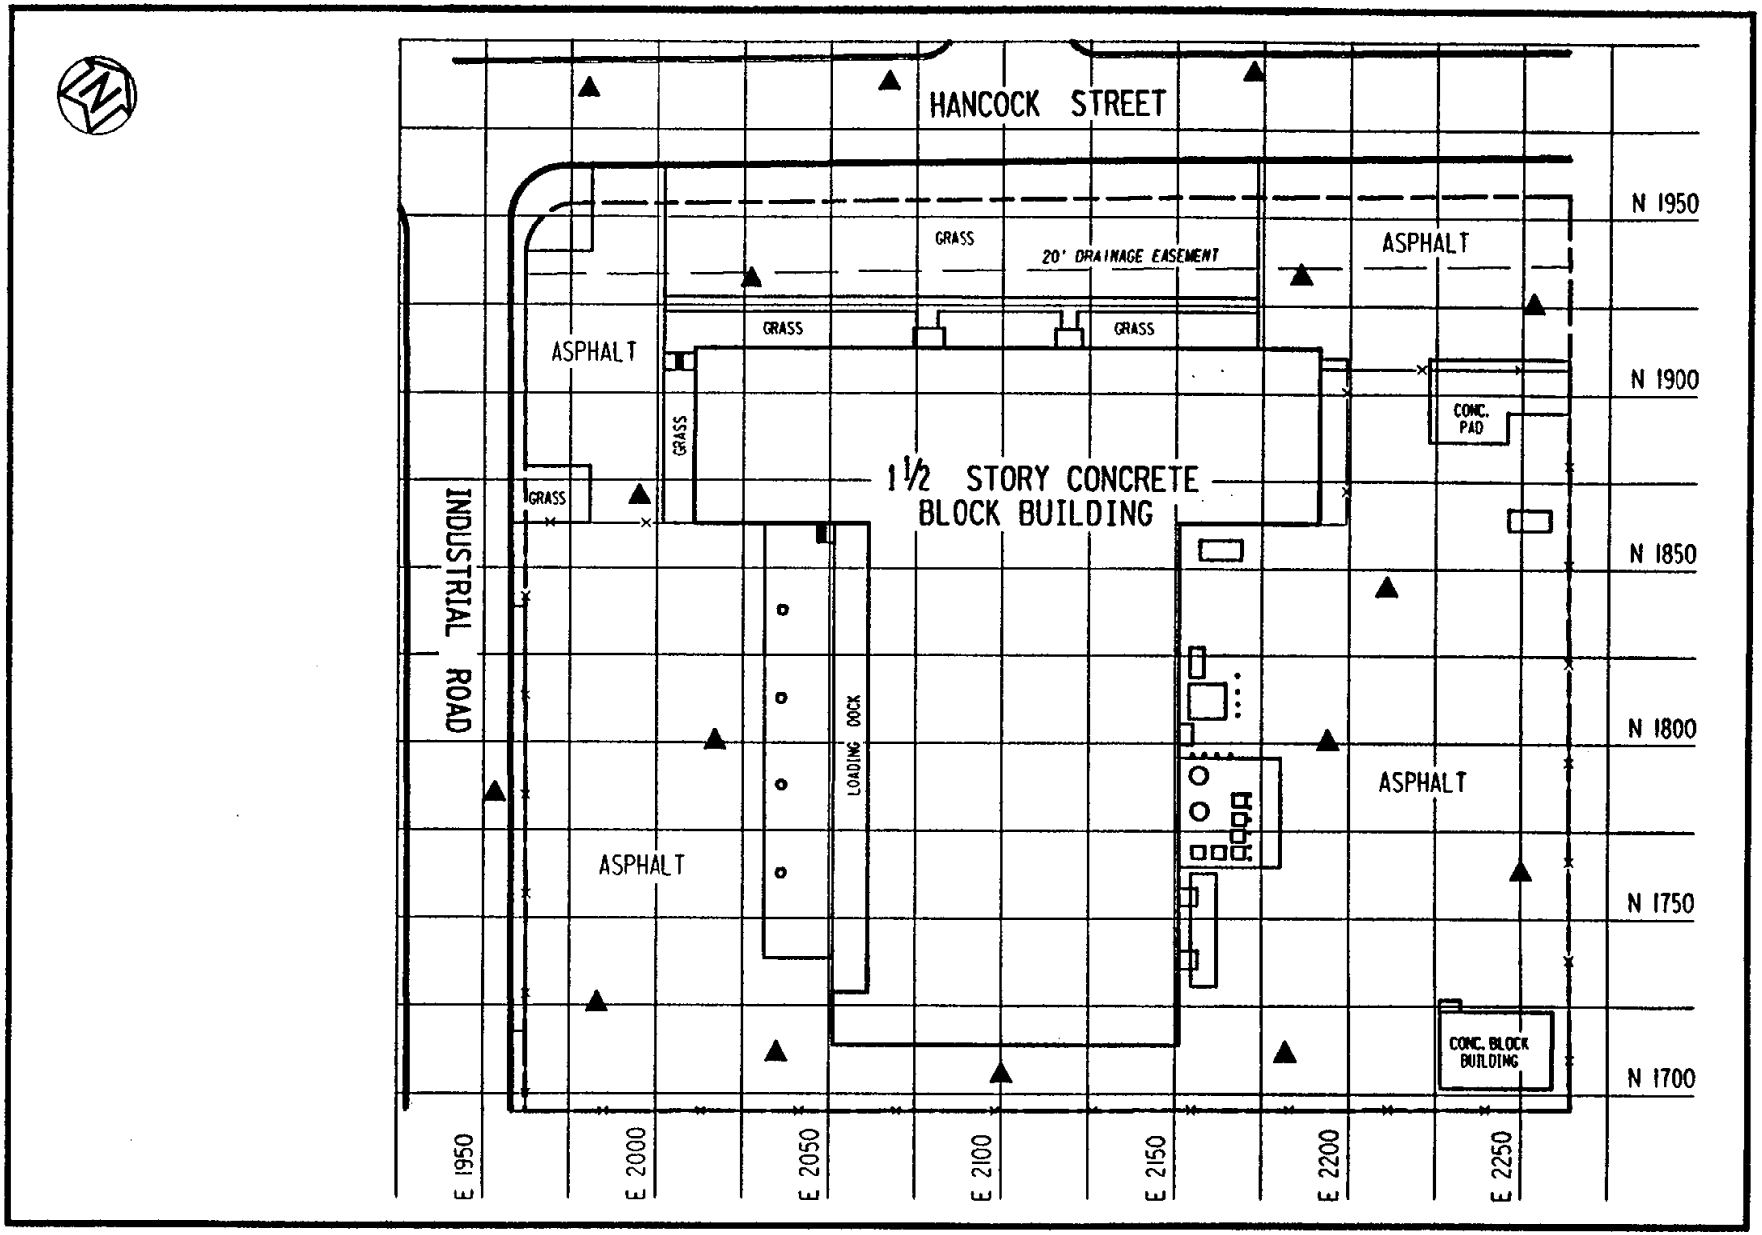
FIGURE 4-2 SURFACE AND SUBSURFACE SOIL SAMPLING LOCATIONS AT 80 HANCOCK STREET

Subsurface soil samples were collected from 15 locations (Figure 4-2) using a 7.6-cm (3.0-in.) outside diameter (O.D.) split-spoon sampler mounted on a tripod or attached to a truck-mounted auger stem. The subsurface soil samples were analyzed for radium-226, uranium-238, and thorium-232 in the same manner as the surface soil samples.

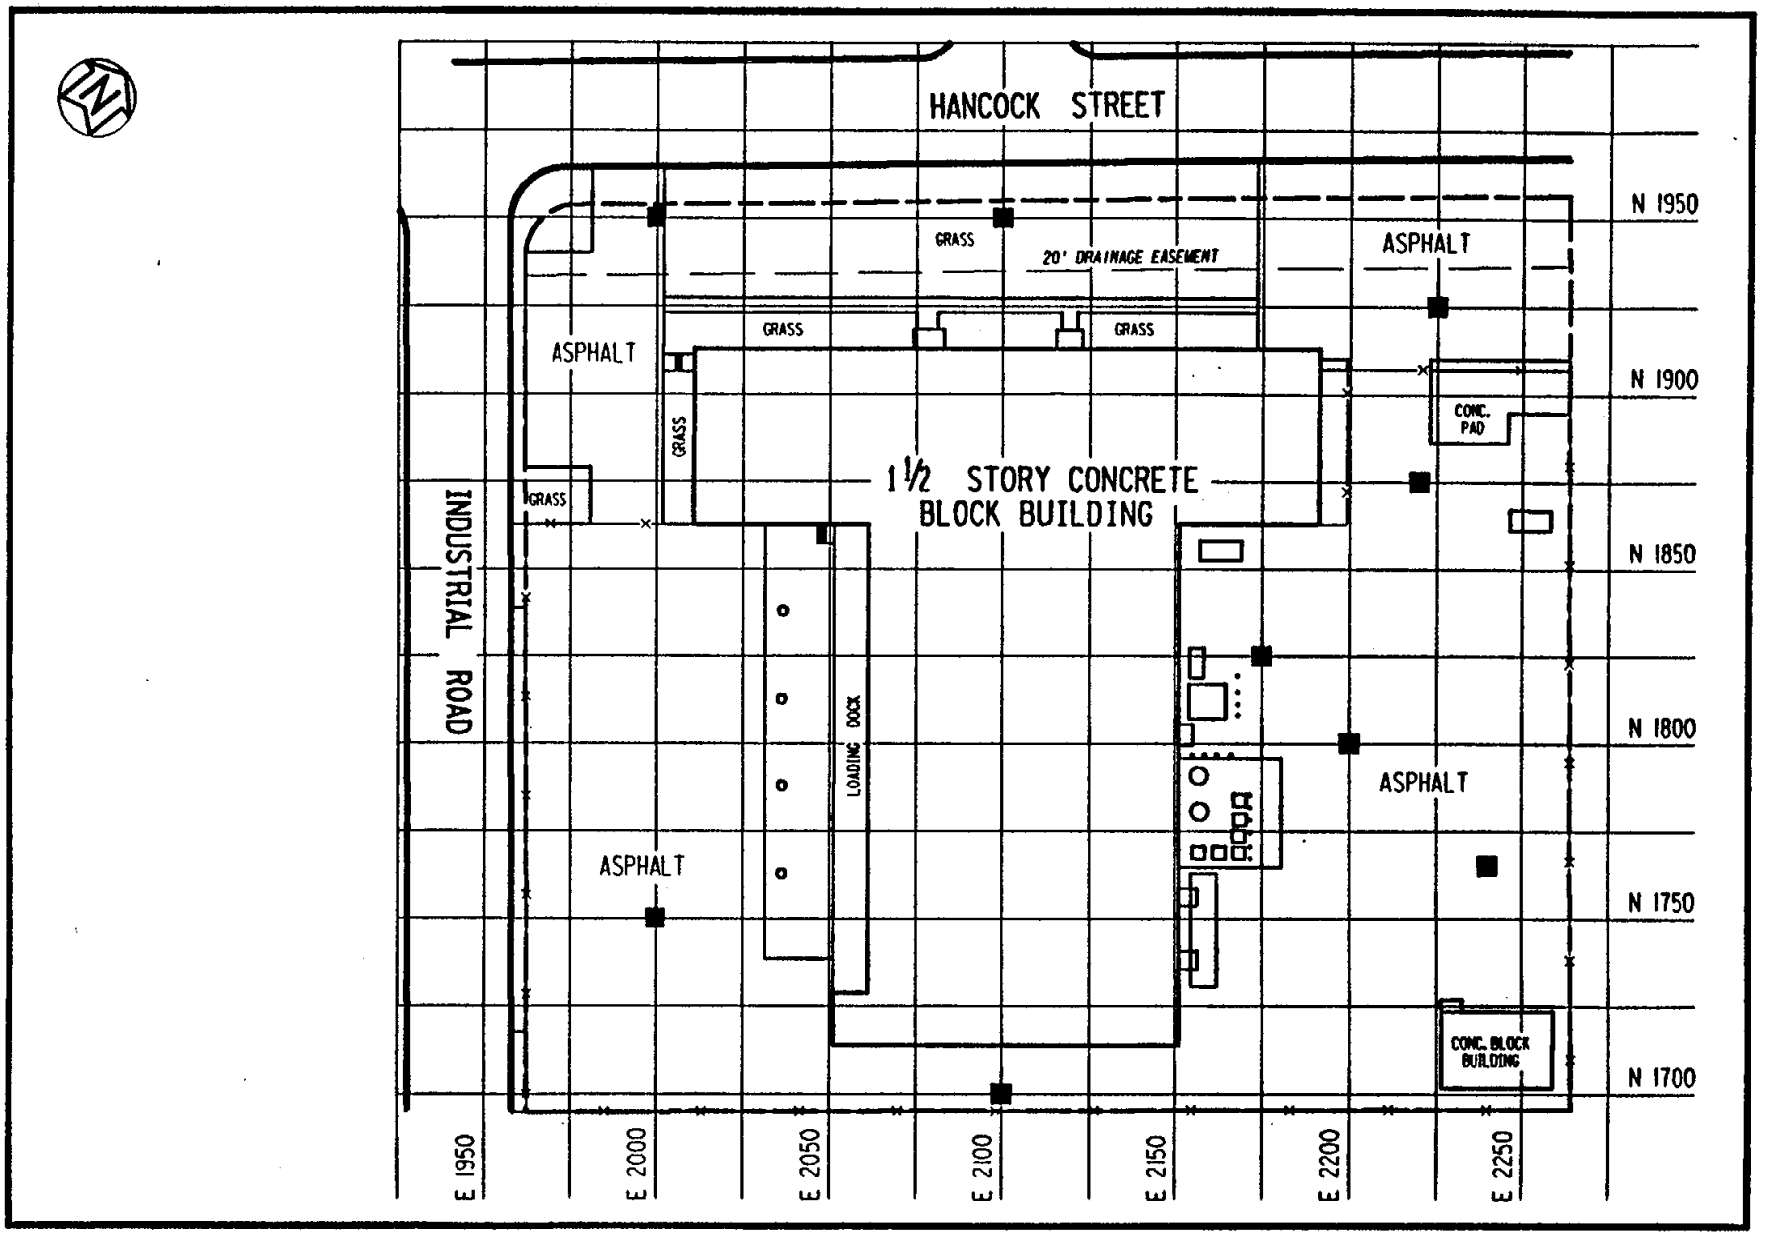
FIGURE 4-3 GAMMA EXPOSURE RATE MEASUREMENT LOCATIONS AT 80 HANCOCK STREET

Exterior gamma radiation exposure rate measurements ranged from 4 to 9 μR/h, including background. These results can be found in Table 5-3. The average exterior exposure rate of 6 μR/h does not exceed the average background level of 9 μR/h (Ref. 12). Therefore, no dose in excess of average background would be received as a result of contamination present on the property by employees spending time outside the building.

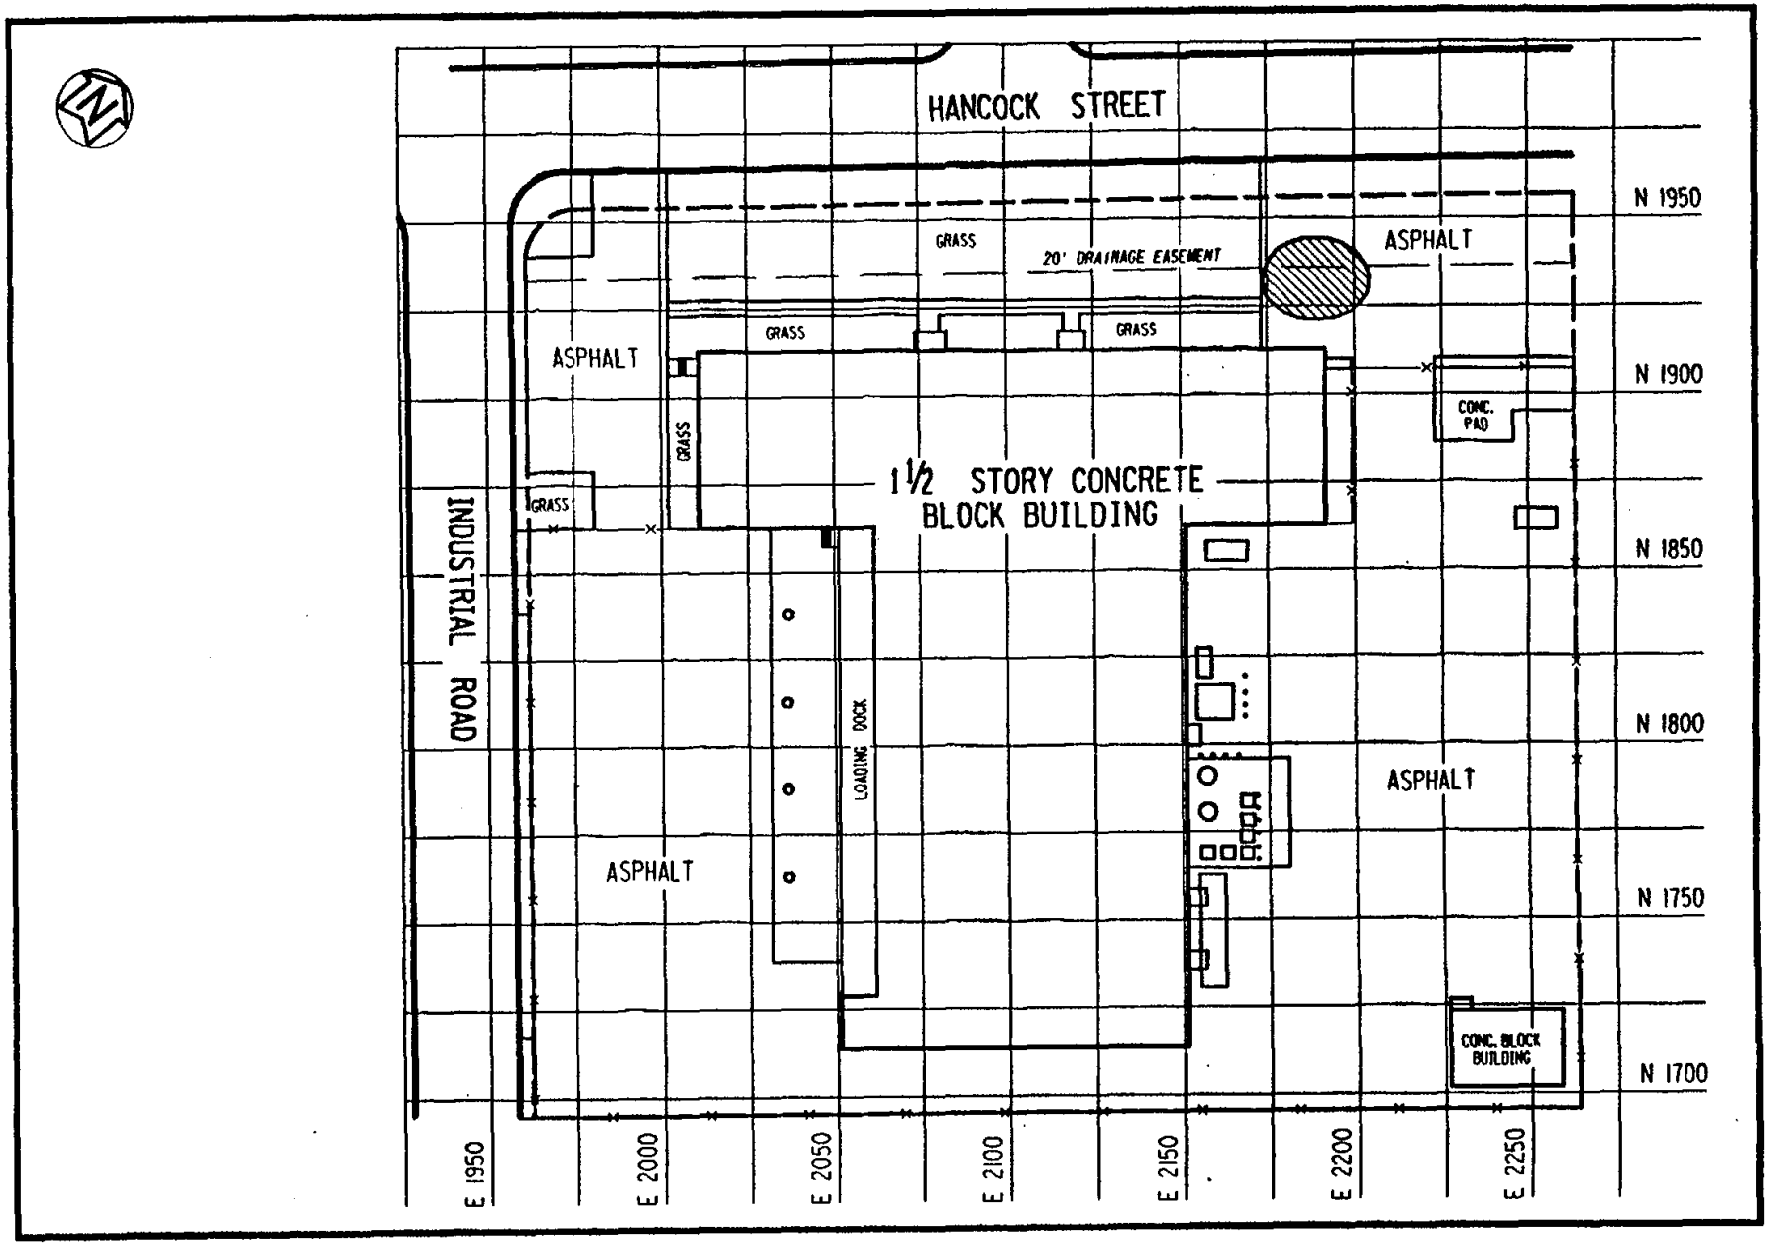
FIGURE 5-1 AREAS OF SURFACE CONTAMINATION AT 80 HANCOCK STREET

Near-surface gamma radiation measurements on the property ranged from 5,000 cpm to approximately 13,000 cpm. The average background level for this area is 5,000 cpm. A measurement of 11,000 cpm is approximately equal to the DOE guideline for thorium-232 of 5 pCi/g above background for surface soil contamination. Using this correlation, the near-surface gamma measurements were used to determine the extent of surface contamination and the basis for selecting the locations of soil samples. Areas of surface contamination are shown in Figure 5-1.

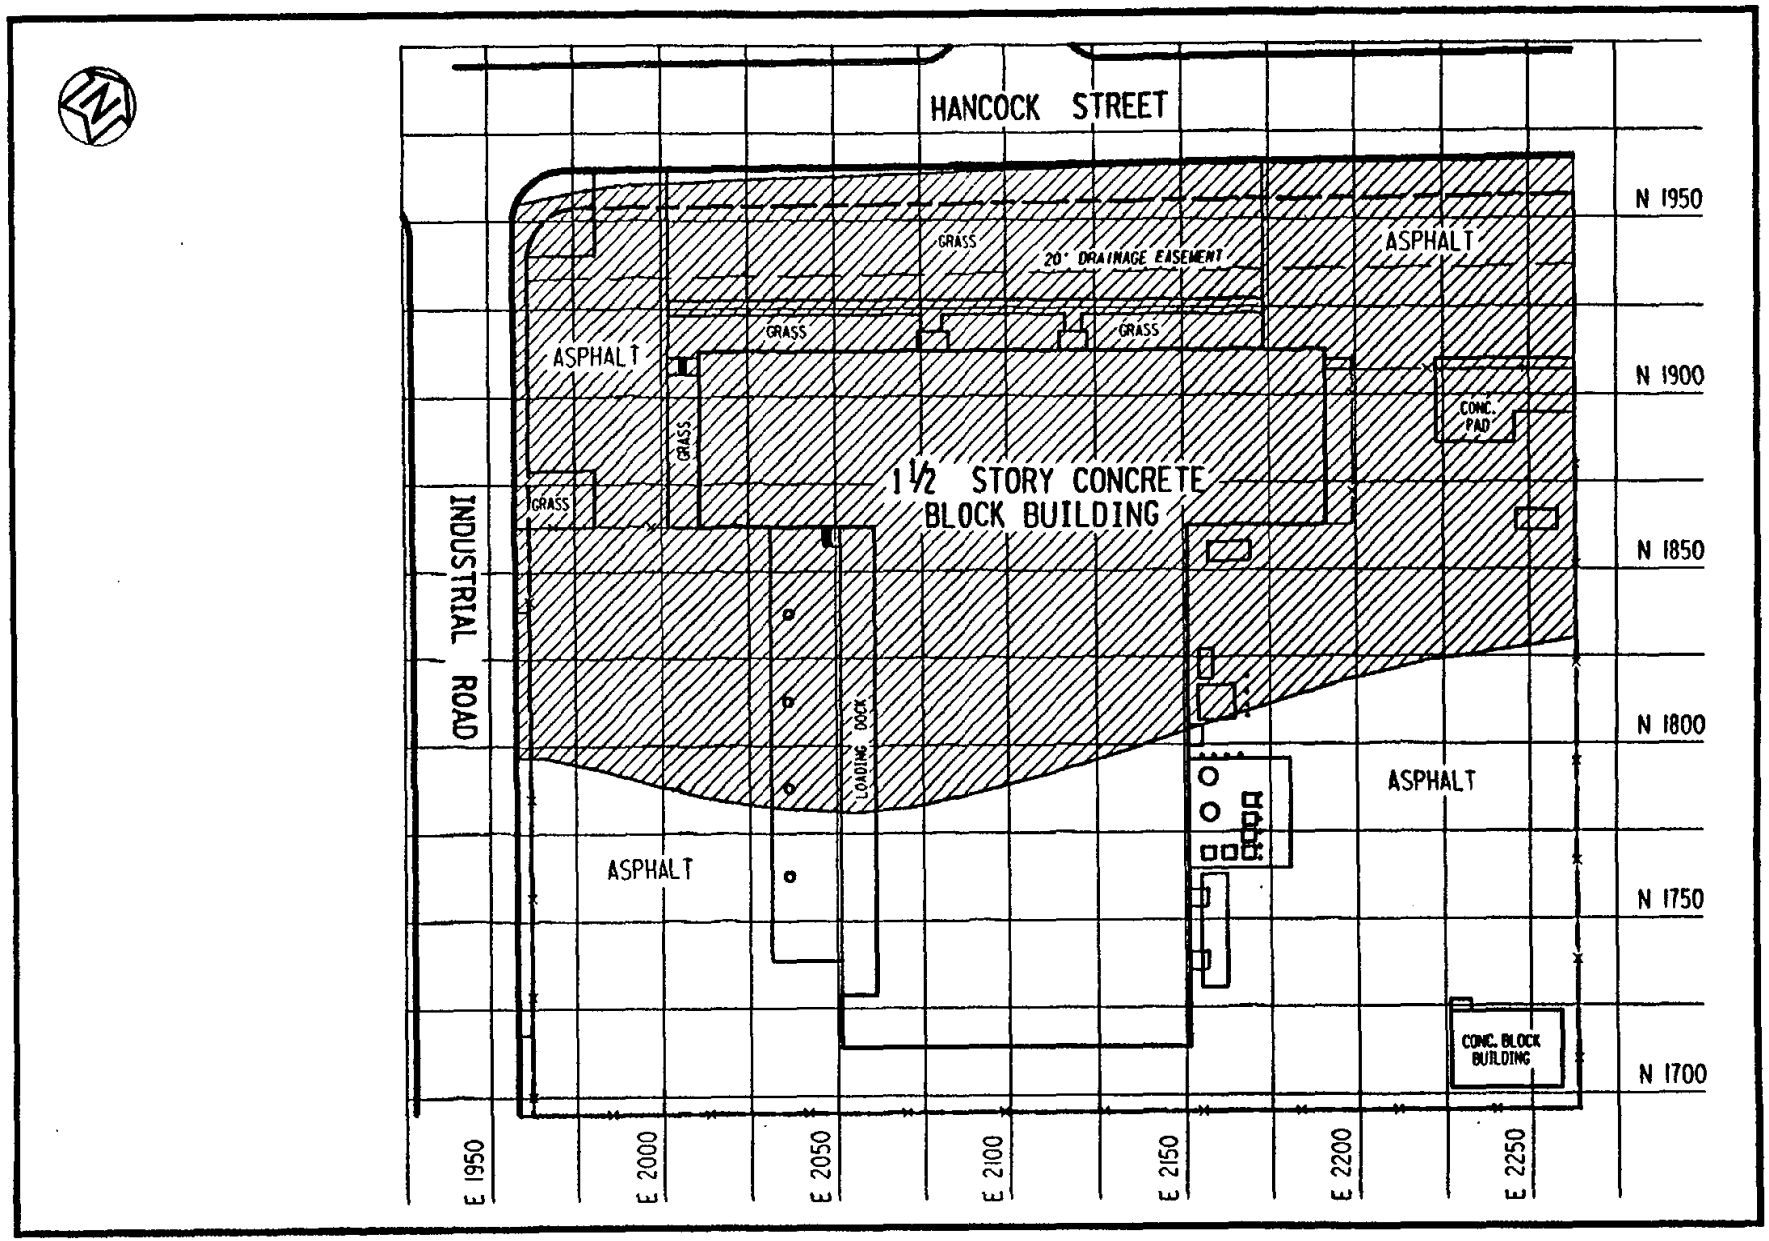
FIGURE 5-2 AREAS OF SUBSURFACE CONTAMINATION AT 80 HANCOCK STREET

On the basis of near-surface gamma radiation measurements, surface and subsurface soil sample analyses, and downhole gamma logging, contamination on this property is believed to consist primarily of subsurface contamination at depths ranging from 0.30 m (1.0 ft) to 1.83 m (6.0 ft). The areas of subsurface contamination are shown in Figure 5-2. The subsurface contamination appears to extend beneath the building and the streets (Hancock Street and Industrial Road) adjacent to the property.

It is apparent from review of historical documentation (e.g., aerial photographs of the area, interviews with local residents, and previous radiological surveys) that the subsurface contamination on this property lies along the former channel of Lodi Brook and its associated floodplain.

The contamination is similar to contamination found on two commercial properties in close proximity to this property. It has been established that the Lodi Brook channel through these neighboring properties once occupied locations connecting to those where stream sediments were found at 80 Hancock Street. Thus, the elevated gamma readings shown on gamma logs from boreholes drilled on this property serve as further indication of the suspected mechanism of transport for radiological contamination (i.e., stream deposition from Lodi Brook).
