DOE/OR/20722-153

CHARACTERIZATION REPORT FOR THE NEW JERSEY VEHICLE INSPECTION STATION PROPERTY

Lodi, New Jersey

June 1987

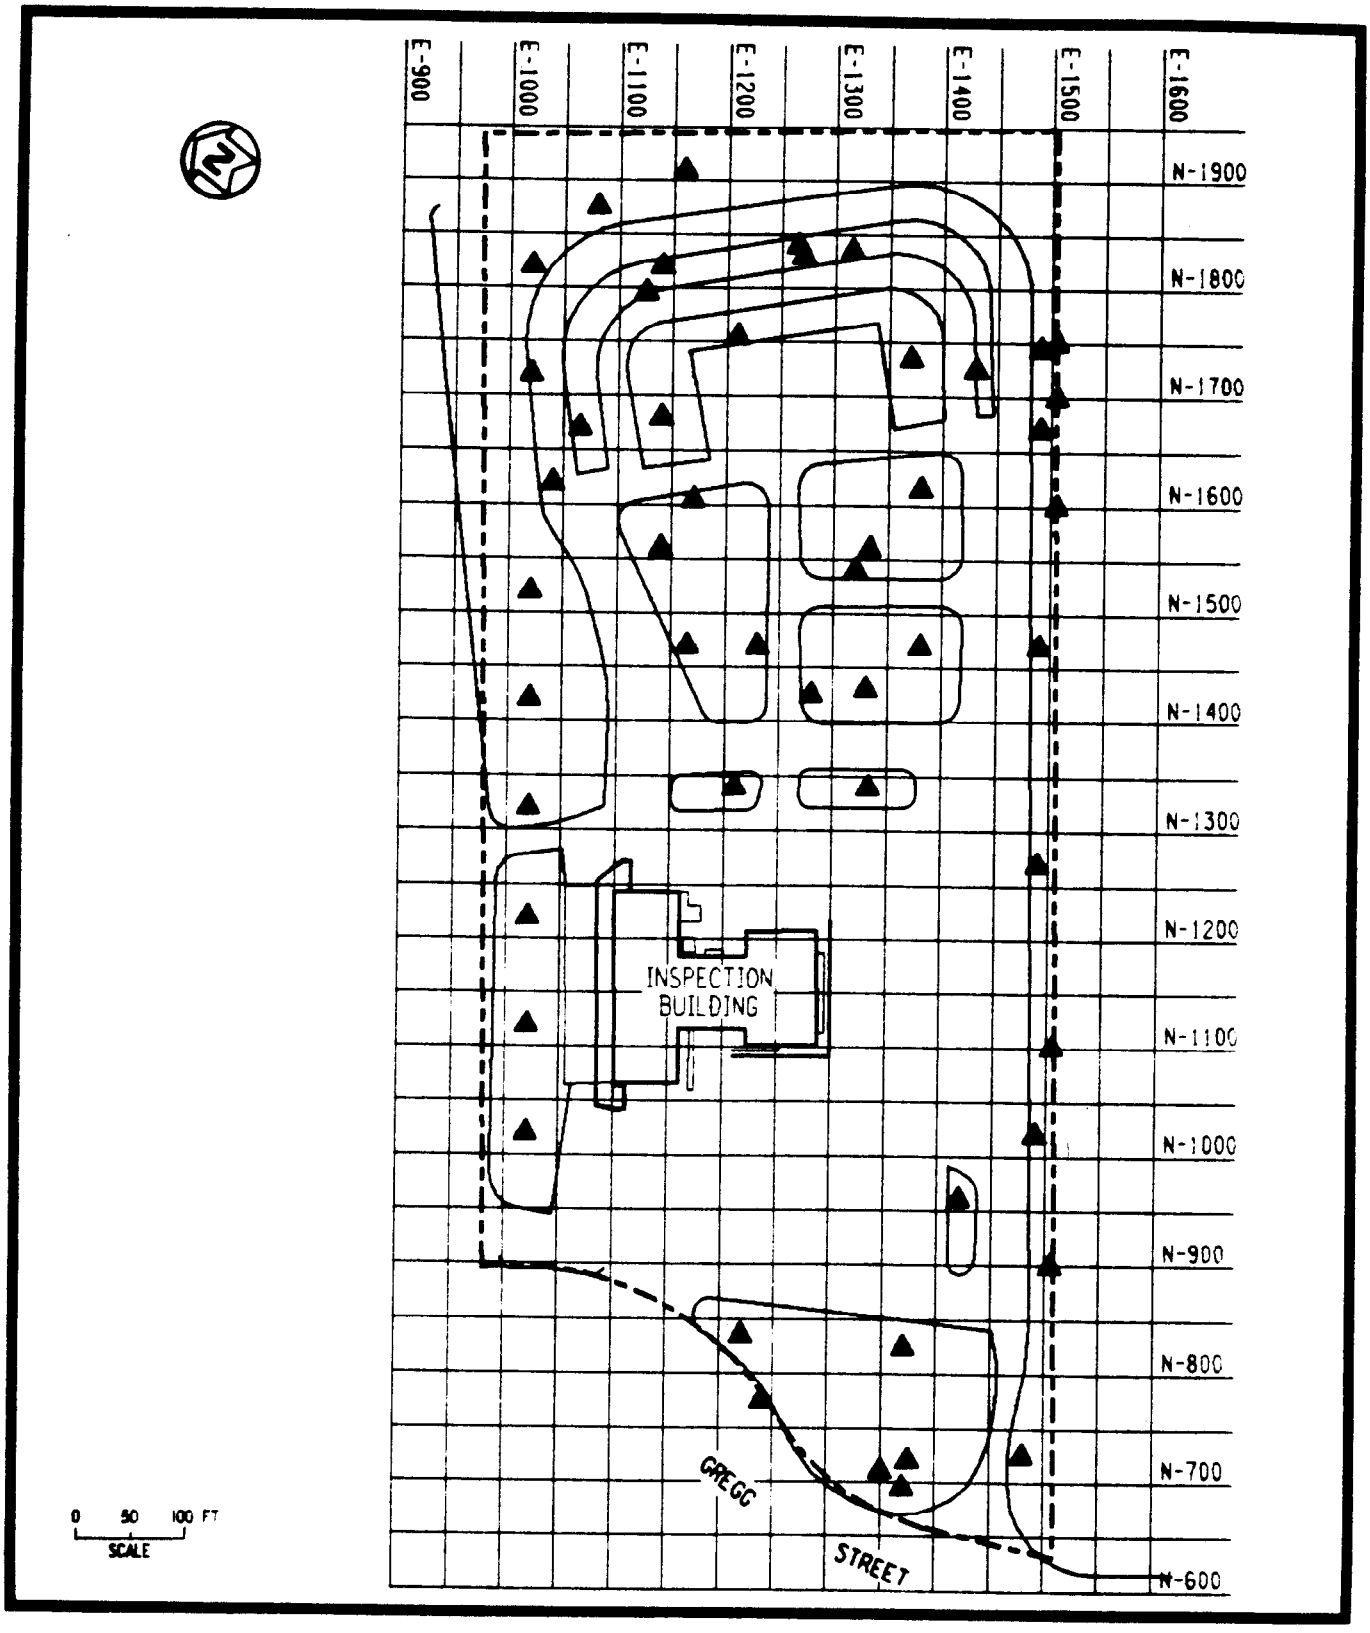
FIGURE 3-1 SURFACE SOIL SAMPLING LOCATIONS AT THE NEW JERSEY VEHICLE INSPECTION STATION PROPERTY

Analysis of the surface soil sample taken at Coordinates E1210, N1340 indicated the presence of cesium-137 at a concentration of 12 pCi/g. This appears to be an isolated occurrence as no evidence of cesium was found in other radiological samples. No explanation for the presence of this radionuclide has been determined.

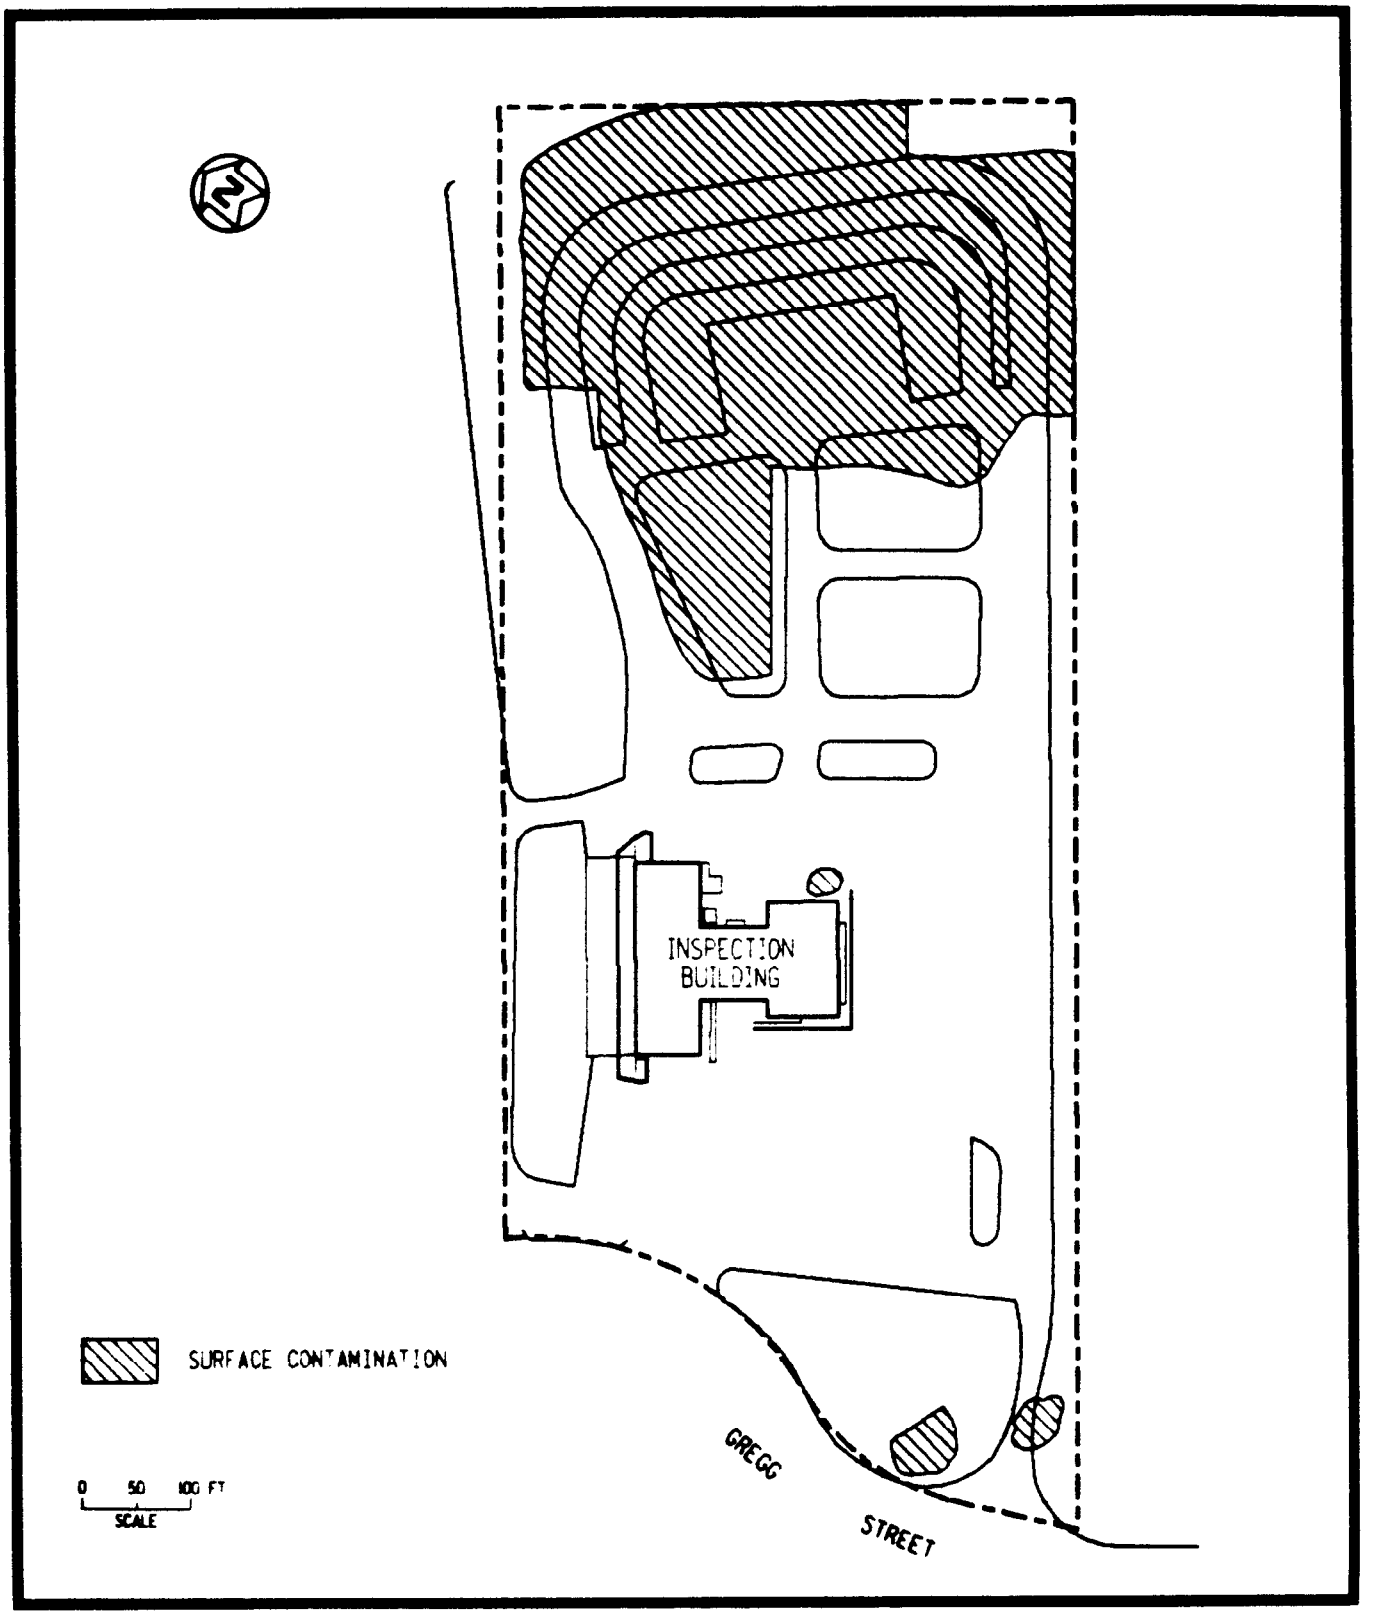
FIGURE 3-2 AREAS OF SURFACE CONTAMINATION AT THE NEW JERSEY VEHICLE INSPECTION STATION PROPERTY

measurements of more than 11,000 cpm were noted as exceeding the DOE guideline of 5 pCi/g for thorium-232 in surface soils. To better define the limits of contamination, soil sampling locations were chosen by evaluating locations with measurements of more than 11,000 cpm, locations with measurements at or near 11,000 cpm, and the potential for lateral gamma flux. The sampling locations are shown in Figure 3-1. It should be noted that not all surface soil samples indicated contamination because some samples were taken from locations where the gamma measurement was at or near the guideline. The data in Table 3-2 show the maximum concentration of thorium-232 to be 12.5 pCi/g, which exceeds the DOE guideline for surface soils. Use of the "less than" (<) notation indicates that the radionuclide was not present in measurable concentrations. The value following the less than notation is the minimum detectable amount (MDA). The MDA is based on various factors, including the volume, size, and weight of the sample; the type of detector used; the counting time, and the background count rate. In addition, since radioactive decay is a random process, a correlation between the rate of disintegration and a given radionuclide concentration cannot be precisely established; therefore, the exact concentration of the radionuclide cannot be determined. As such, each value that is equal to or greater than the MDA has an associated uncertainty term ($\pm$), which represents the maximum amount by which the actual value can be expected to differ from the value given in the table. The uncertainty term has an associated confidence level of 95 percent.

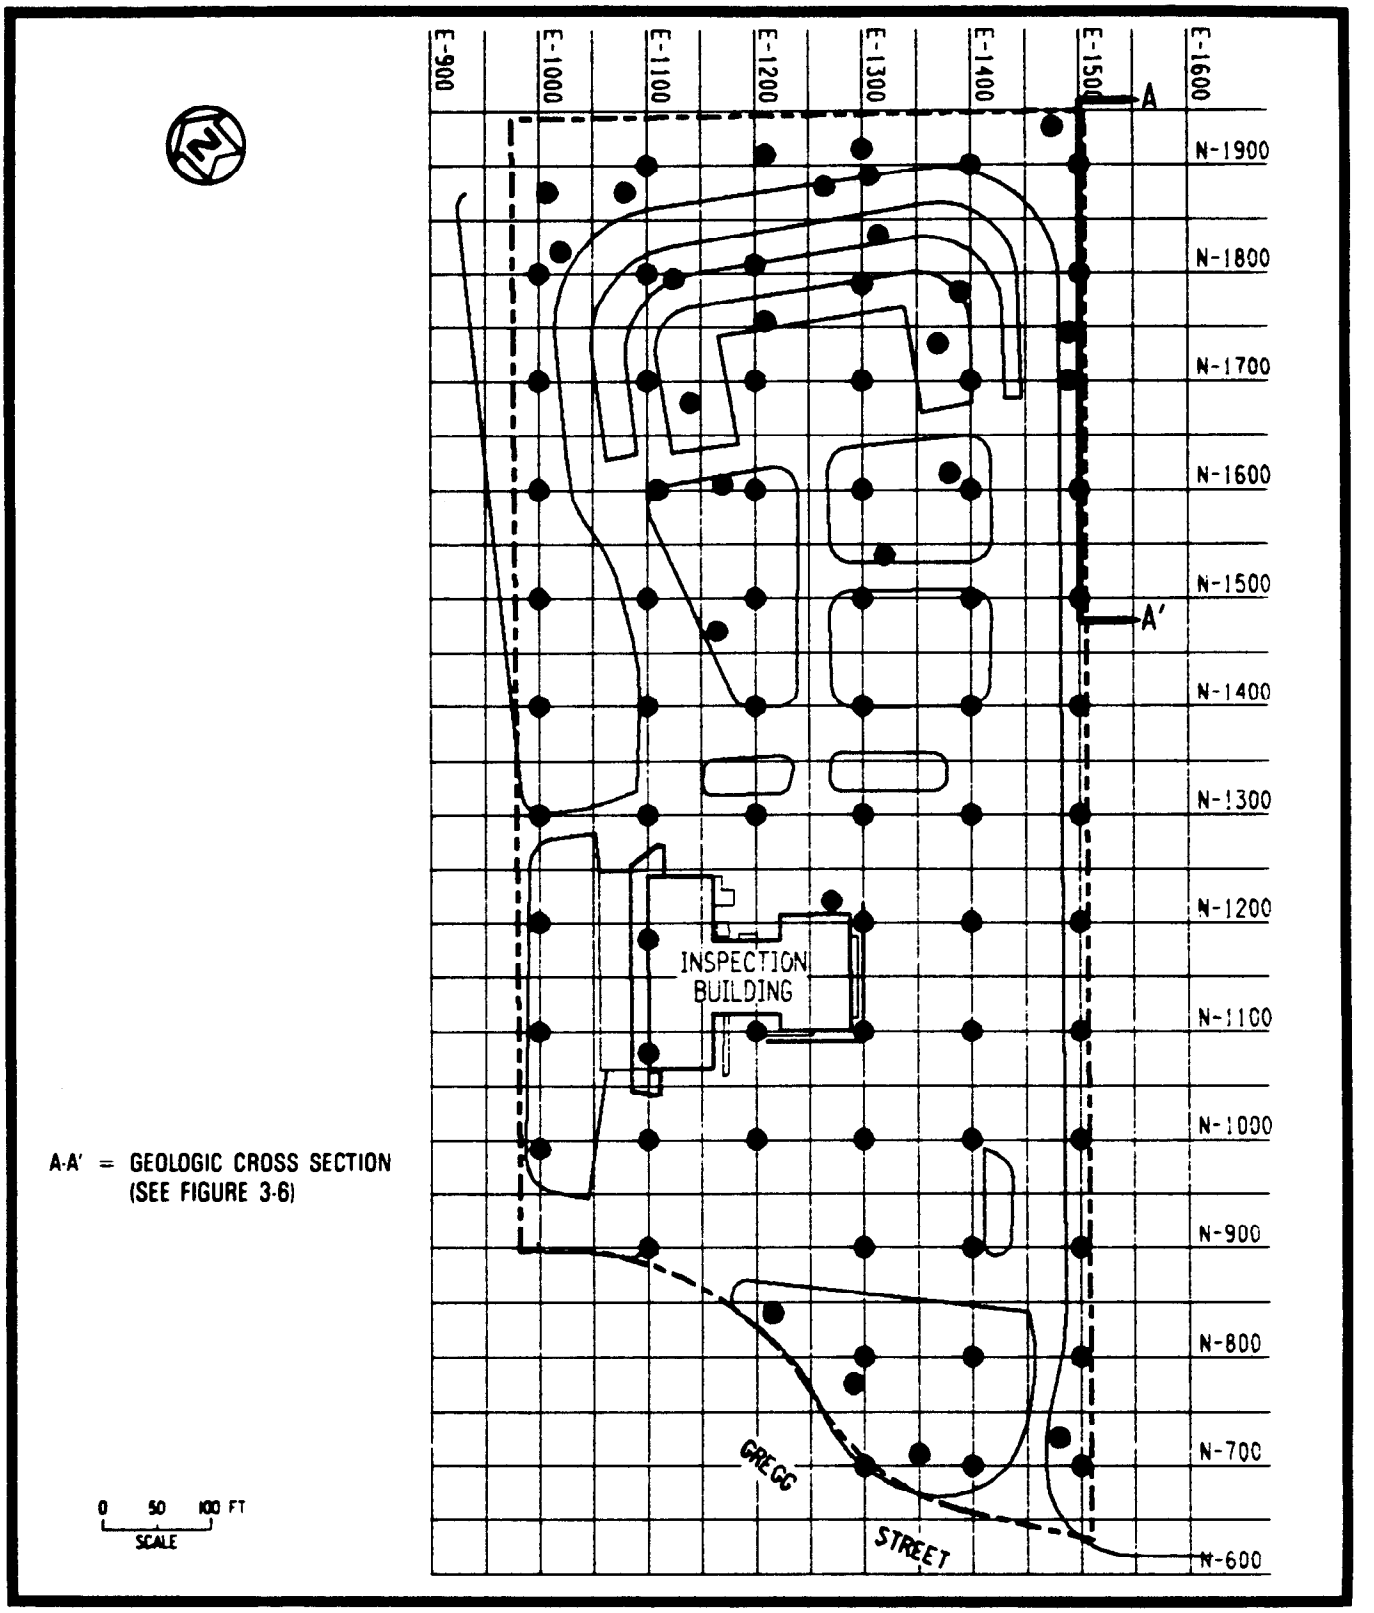
FIGURE 3-3 BOREHOLE LOCATIONS AT THE NEW JERSEY VEHICLE INSPECTION STATION PROPERTY

Subsurface contamination (0.5 to 1.0 ft) found in a small area near the northeastern corner of the NJVIS building (Figure 3-3) is thought to result from fill emplacement. Contamination is not thought to exist beneath the building itself for four reasons: (1) no other areas of subsurface contamination were found either adjacent to or in close proximity to the building; (2) no subsurface contamination was indicated by any of the near-surface measurements taken close to the building; (3) the building may be founded on bedrock; no contamination has been found in any of the boreholes that have penetrated bedrock in this area (depth of bedrock is approximately 6 ft in this area), and the bedrock in this area has an extremely low primary hydraulic conductivity; and (4) interior exposure rate measurements were all within background levels. On the basis of this information, drilling inside the building was considered unnecessary and therefore was not performed.

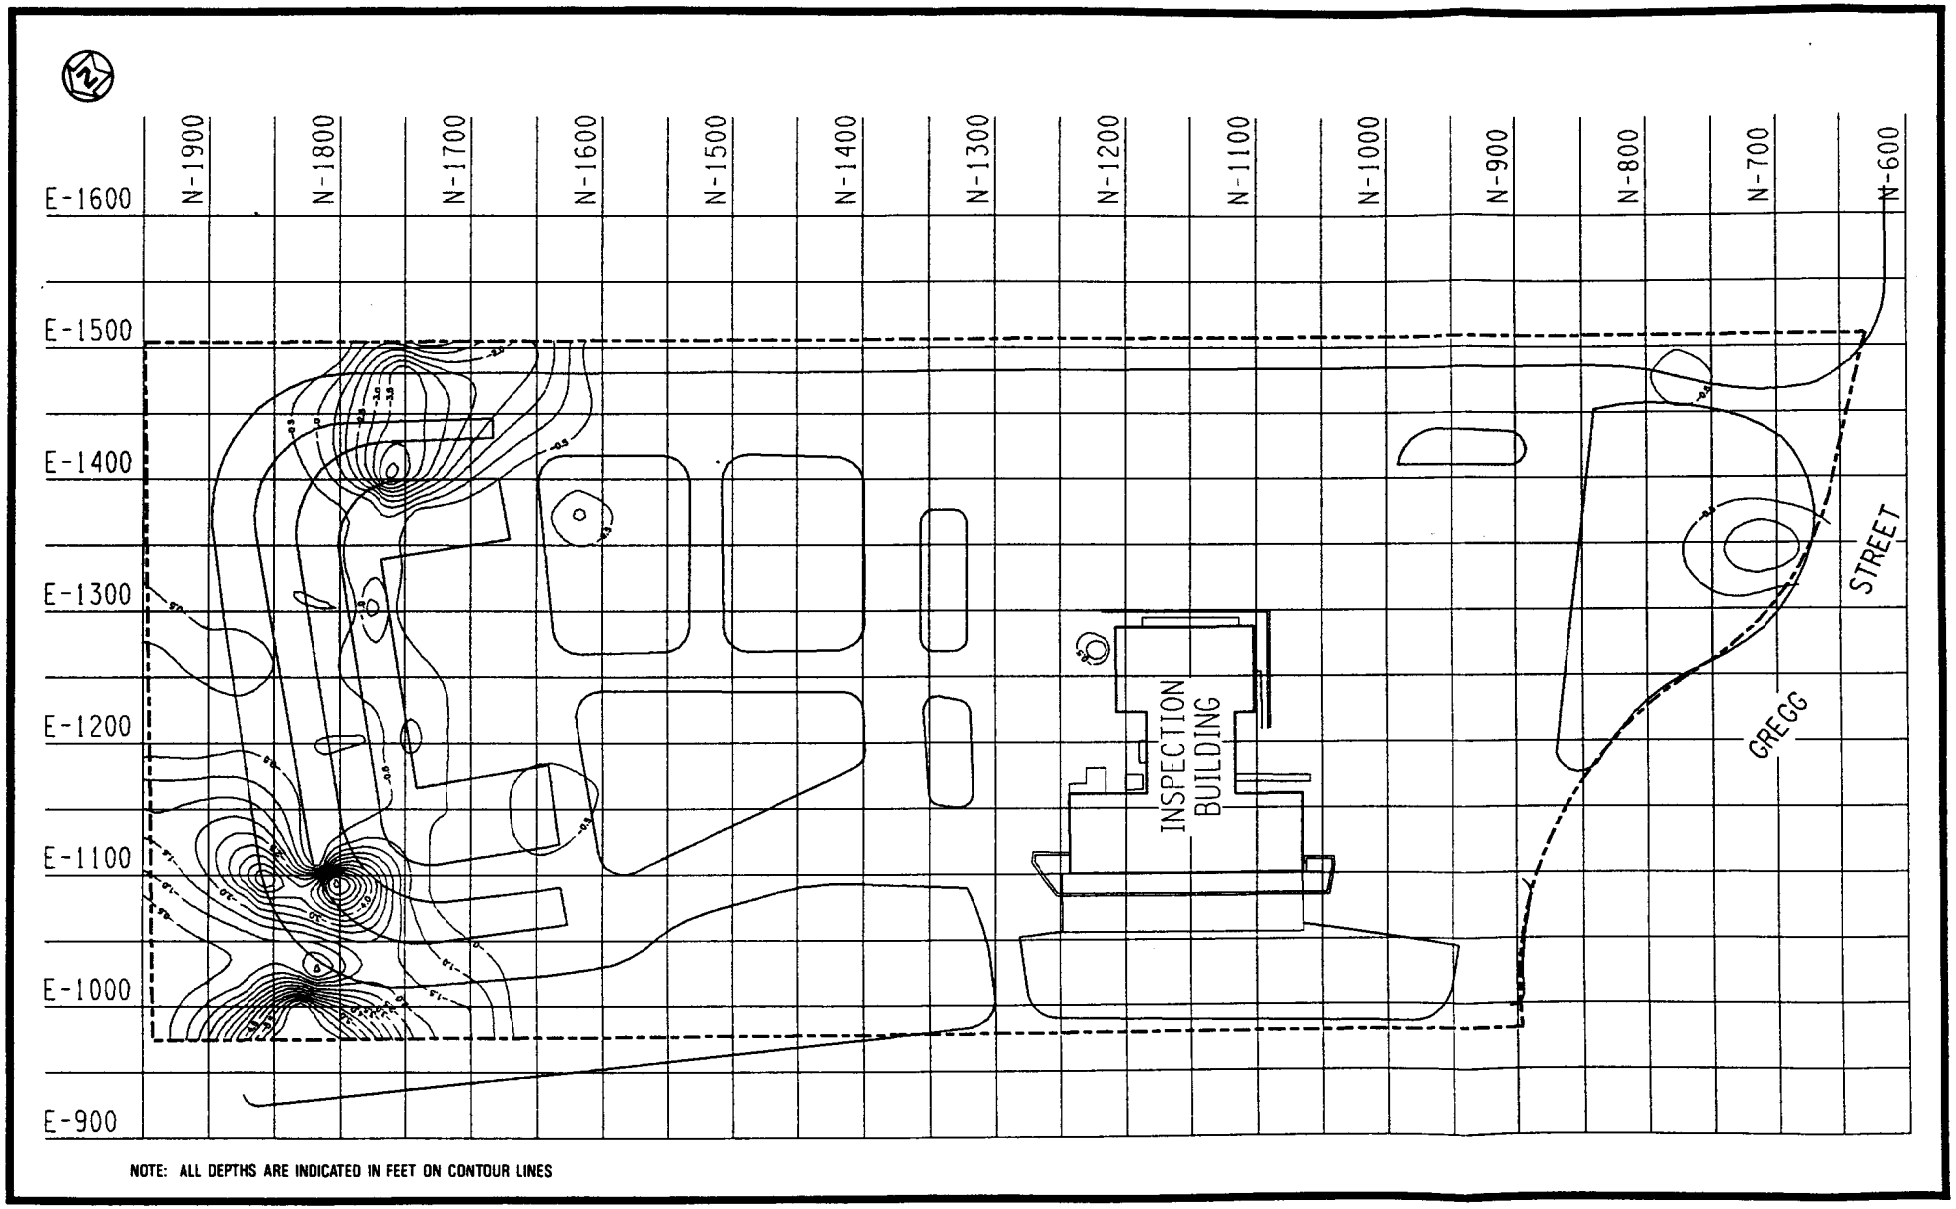
FIGURE 3-4 CONTOURS OF SUBSURFACE CONTAMINATION AT THE NEW JERSEY VEHICLE STATION INSPECTION PROPERTY

As shown in Figure 3-4, the largest area of subsurface contamination exists in the same location as surface contamination (north and east of the NJVIS building). The depths of this contamination range from 1 to 7 ft. Contamination is believed to have resulted primarily from stream sediment deposition and possibly from fill emplacement. This belief is based on information obtained during additional drilling activities conducted to better define the location of the original Lodi Brook streambed. It was determined that the streambed flowed through the northern section of the property. Radiological and geological data can be used to infer the streambed location on the basis of the presence of stream sediments and their degree of contamination. A logical assumption would be that the original streambed was probably located where the deepest and most contaminated stream sediments are found. Lodi Brook currently flows through a buried conduit in the northern section of the property. The conduit is parallel to Hancock Street (Figure 3-5).

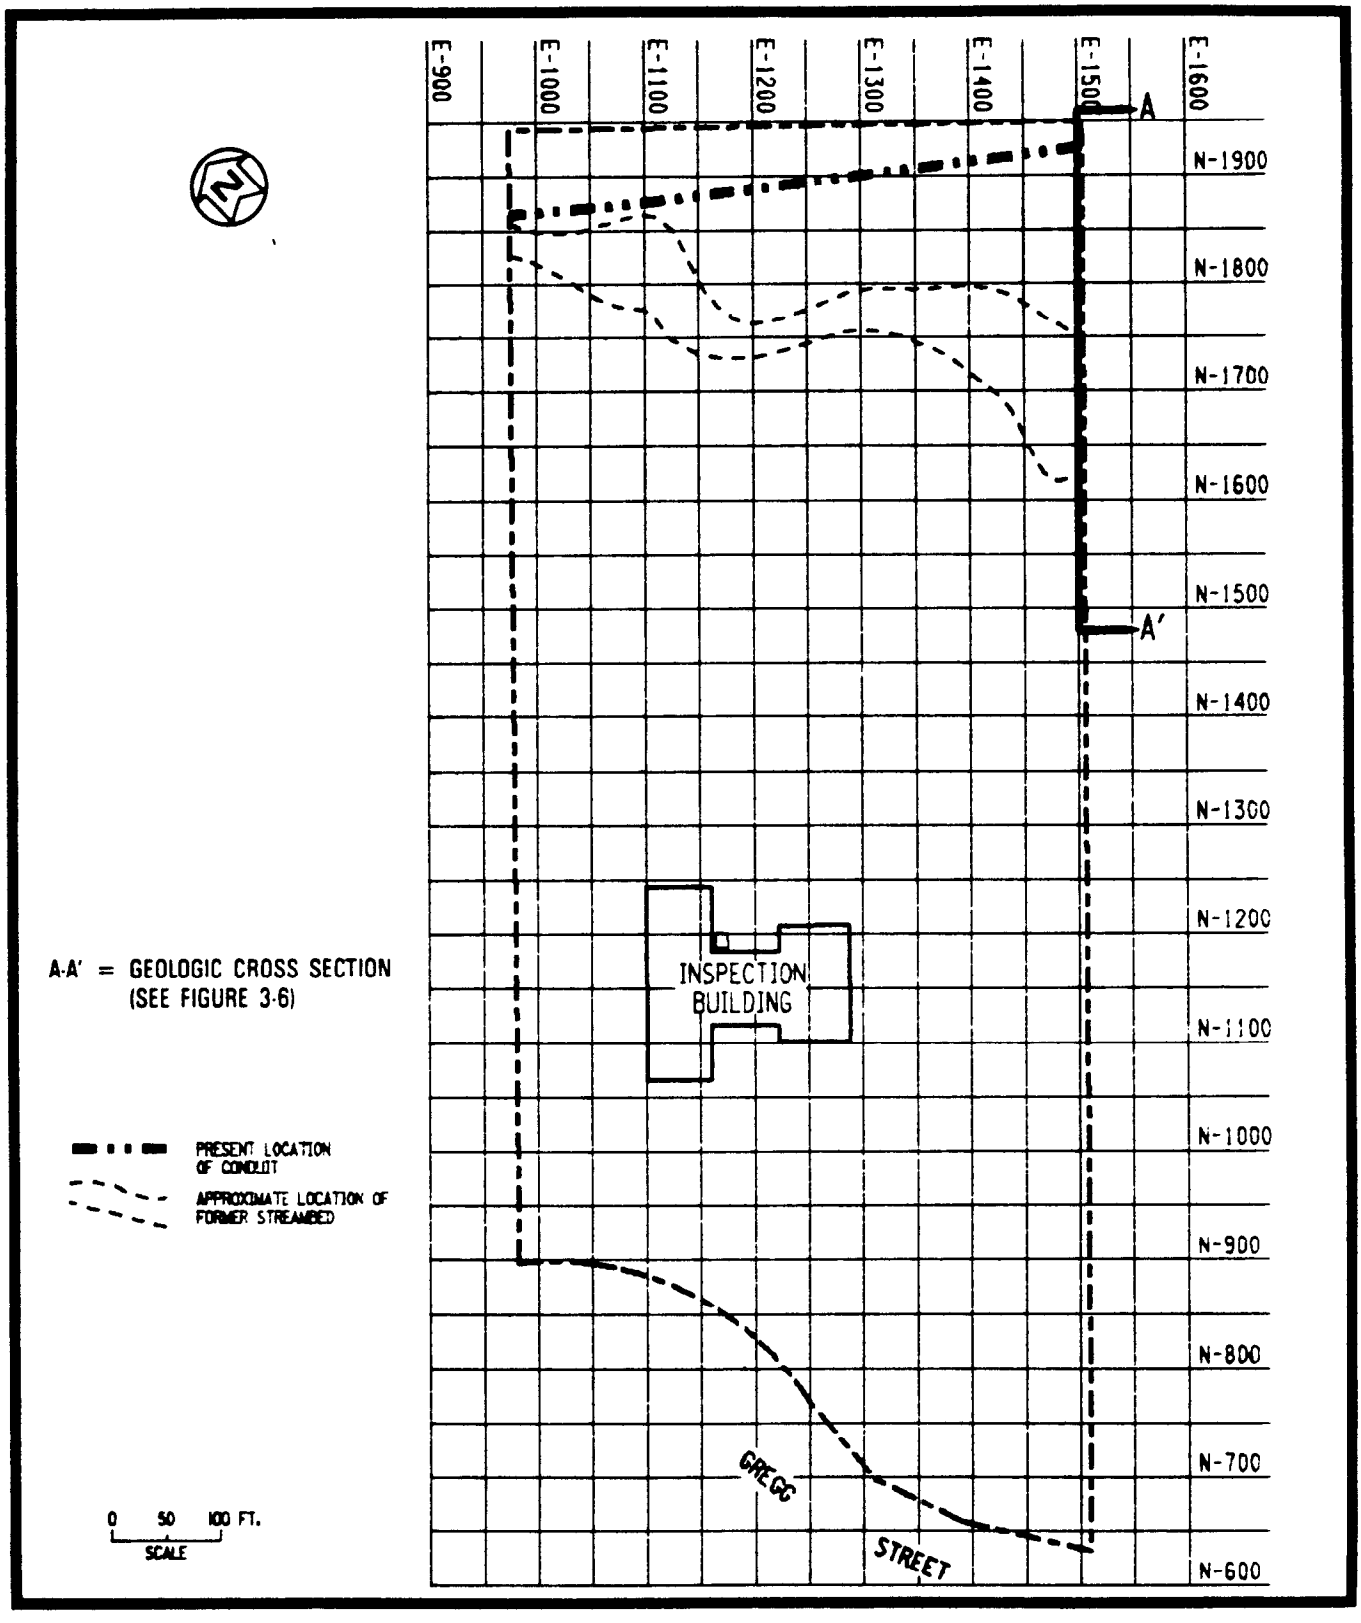
FIGURE 3-5 LOCATIONS OF THE PRESENT LODI BROOK (CONDUIT) AND THE ORIGINAL STREAMBED

Geological information regarding the location of the former Lodi Brook streambed also indicates that the exposed relic channel (Coordinates E1500, N1800, approximately) was not incised but rather was a broad, open channel, and contamination is not evenly distributed (Figure 3-6). This offers further explanation as to why some gamma logs from boreholes in or near the channel indicate concentrations below guidelines. It also explains why so little fill was needed to bring the concave channel up to its present grade. Fill depths in the former streambed vary from 0 to 6 ft.

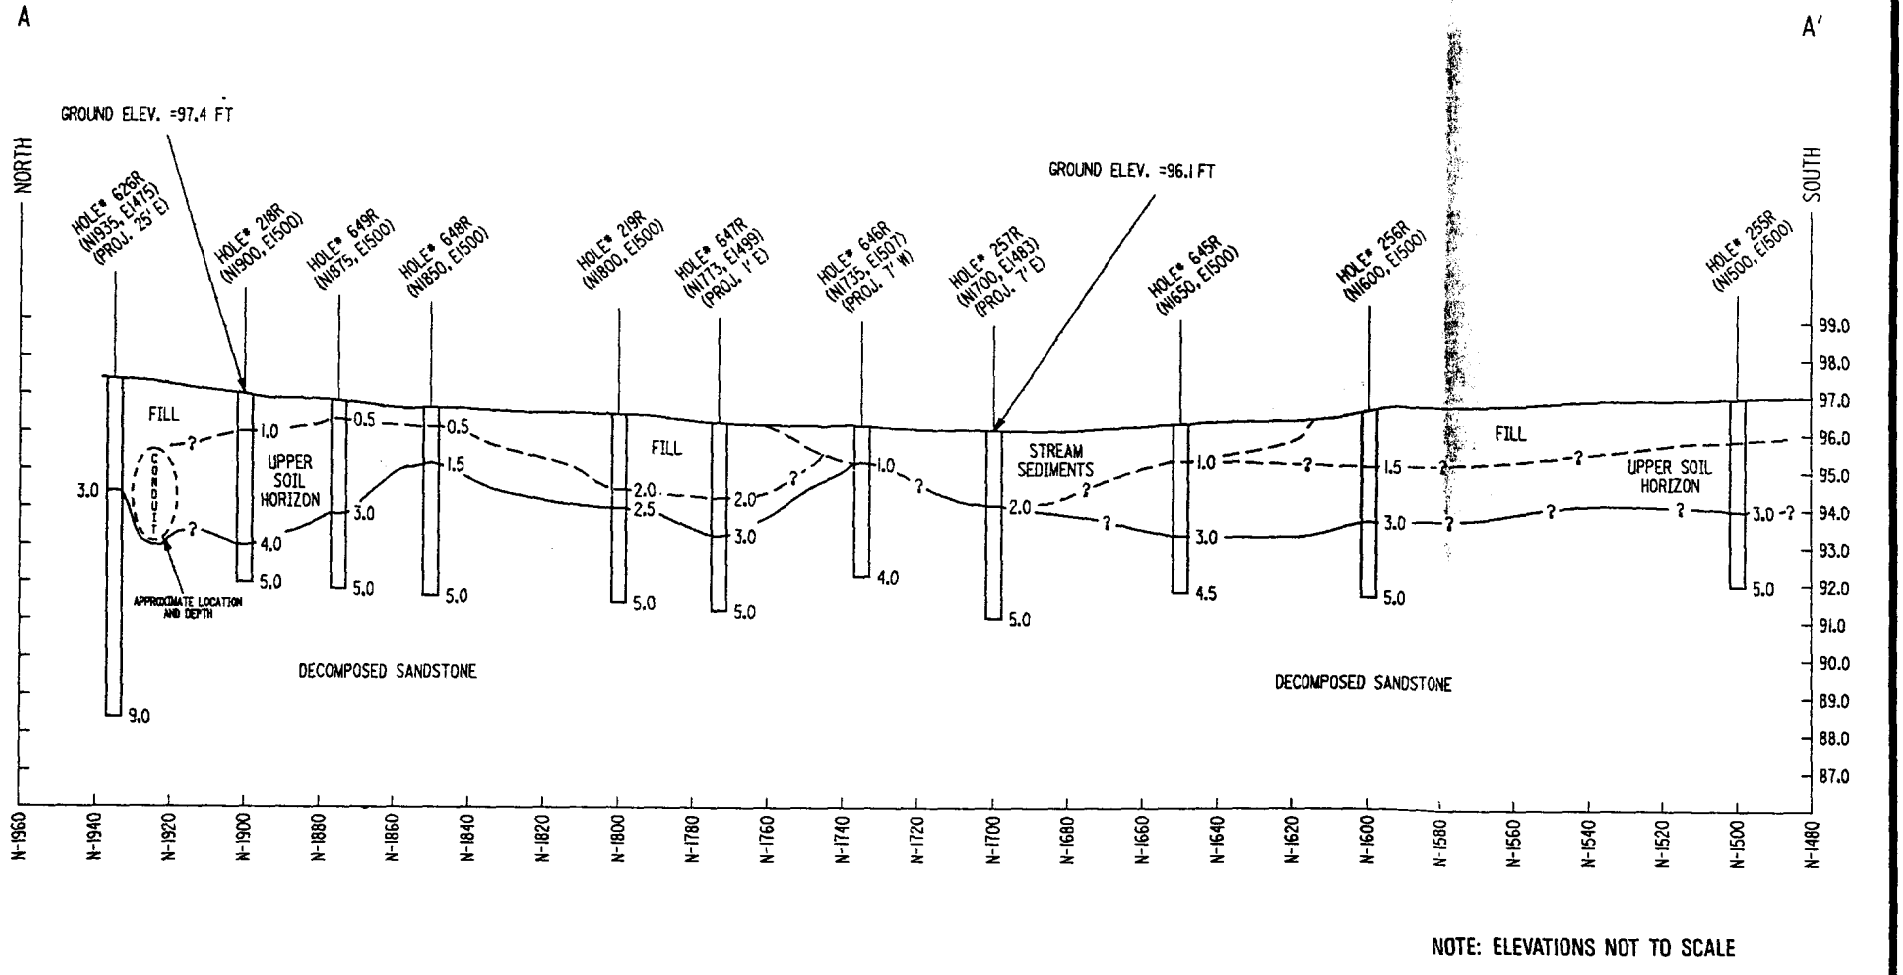
FIGURE 3-6 GEOLOGIC CROSS SECTION OF THE FORMER LODI BROOK STREAMBED

These fill depths conform to the natural 1-percent grade of the former streambed. The shallowness of fill (moved indigenous soil) also explains why the fill is so thoroughly contaminated with underlying black, thorium-bearing stream sediments. The former streambed and the present conduit converge in the northwestern corner of the property with contamination indicated above the conduit. Although drilling data in this area suggest that this contamination is mostly surficial, it may extend around the conduit in the northwestern corner of the property. Contamination appears to trend off the property to the north under Hancock Street as well as to the east and west toward properties contiguous with the NJVIS property.

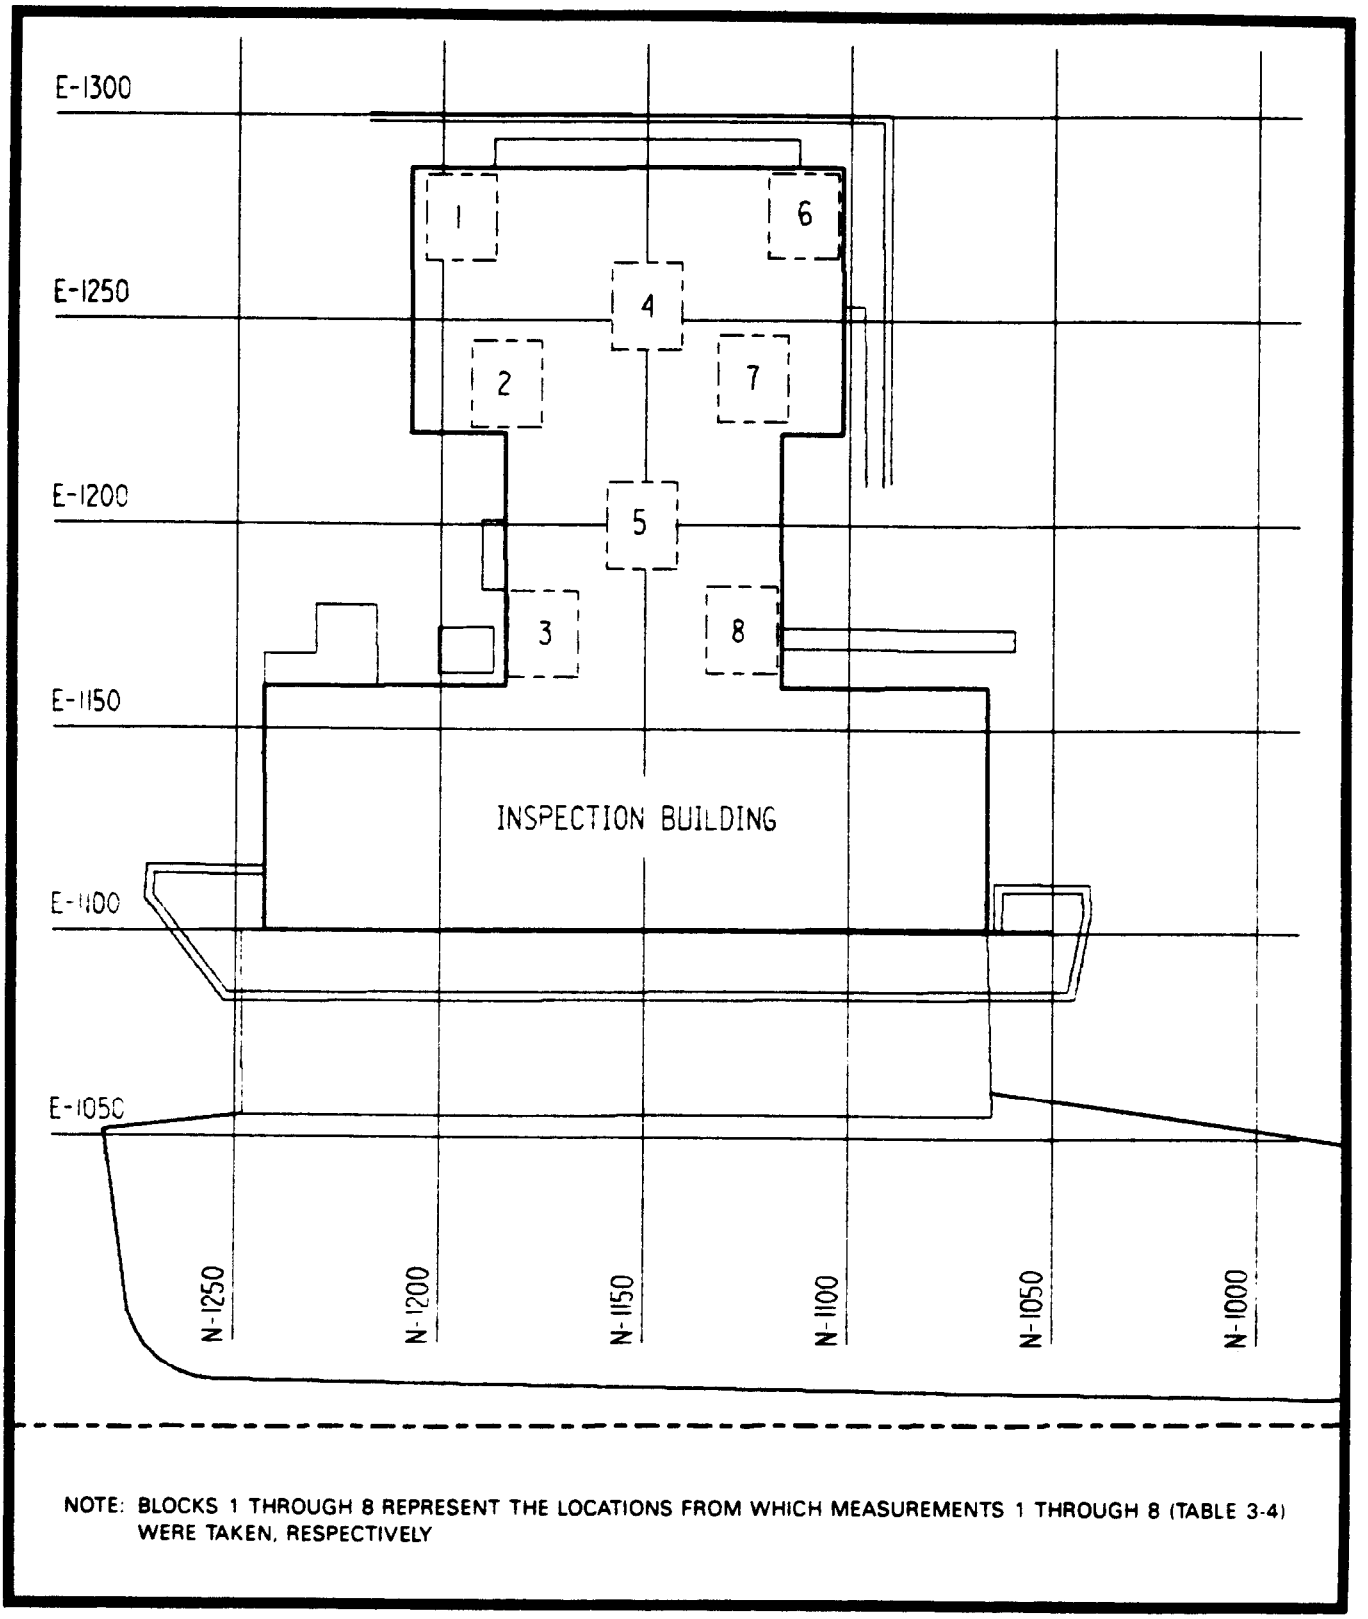
FIGURE 3-7 EXPOSURE RATE MEASUREMENT LOCATIONS AT THE NEW JERSEY VEHICLE INSPECTION STATION PROPERTY

In addition, exposure rate measurements were taken inside the NJVIS building to determine the potential health risk for employees in the event that contamination might be present beneath the building. These measurements are taken 3 ft above the floor using either a SPA-3 or a pressurized ionization chamber (PIC). The latter instrument has a response to gamma radiation that is proportional to exposure in roentgens. A conversion factor for SPA-3 measurements was established through a correlation of measurements taken at four locations in the vicinity of the NJVIS property with these two instruments. The unshielded SPA-3 readings were then used to estimate gamma exposure rates for each location. Locations of these measurements (Figure 3-7) were determined to be representative of the entire building interior. Gamma radiation exposure rate measurements ranged from 4 μR/h to 5 μR/h, giving an average of 4 μR/h, including background. These measurements are considered within the normal variation of background radiation. These results can be found in Table 3-4.
