N J Report #
Results of
June 1981
RAD Survey

# RESULTS OF THE RADIOLOGICAL SURVEY AT 459 LATHAM STREET, MAYWOOD, NEW JERSEY

September 1981

OAK RIDGE NATIONAL LABORATORY
Oak Ridge, Tennessee 37830
operated by
UNION CARBIDE CORPORATION
for the
DEPARTMENT OF ENERGY

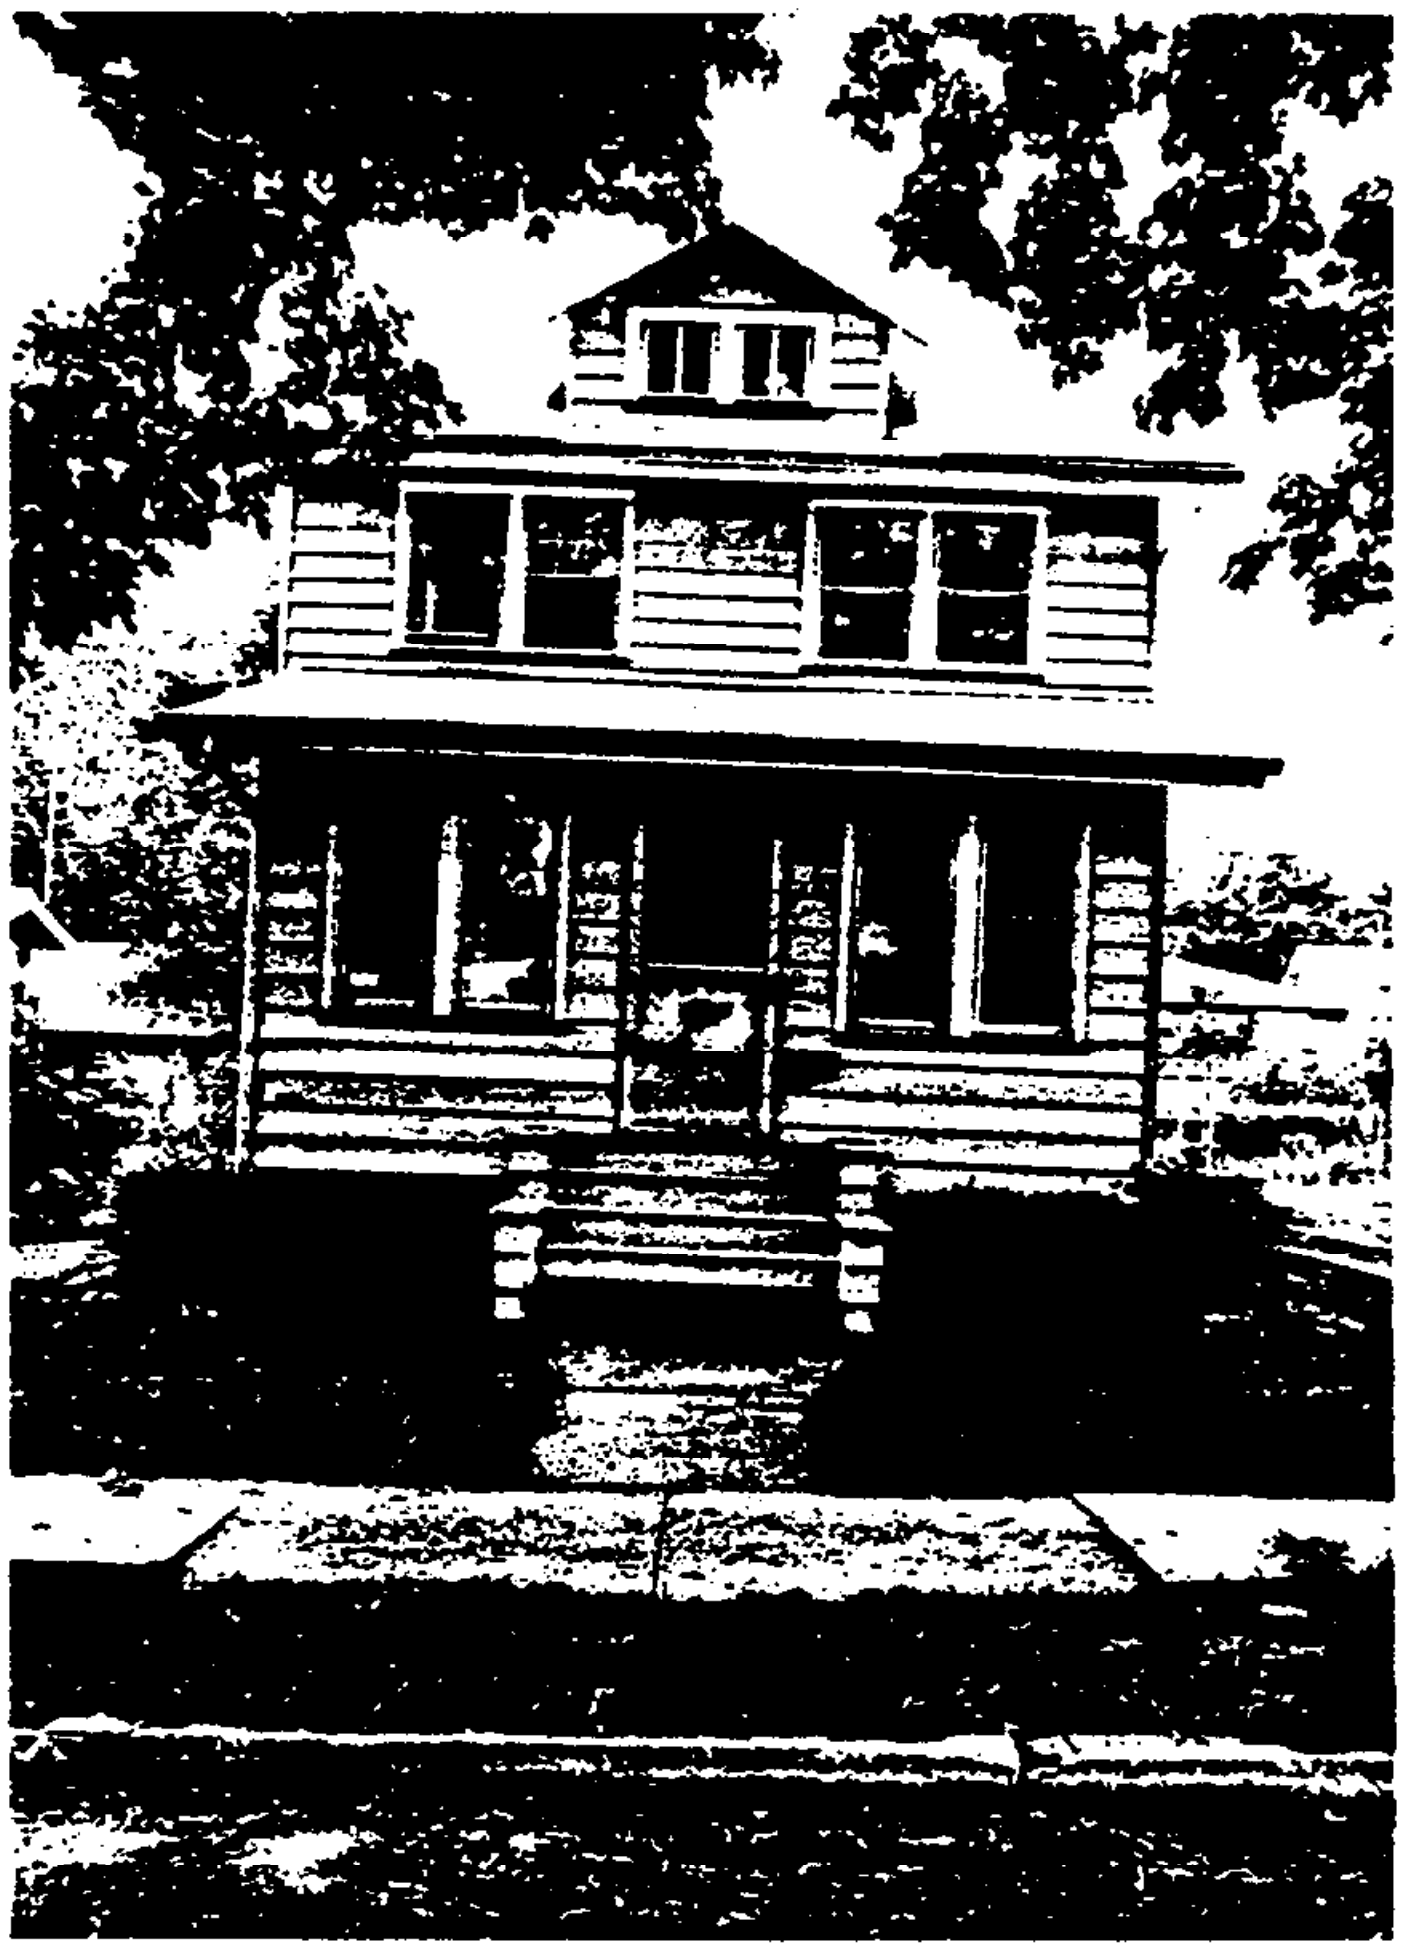
Fig. 1. Front view of property at 459 Latham Street

Fig. 2. Rear view of property at 459 Latham Street

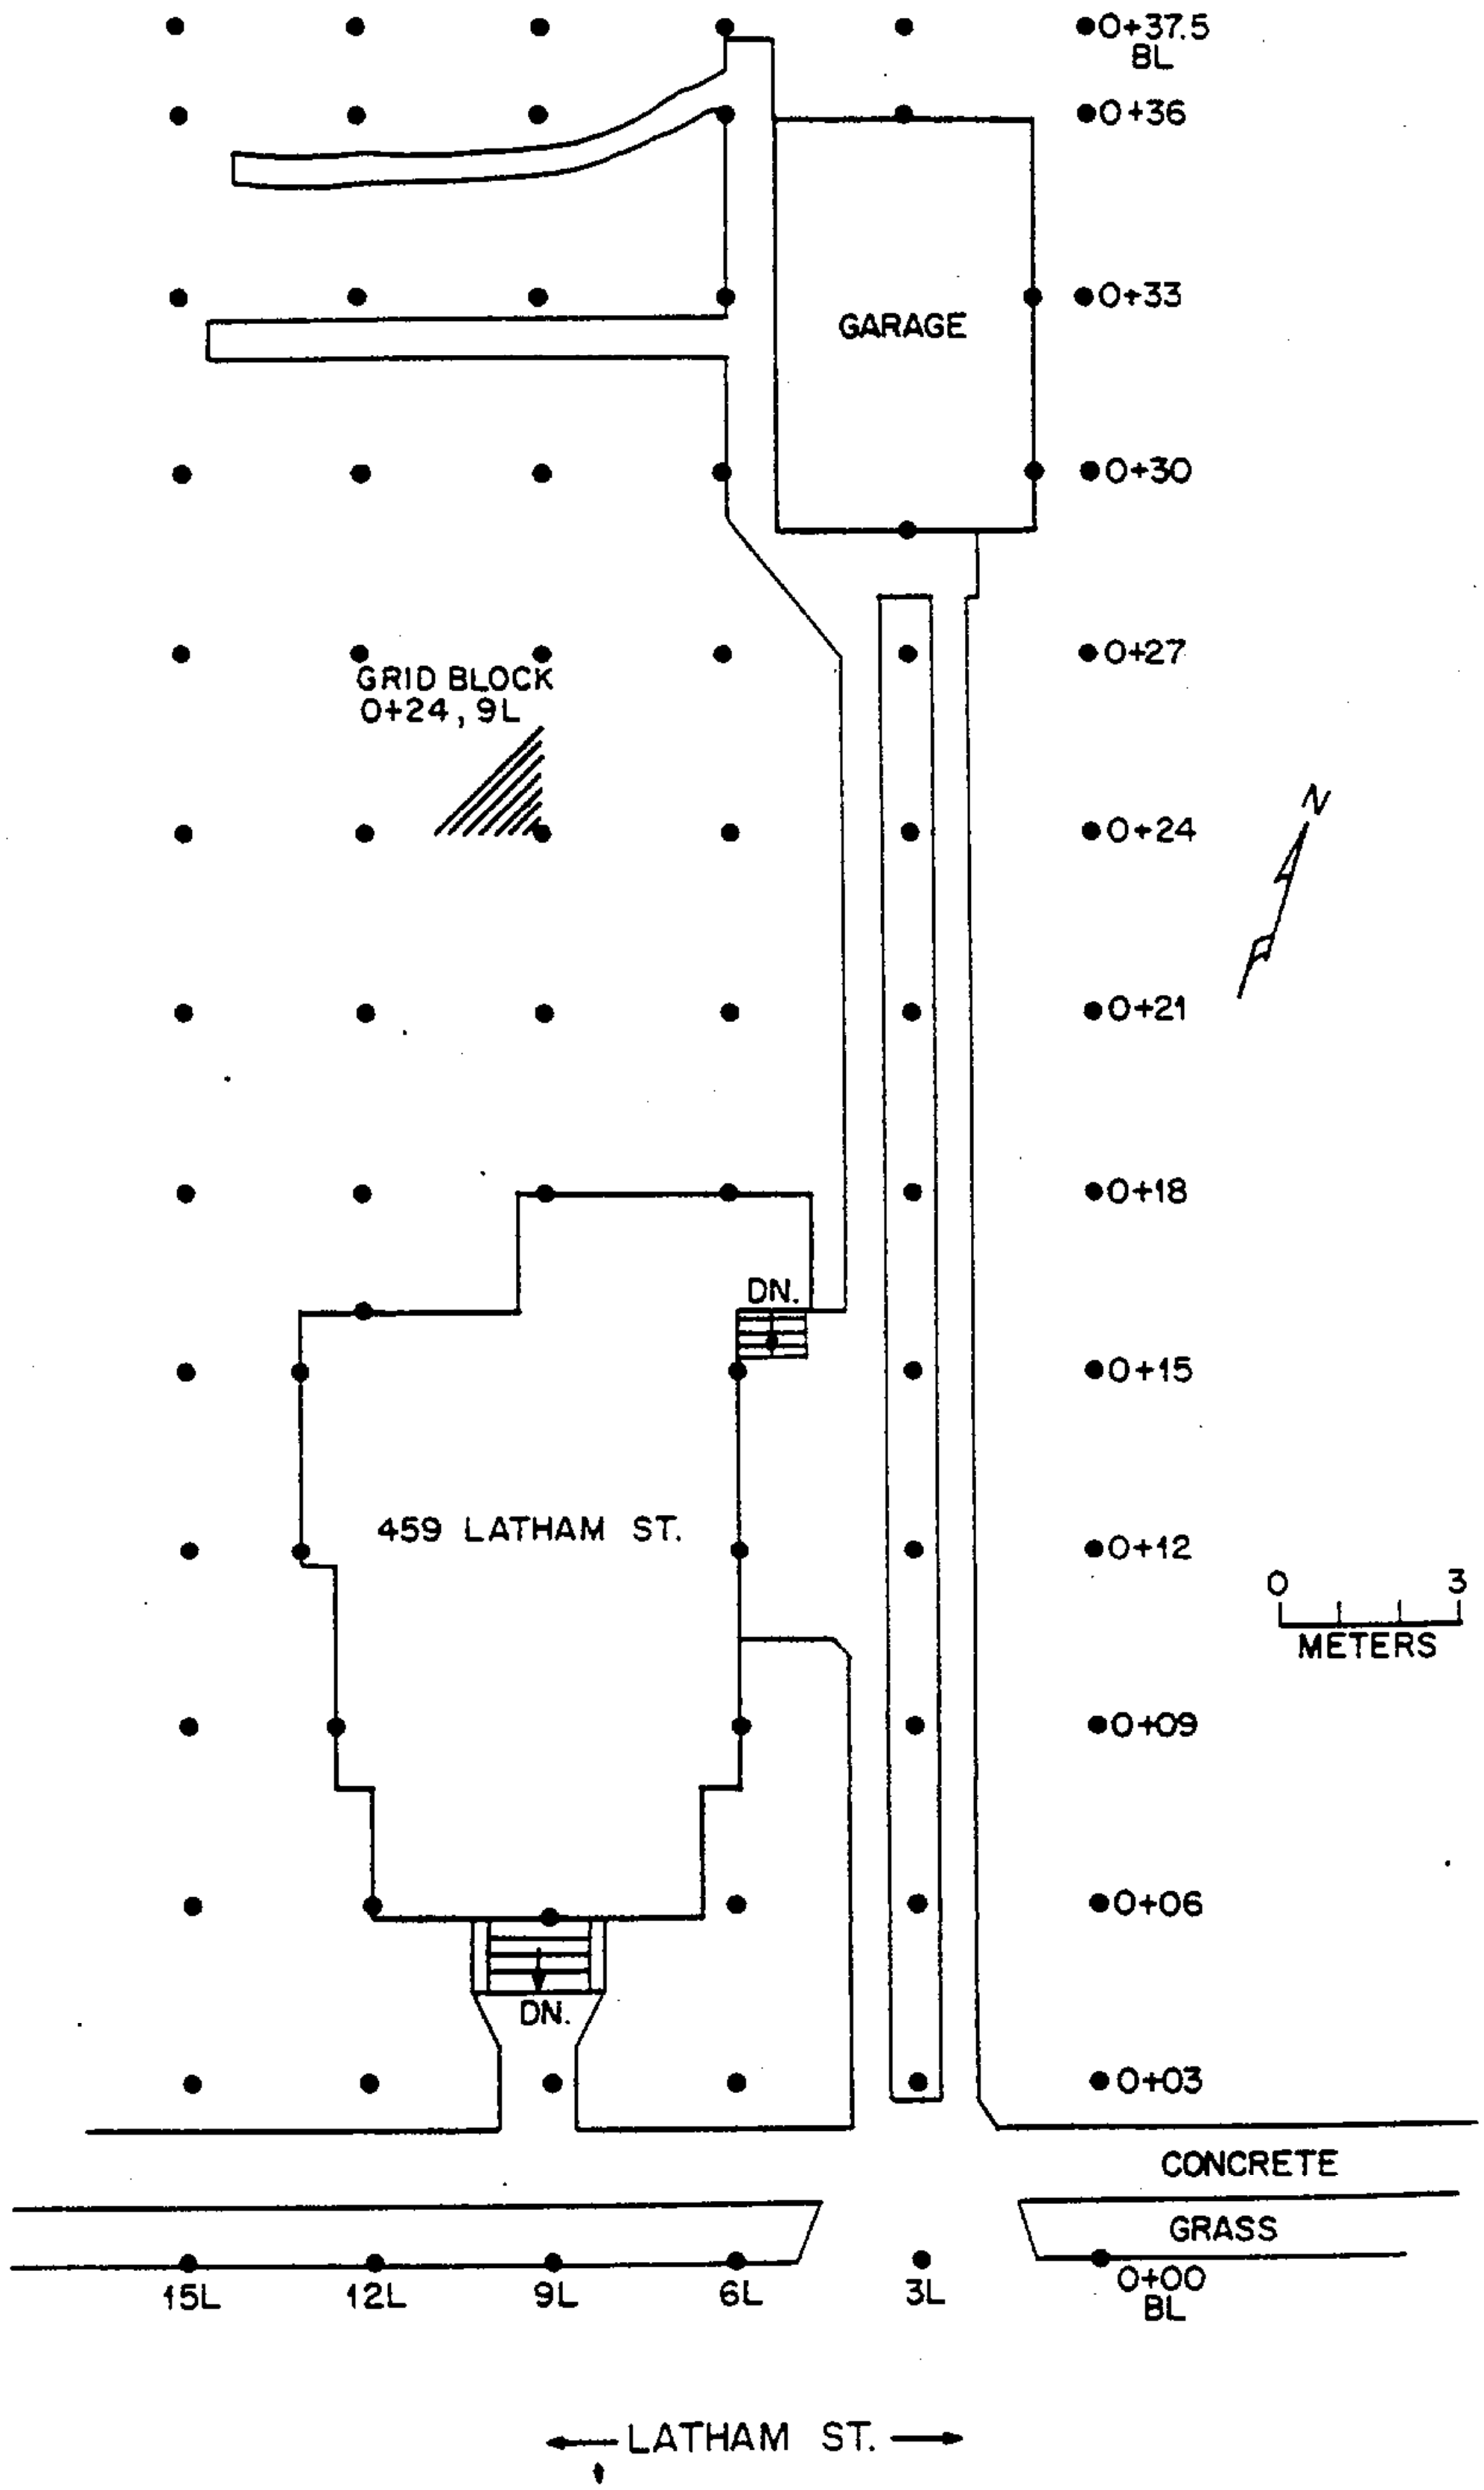
Fig. 3. Grid point and block locations at 459 Latham Street.

External gamma-ray and beta-gamma measurements. Results of grid point/grid block measurements are presented in Table 3. The location of grid points/blocks are shown in Fig. 3. Elevated gamma levels were observed on the eastern side of 459 Latham Street, (adjacent to 461 Latham Street), however, these levels decreased to background levels on the western side of this property. All elevated gamma levels were related to contaminated material on the adjacent 461 Latham Street property, with the exception of a 0.3-m wide by 16-m long strip of property with spotty contamination along the northeast corner of the property (see shading on Fig. 4). The maximum gamma-ray exposure rate at 1 m on this property (82 μR/h) exceeded the background value by a factor of 10 and guideline value (10 CFR 20) by a factor of 1.4. The average gamma level on this property at 1 m was 16 μR/h (twice the background level). Beta-gamma dose-rate measurements at grid points ranged from 0.01 to 0.1 mrad/h, and averaged 0.03 mrad/h.

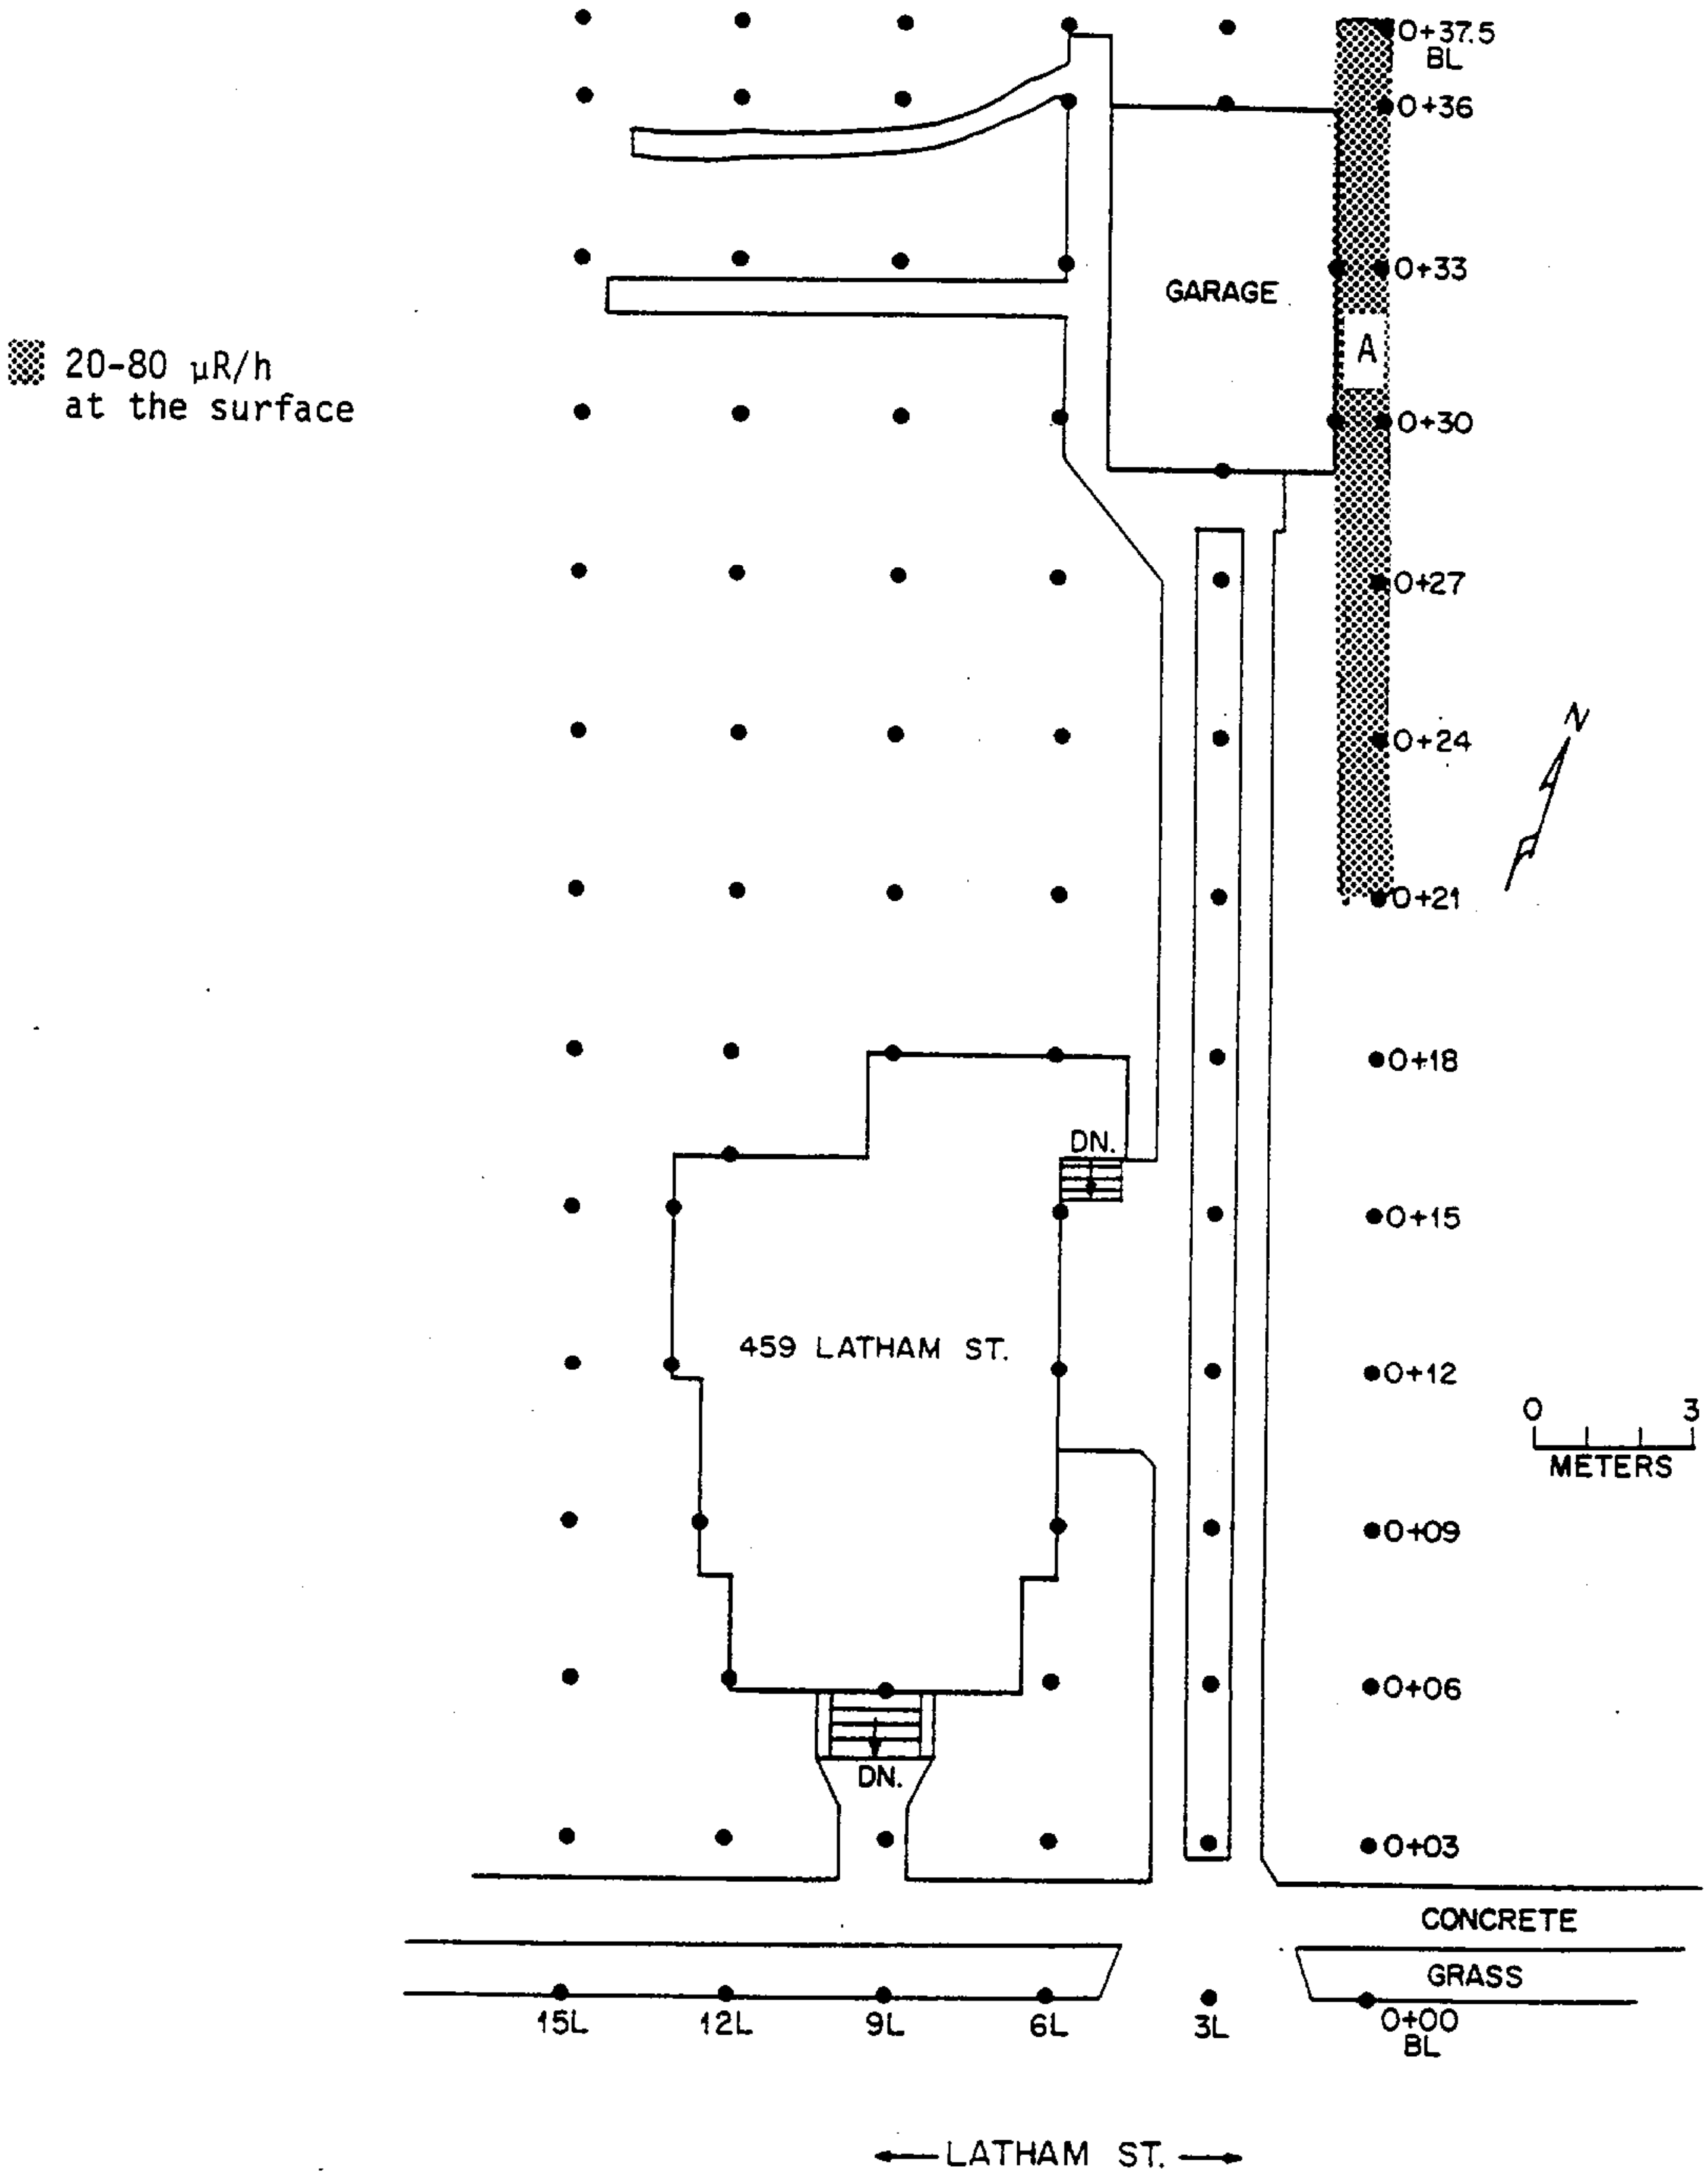
Fig. 4. Estimated extent of contaminated areas at 459 Latham Street based on results of external gamma-ray surface scan.

Summaries of outdoor and indoor measurement results of the radiological survey conducted at 459 Latham Street are provided in Table 7. These measurement results indicate that this property contains a slight amount of radioactive contamination (primarily from the $^{232}$Th decay chain). This material is irregularly distributed in a 0.3 m x 16 m strip along the northeast border of the property (adjacent to 461 Latham property). The contaminated material is contained within the top 20 cm

of the ground surface. Based on these estimates, the volume of contaminated material is approximately 0.8 $m^3$. No contaminated material is present inside or beneath the house.

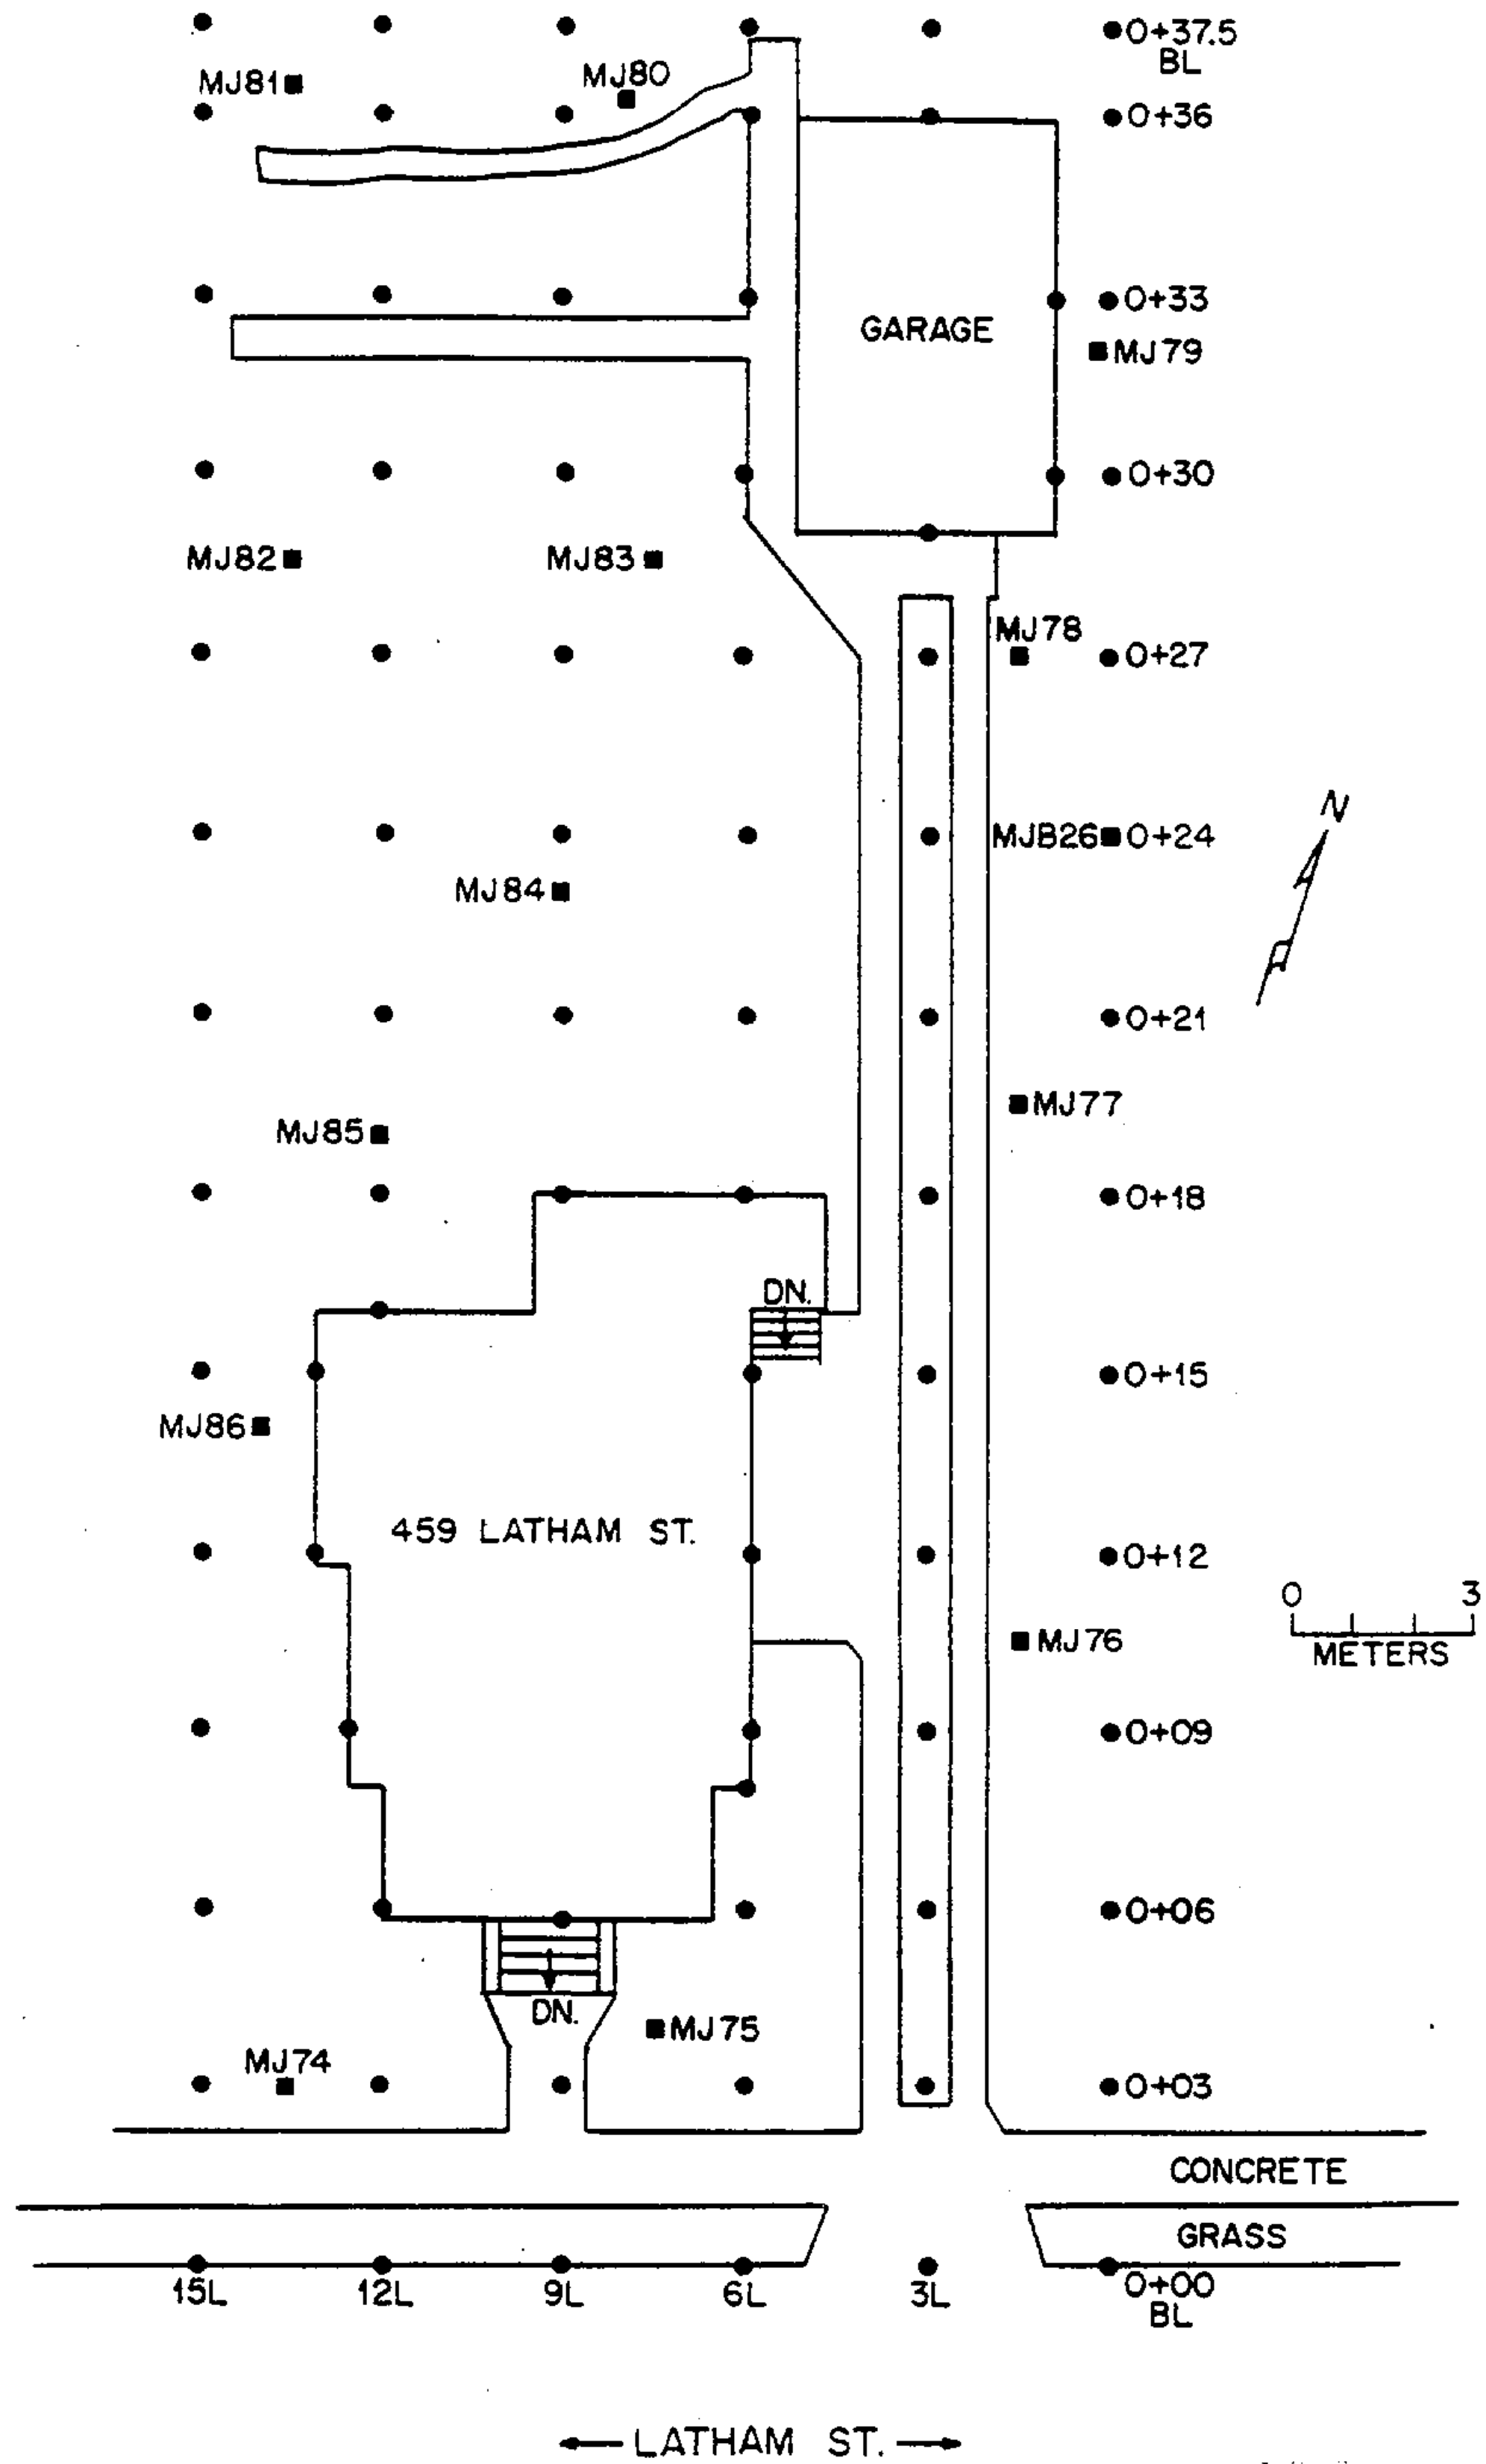
Fig. 5. Location of systematic (MJ) and biased (MJB) surface soil samples at 459 Latham Street.

All systematic surface soil samples were within background levels with the exception of MJ79, which was obtained in the 0.3 m x 16 m strip of spotty contamination identified in the gamma-ray scan of the property. The $^{232}$Th concentration in this sample was 4.0 pCi/g. The single biased sample also taken from this slightly contaminated area (MJB26) had a $^{232}$Th concentration of 7.1 pCi/g. The contamination along the previously identified strip was in the upper 20 cm of soil.

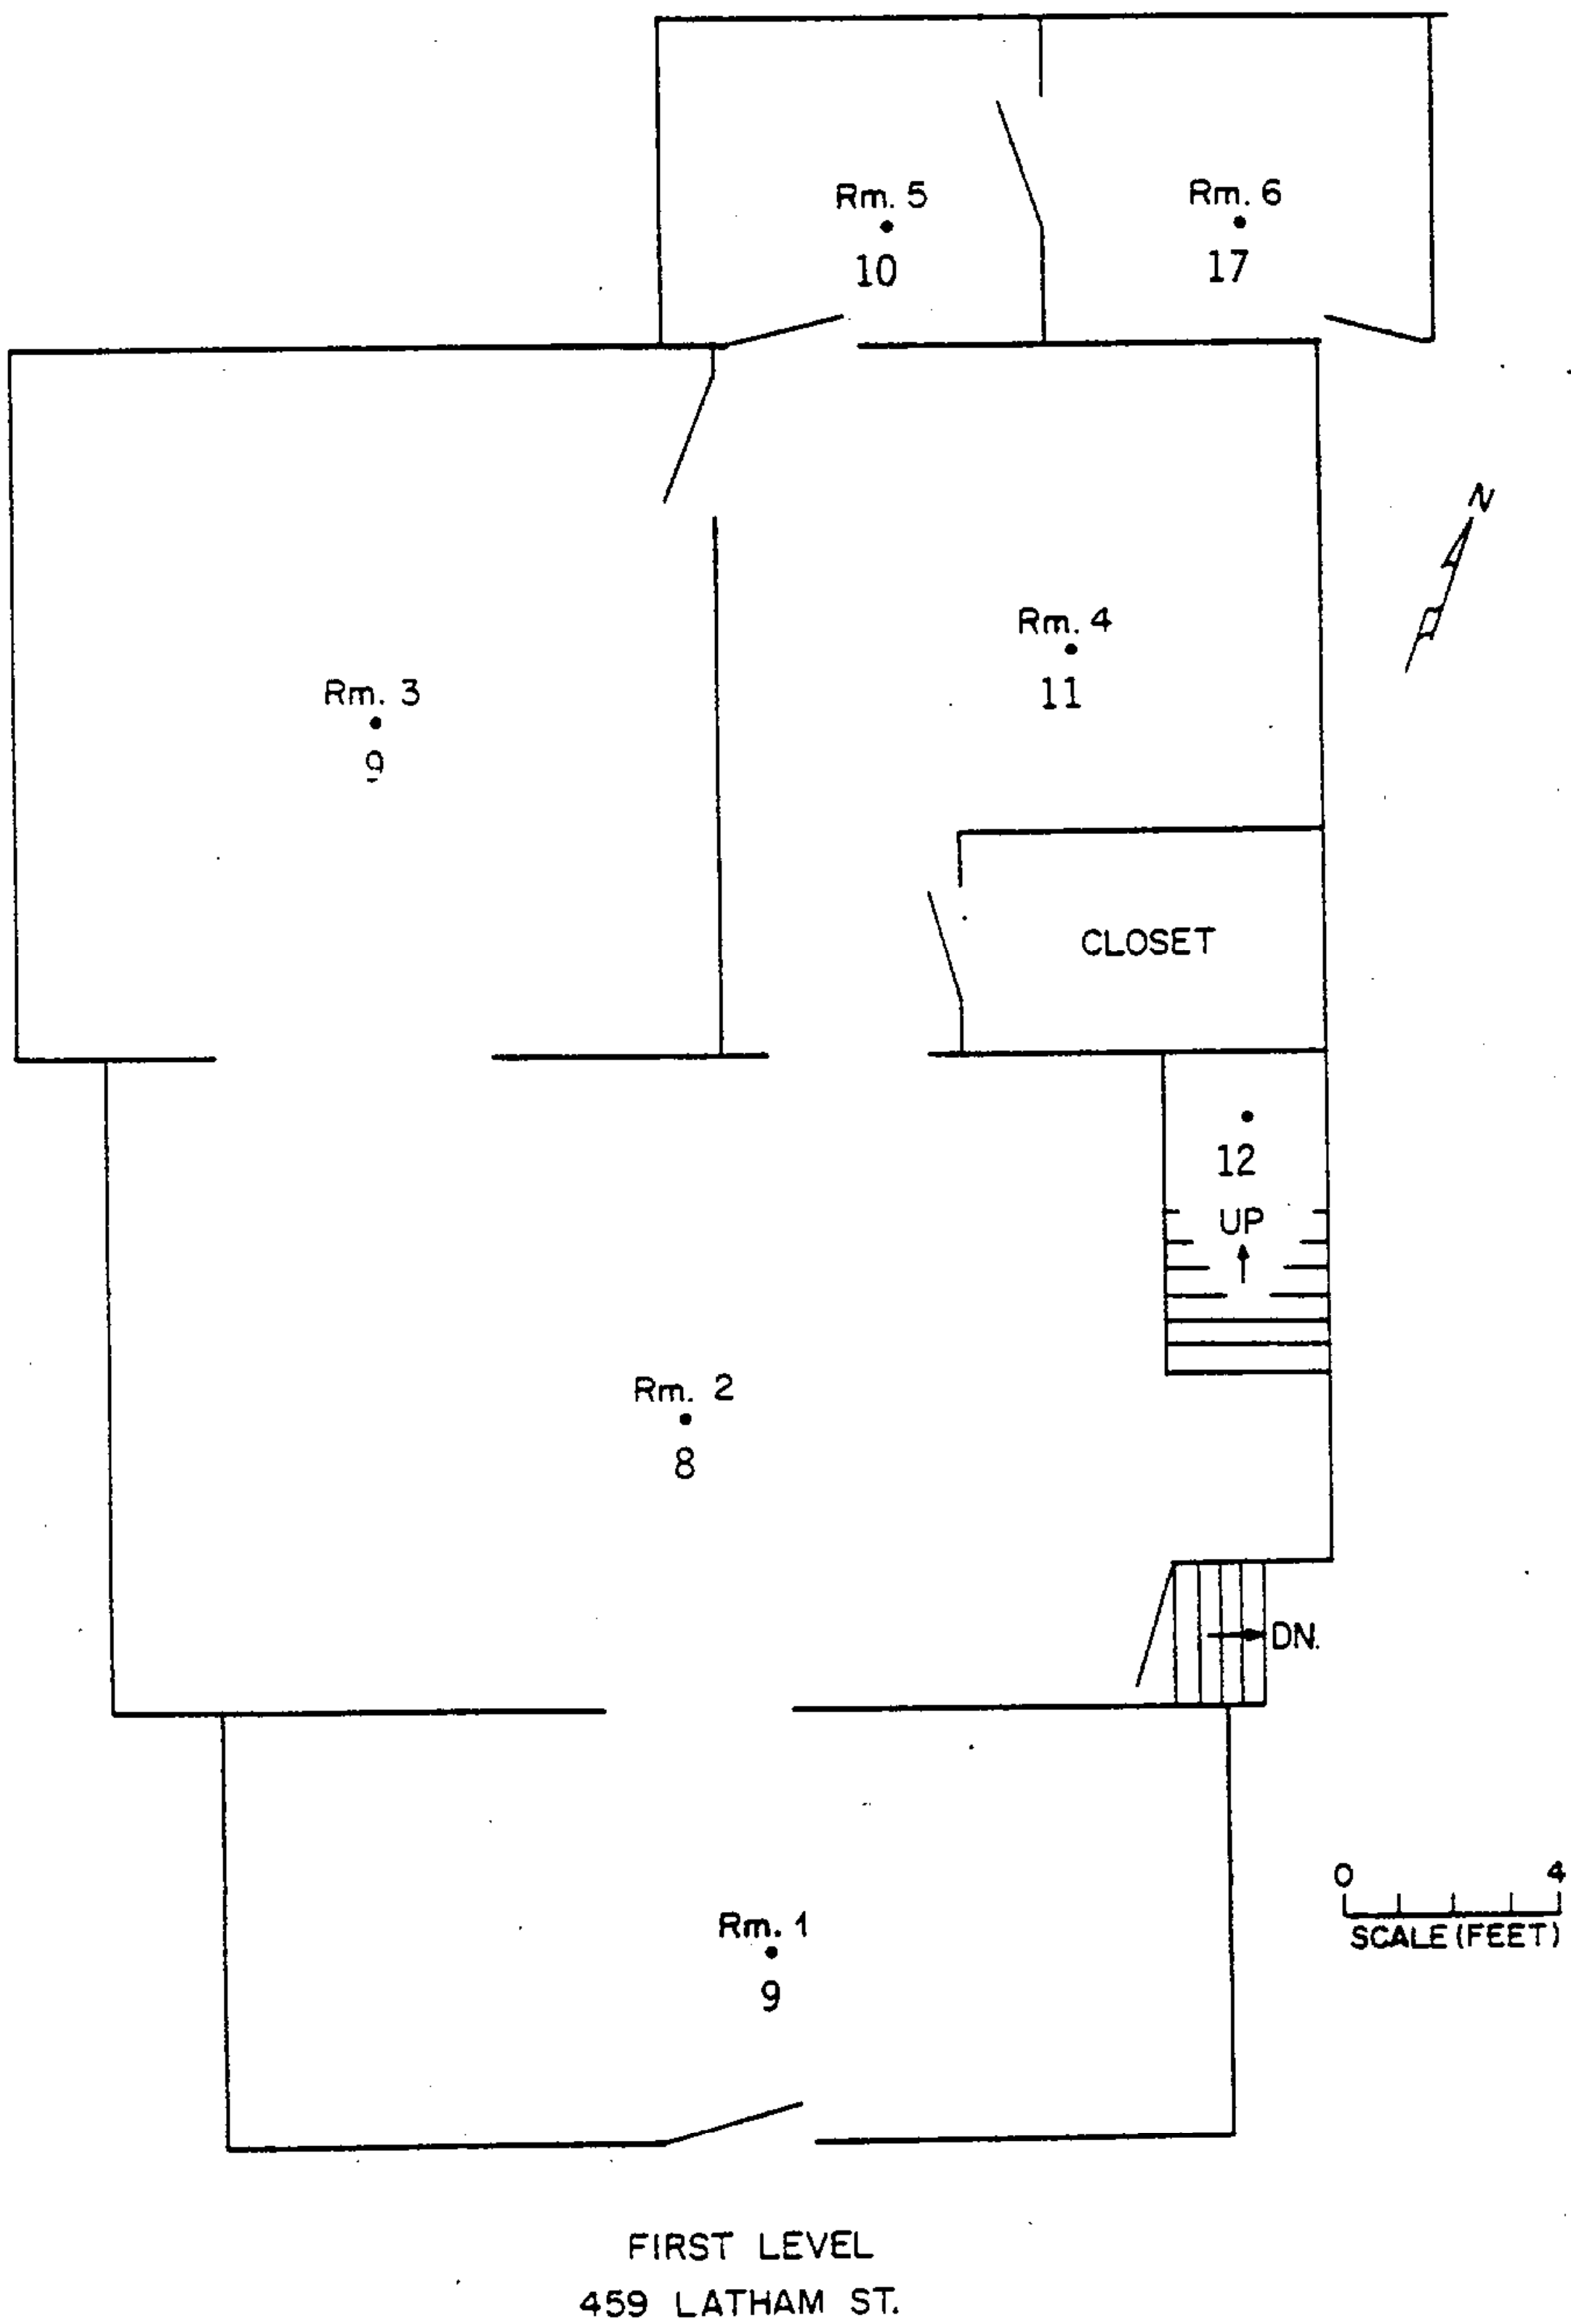
Fig. 6. Schematic of the first level floor plan at 459 Latham Street showing external gamma-ray measurement results at 1 m.

External gamma-ray exposure rates inside the house were generally elevated above background. Gamma-ray exposure rates at 1 m ranged from 8 to 17 μR/h and averaged 11 μR/h. There was no evidence that the source of these slightly elevated measurements was contaminated material indoors. However, these measurements can be related to outdoor contamination. Indoor external gamma-ray measurements were highest at locations in the north and east rooms of the house near areas where outdoor contamination was greatest (e.g., the porch on the street level, and the bath and stairway on the second level).
