RESULTS OF THE RADIOLOGICAL SURVEY
AT 459 DAVISON AVENUE, MAYWOOD, NEW JERSEY

September 1981

Work performed
as part of the
REMEDIAL ACTION SURVEY AND
CERTIFICATION ACTIVITIES

OAK RIDGE NATIONAL LABORATORY
Oak Ridge, Tennessee 37830
operated by
UNION CARBIDE CORPORATION
for the
DEPARTMENT OF ENERGY

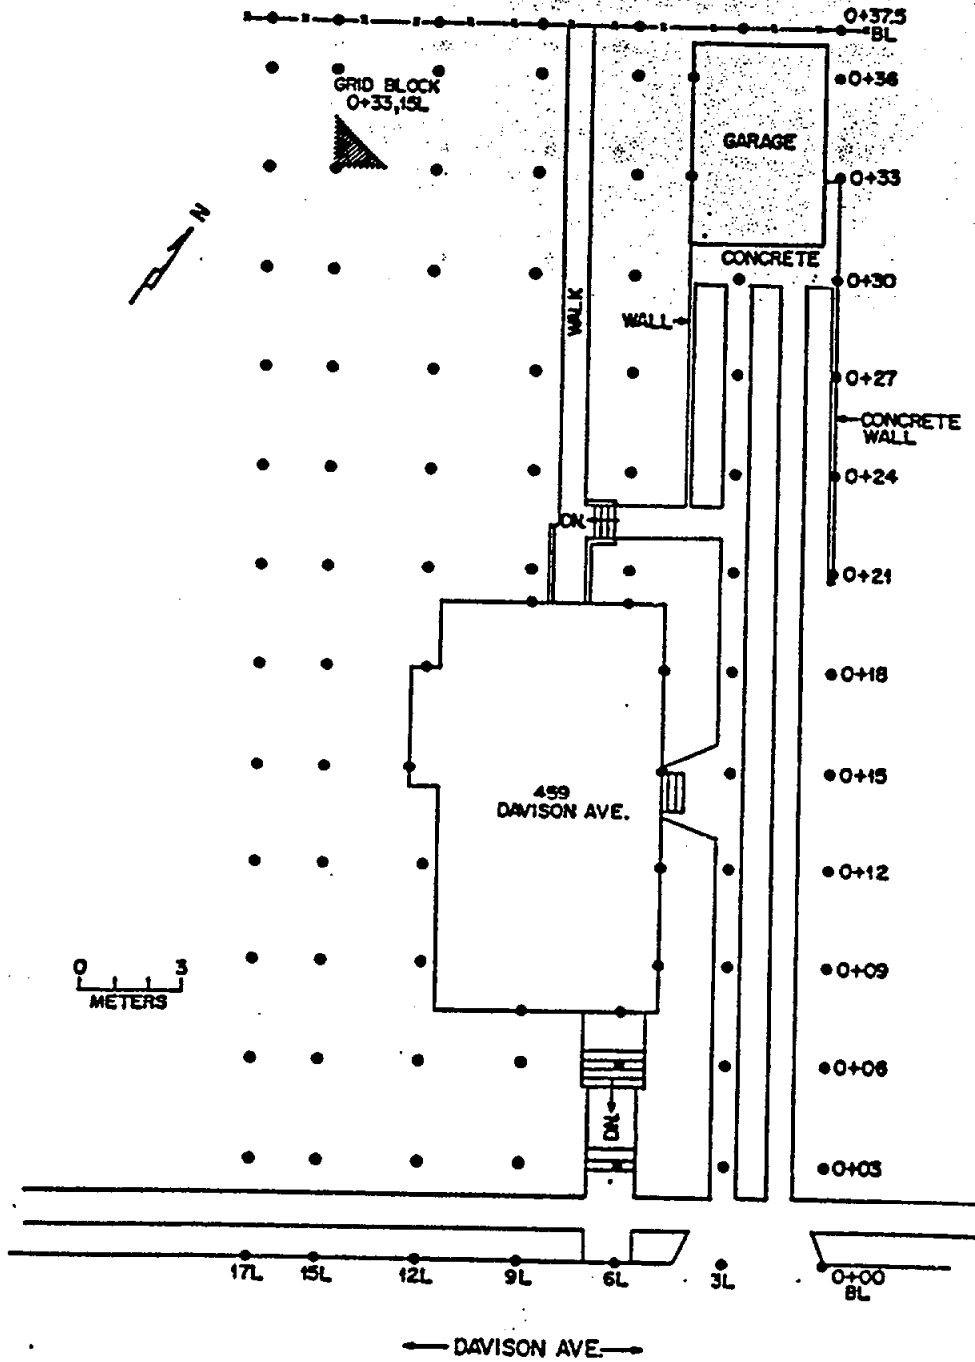
Fig. 3.   Grid point and grid block locations at
          459 Davison Avenue

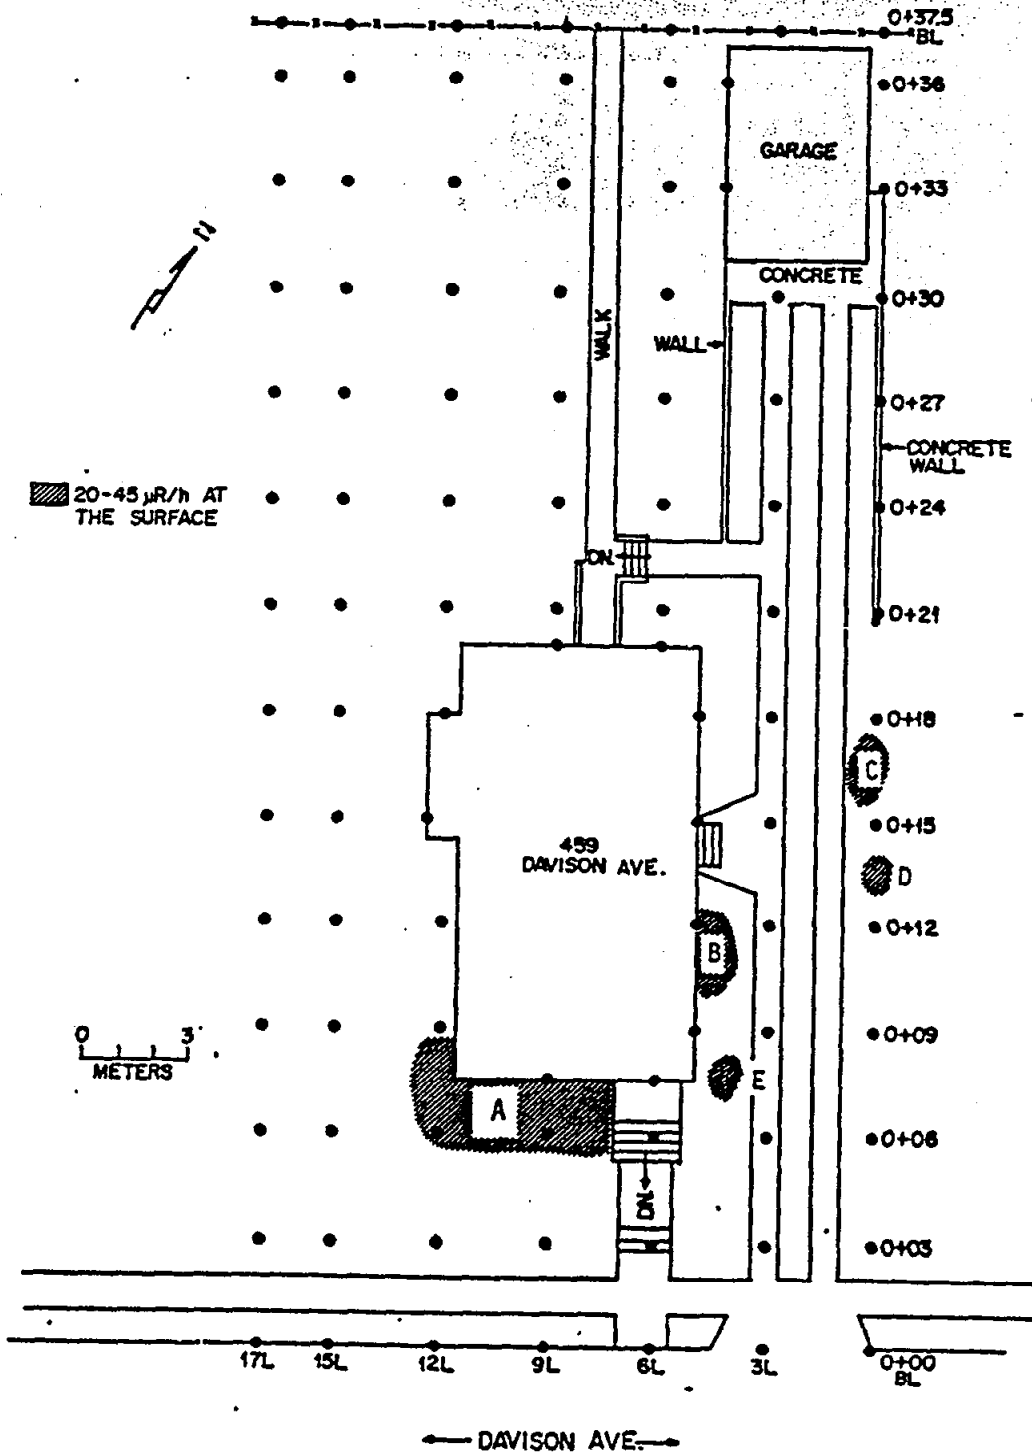
External gamma-ray and beta-gamma measurements. The results of the grid point measurements and grid block scans at 459 Davison Avenue are presented in Table 3. Analysis of these data indicates that contaminated materials are present at isolated locations in the front yard and along the east side of the property. The location and approximate areal extent of these contaminated areas are highlighted by shading in Fig. 4.

The average gamma-ray exposure rate at 1 m above the surface outdoors was determined to be 10 µR/h, a value only slightly above the normal background level for the Maywood area. Surface gamma-ray exposure rates over the property ranged from 9 to 41 µR/h, with the highest values being recorded in the contaminated areas included in grid blocks 0+15, 3L and 0+06, 12L. Surface beta-gamma dose rates in the contaminated areas ranged from 0.03 to 0.07 mrad/h.

Fig. 4. Estimated extent of contaminated areas at 459 Davison Avenue based on results of external gamma-ray surface scan.

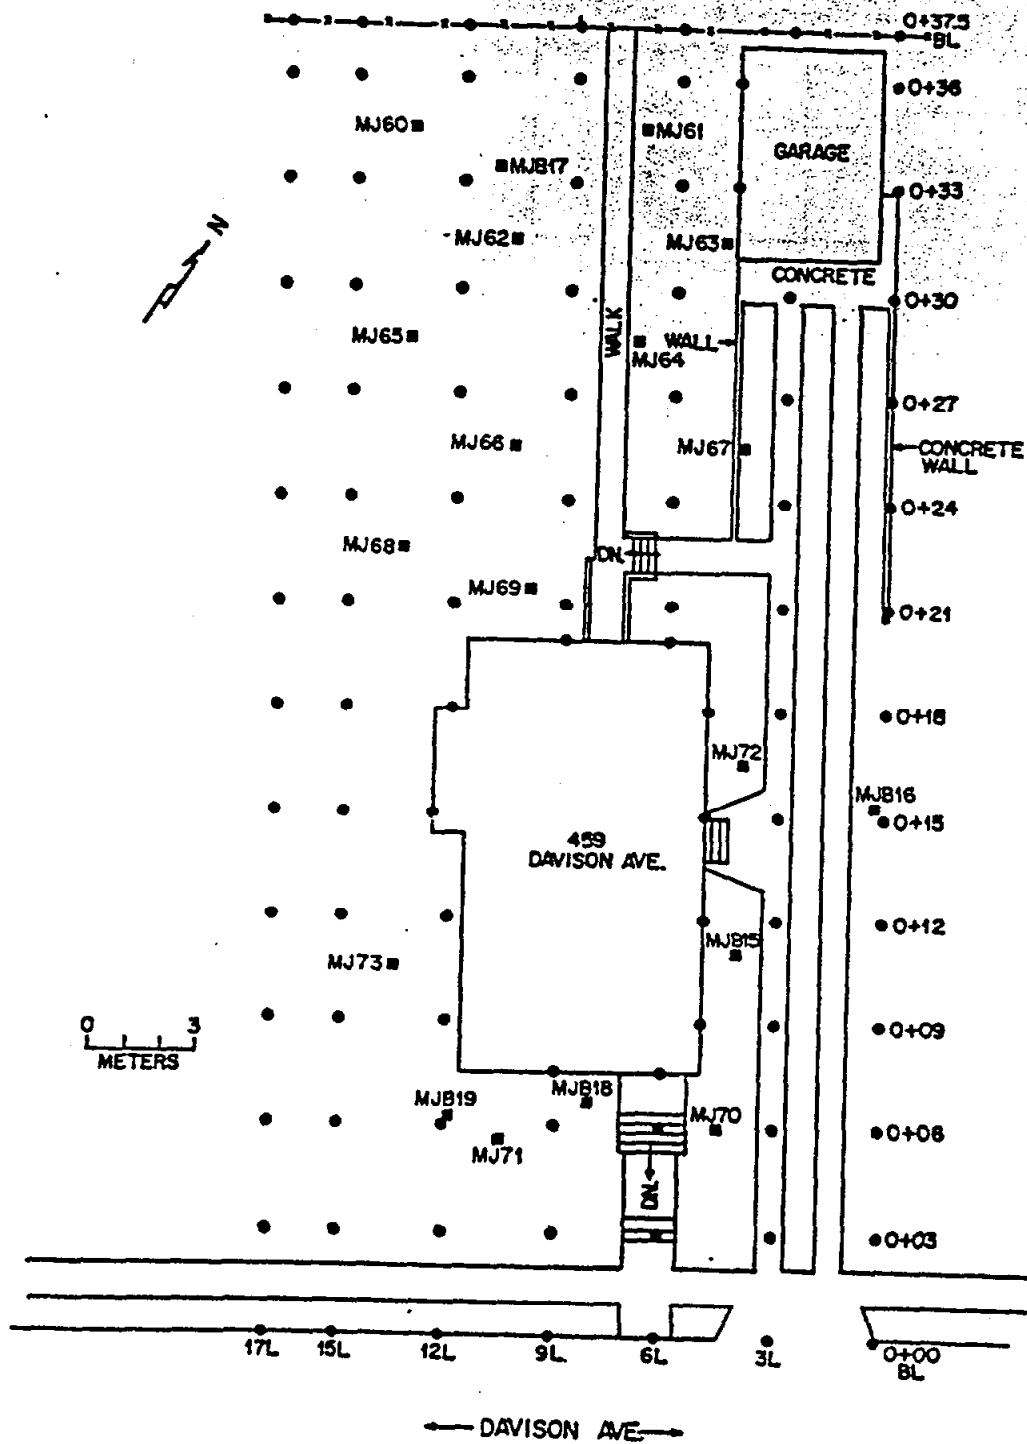
at five biased locations (MJB samples) on the property (a biased soil sample is one which is collected at a location exhibiting elevated gamma radiation levels). These sampling locations are depicted in Fig. 5. Results of the laboratory analysis for ^{232}Th, ^{238}U, and ^{226}Ra concentrations in these samples are presented in Table 4. Measured concentrations in systematic samples were found to range from 0.84 to 2.0 pCi/g for ^{232}Th, 0.73-1.7 pCi/g for ^{238}U, and 0.67-1.3 pCi/g for ^{226}Ra. The mean concentration of ^{232}Th in the systematic surface soil samples was 1.1 pCi/g, a value only slightly above the normal background level.

Surface and subsurface soil samples from the contaminated areas on the property contained elevated concentrations of ^{232}Th at each location. The maximum measured concentration of ^{232}Th was determined to be 34 pCi/g (MJB16A), occurring in soil from the surface layer. In the four locations where depth samples were obtained, the data indicate that the contamination extends from the surface to an average depth of approximately 30 cm. The primary contaminant in subsurface soil was ^{232}Th, with lesser concentrations of ^{238}U and ^{226}Ra being measured.

Fig. 5. Location of systematic and biased surface soil samples at
459 Davison Avenue.

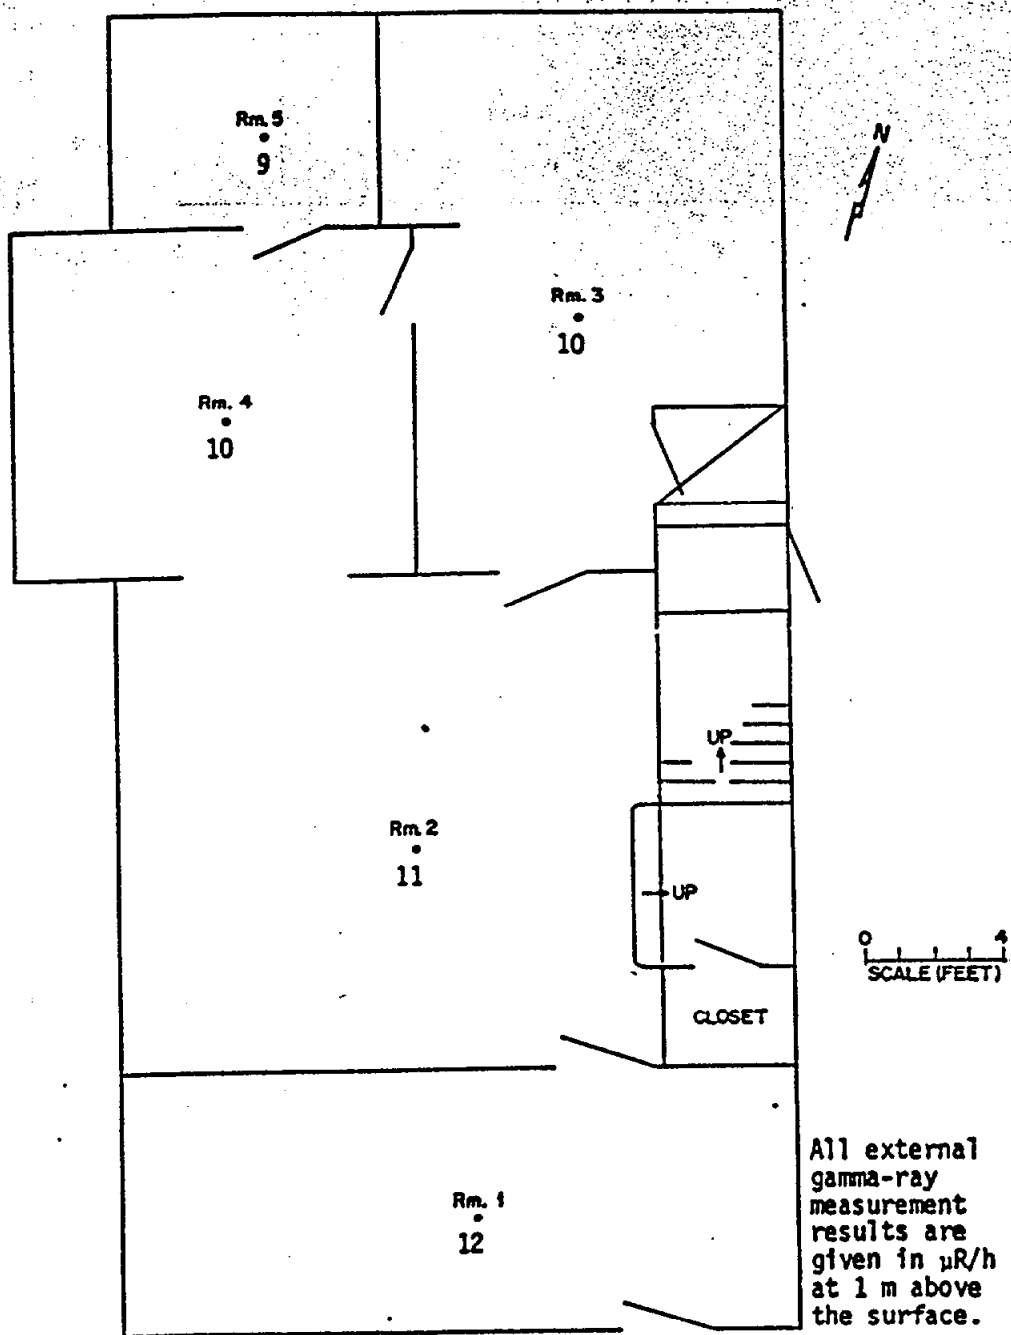
Fig. 6. Schematic of the first level floor plan at 459 Davison Avenue
showing external gamma-ray measurement results at 1 m.

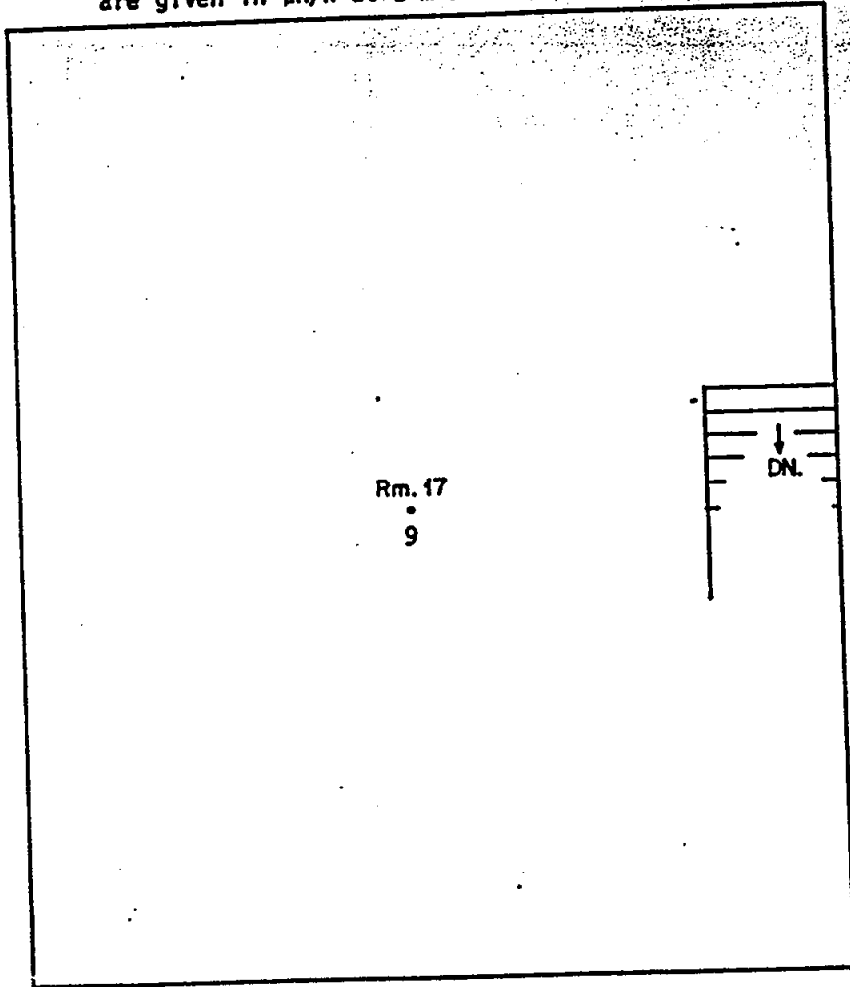
Fig. 8. Schematic of the third level floor plan at 459 Davison Avenue
showing external gamma-ray measurement results at 1 m.

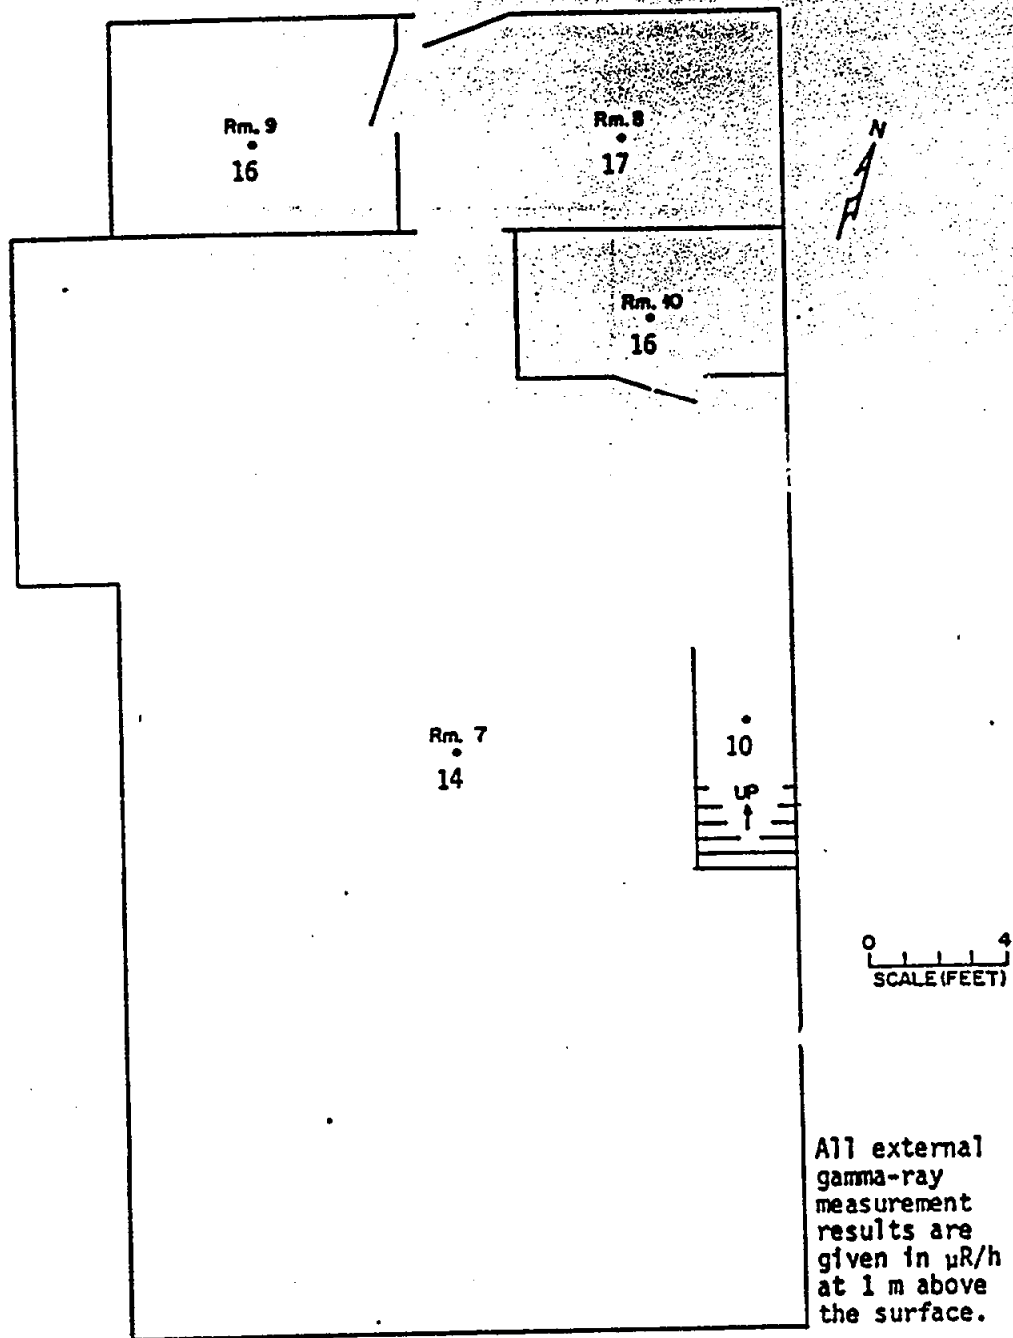
Fig. 9. Schematic of the basement floor plan at 459 Davison Avenue
showing external gamma-ray measurement results at 1 m.

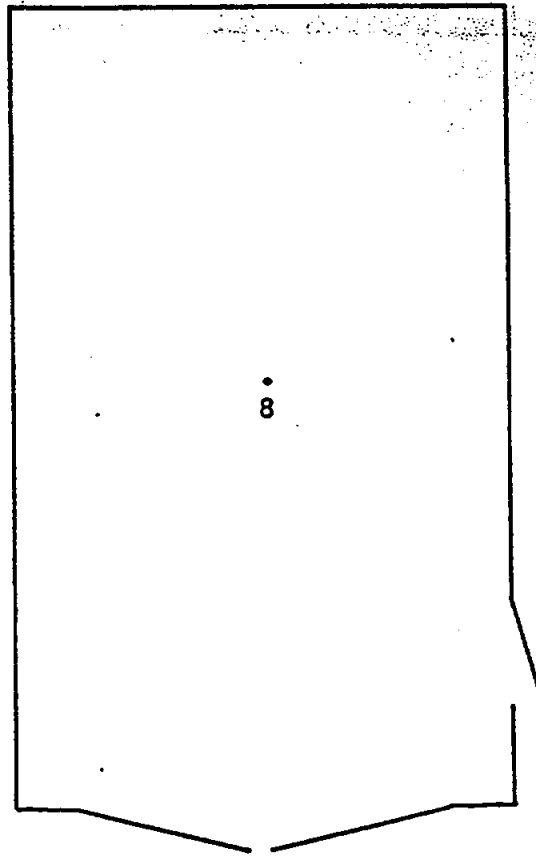
Fig. 10. Schematic of the garage floor plan at 459 Davison Avenue
          showing external gamma-ray measurement results at 1 m.
