ORNL/RASA-88/14

RESULTS OF THE RADIOLOGICAL SURVEY AT 60 TRUDY DRIVE (LJ057), LODI, NEW JERSEY

Date of Issue – March 1989

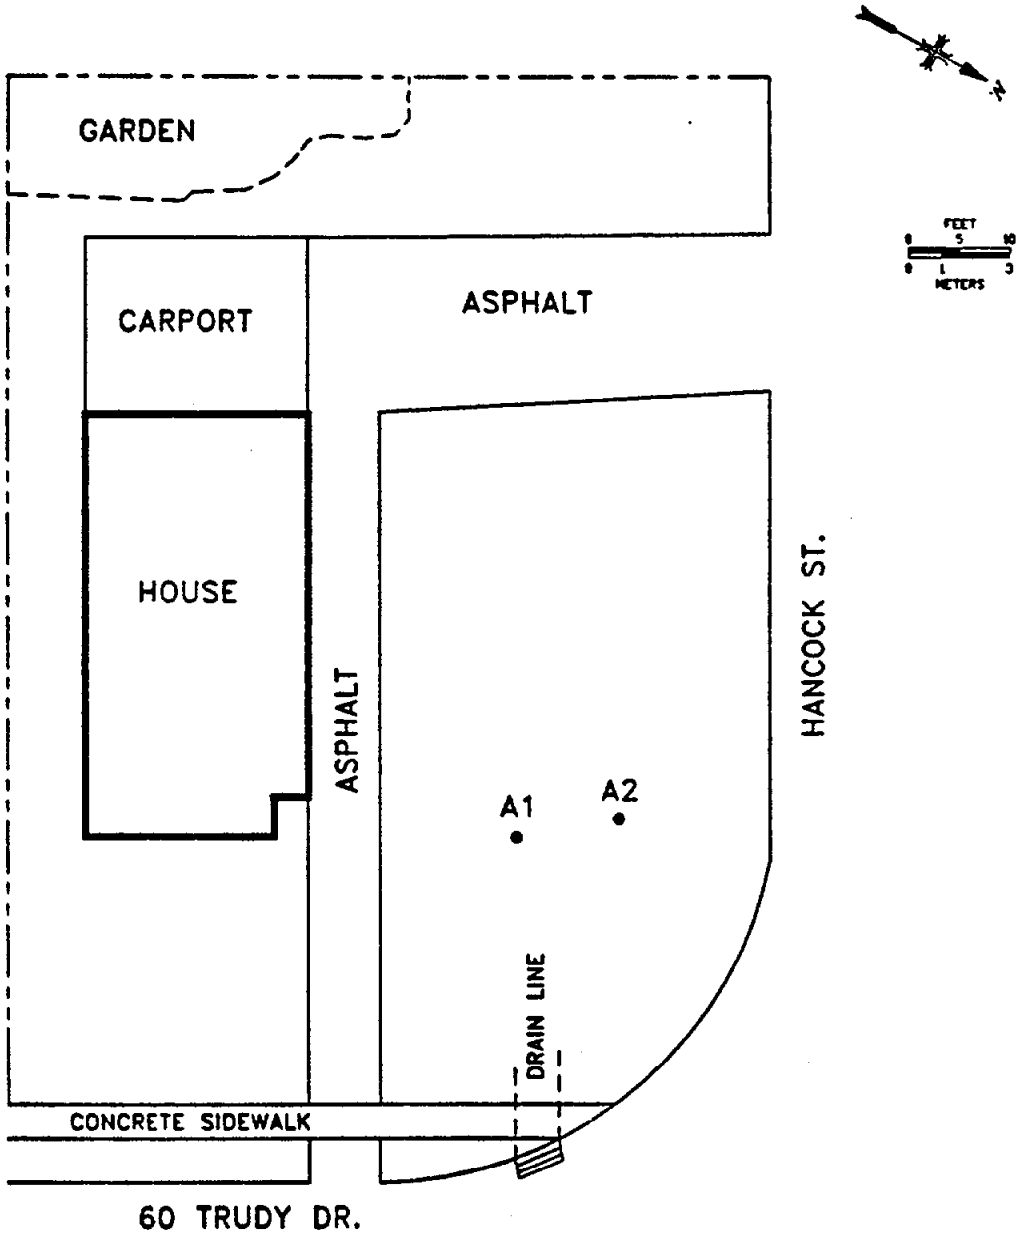
Varying thicknesses of subsurface soil were sampled from depths of 0 to 185 cm in auger holes (A) drilled at the two separate locations indicated in Fig. 1. The results of analyses of samples A1A to A2E are given in Table 3. Concentrations of ^{226}Ra and ^{232}Th in soil samples from the auger holes ranged from 0.81 to 3.8 and 1.5 to 22 pCi/g, respectively. The concentration of ^{232}Th in sample A2E, 22 pCi/g, exceeds the DOE criterion for subsurface soil (Table 1). Sample A2E was collected at a depth of 150 to 185 cm. The maximum concentration of ^{226}Ra, 3.8 pCi/g, was higher than the typical background level of 0.9 pCi/g but well below the guideline.

Fig. 1. Diagram showing locations of soil samples taken at 60 Trudy Drive, Lodi, New Jersey (LJ057).

Measurements taken at 60 Trudy Drive indicate that the property contained radioactive contamination primarily from the ^{232}Th decay chain, with some contribution from ^{226}Ra. These radionuclide distributions are typical of the type of material originating from processing operations at the MCW. The concentration and extent of ^{232}Th on this property are in excess of the applicable DOE criterion (Table 1). This material was found as shown in Fig. 1 at the location of sample A2. Based on the results of this radiological assessment, it is recommended that this site be considered for inclusion in the DOE remedial action program.

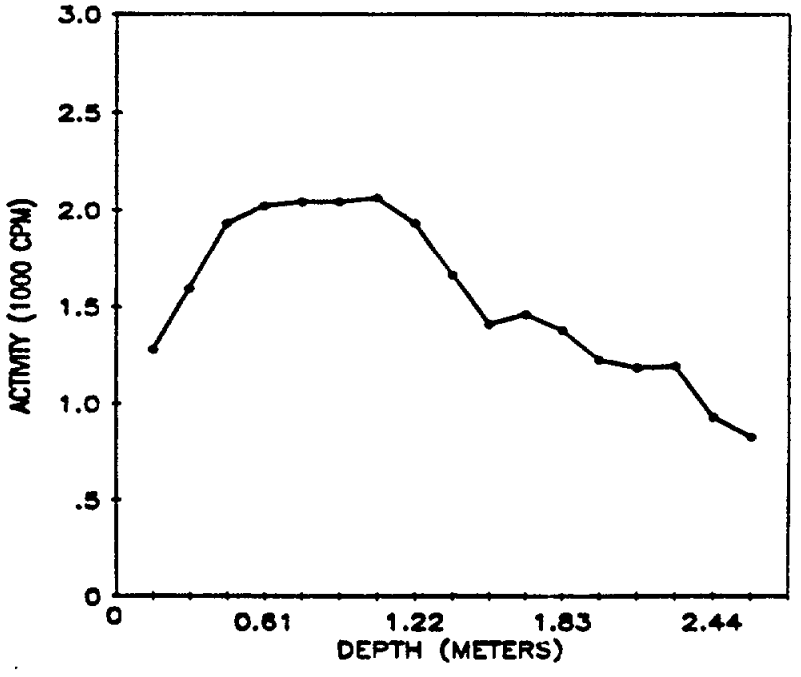
Gamma logging was performed in each of the two auger holes to characterize and further define the extent of possible contamination. The logging technique used here is not radionuclide specific. However, logging data, in conjunction with soil analyses data, may be used to estimate regions of elevated radionuclide concentrations in auger holes when compared with background levels for the area. Following a comparison of these data, it appears that any shielded scintillator readings of 1,000 counts per minute (cpm) or greater generally indicate the presence of elevated concentrations of ^{226}Ra and/or ^{232}Th. Data from the gamma profiles of the logged auger holes are graphically represented in Figs. 2 and 3. Readings at depths between the surface and a depth of 2.3 m were greater than 1,000 cpm in auger hole 1, with a maximum reading of 2,100 cpm at 1.1 m. Readings in auger hole 2 were elevated between the surface and a depth of 2.0 m, with a maximum of 6,700 cpm at 1.7 m.

Fig. 2. Gamma profile for auger hole 1 (LJ057A1) at 60 Trudy Drive, Lodi, New Jersey.

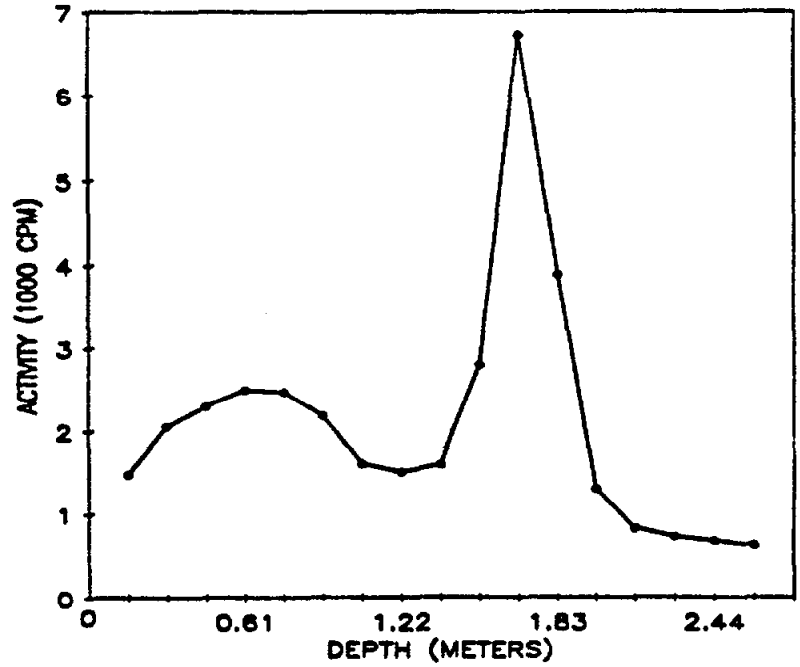
Fig. 3. Gamma profile for auger hole 2 (LJ057A2) at 60 Trudy Drive, Lodi, New Jersey.
