Maywood Chemical Company Superfund Site

Results of Radon and Gamma Radiation Measurements at 19 Commercial and Governmental Properties of the Maywood Site

Maywood, New Jersey

August 1994

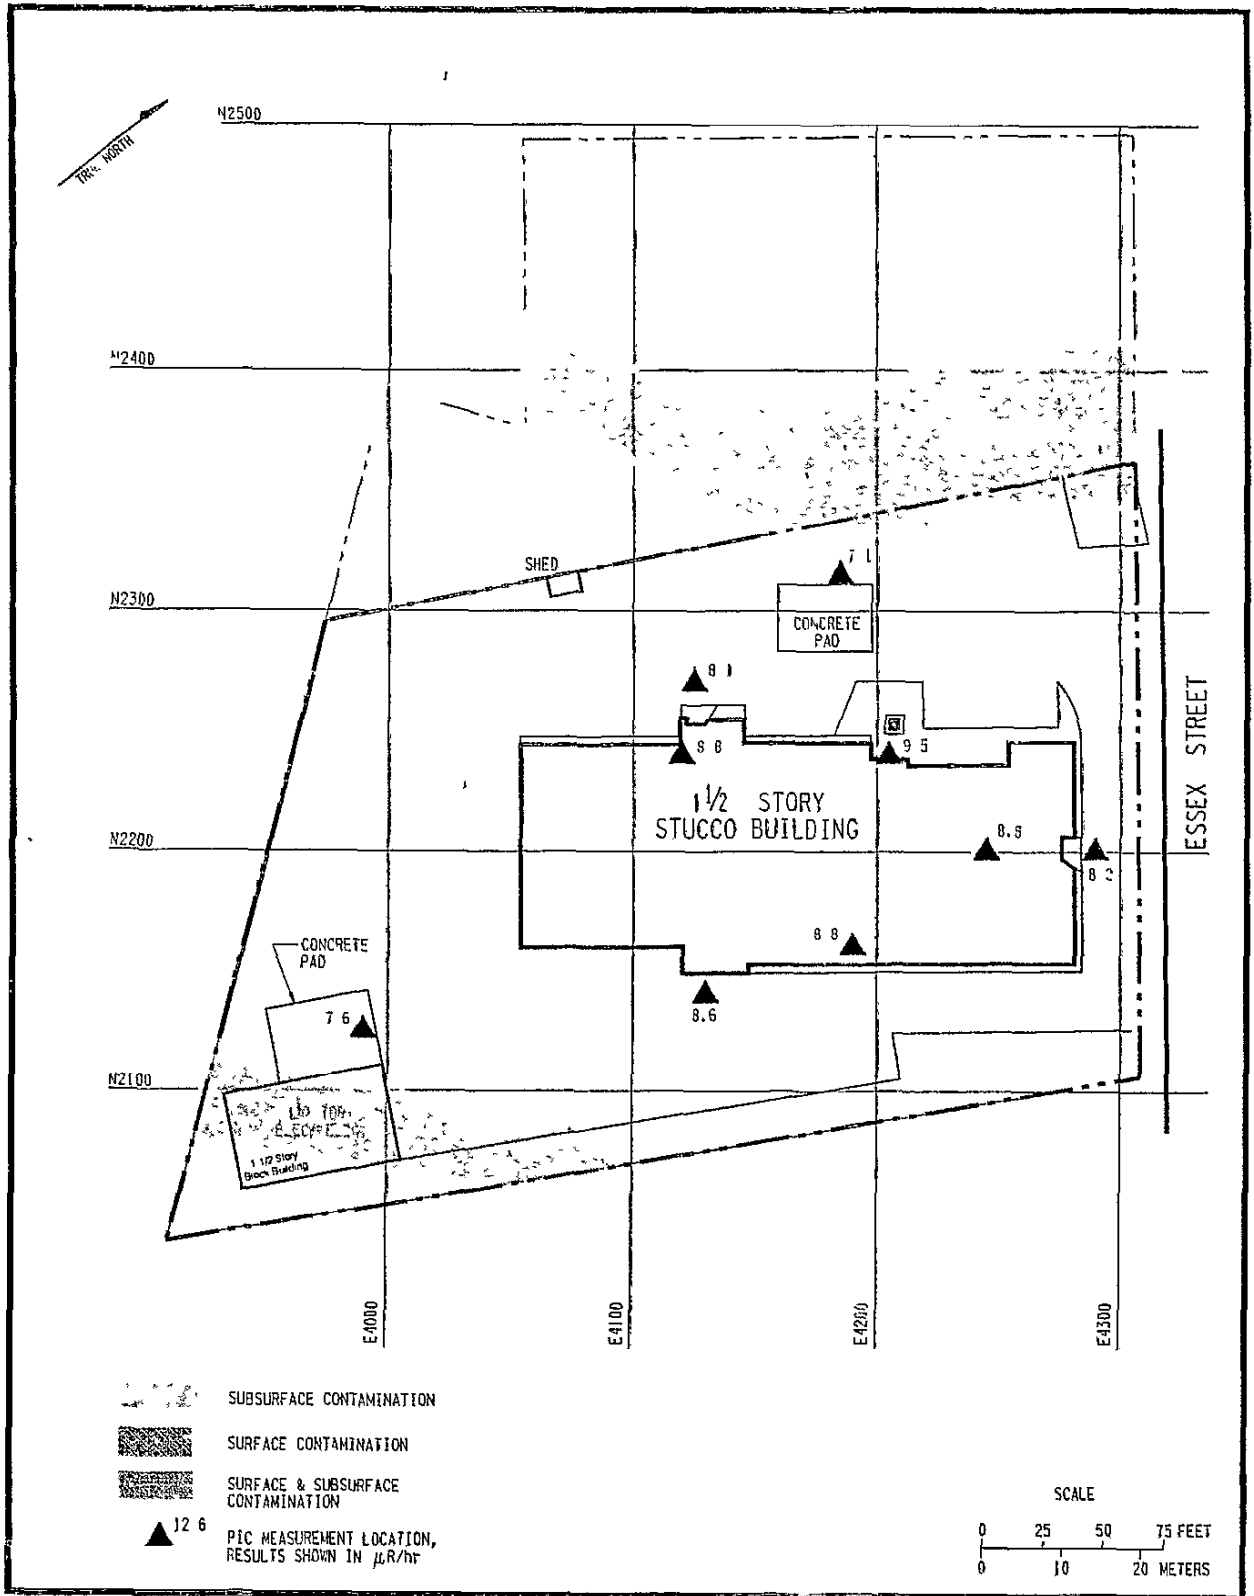
Figure 4-1
PIC Measurement Locations and Areas of Contamination
at National Community Bank 160 and 174 Essex Street

Three interior gamma exposure rate measurements were made at the bank property; locations and data for these measurements are shown in Figure 4-1. All three interior measurements were 8.8 $\mu\text{R}/\text{h}$ and were within background. The six exterior measurements ranged from 7.1 to 9.5 $\mu\text{R}/\text{h}$ and were within background (see Figure 4-1 for locations). None of the interior gamma exposure rate measurements exceeded the DOE guideline of 20 $\mu\text{R}/\text{h}$ above background for habitable structures. Exterior gamma exposure rate measurements taken during this investigation were compared with exterior measurements taken during radiological characterization of the property in 1987 (BNI 1989a). The 1987 exterior measurements ranged from 5 to 8 $\mu\text{R}/\text{h}$ and were within background. No significant change is seen between the 1987 and 1994 measurements.

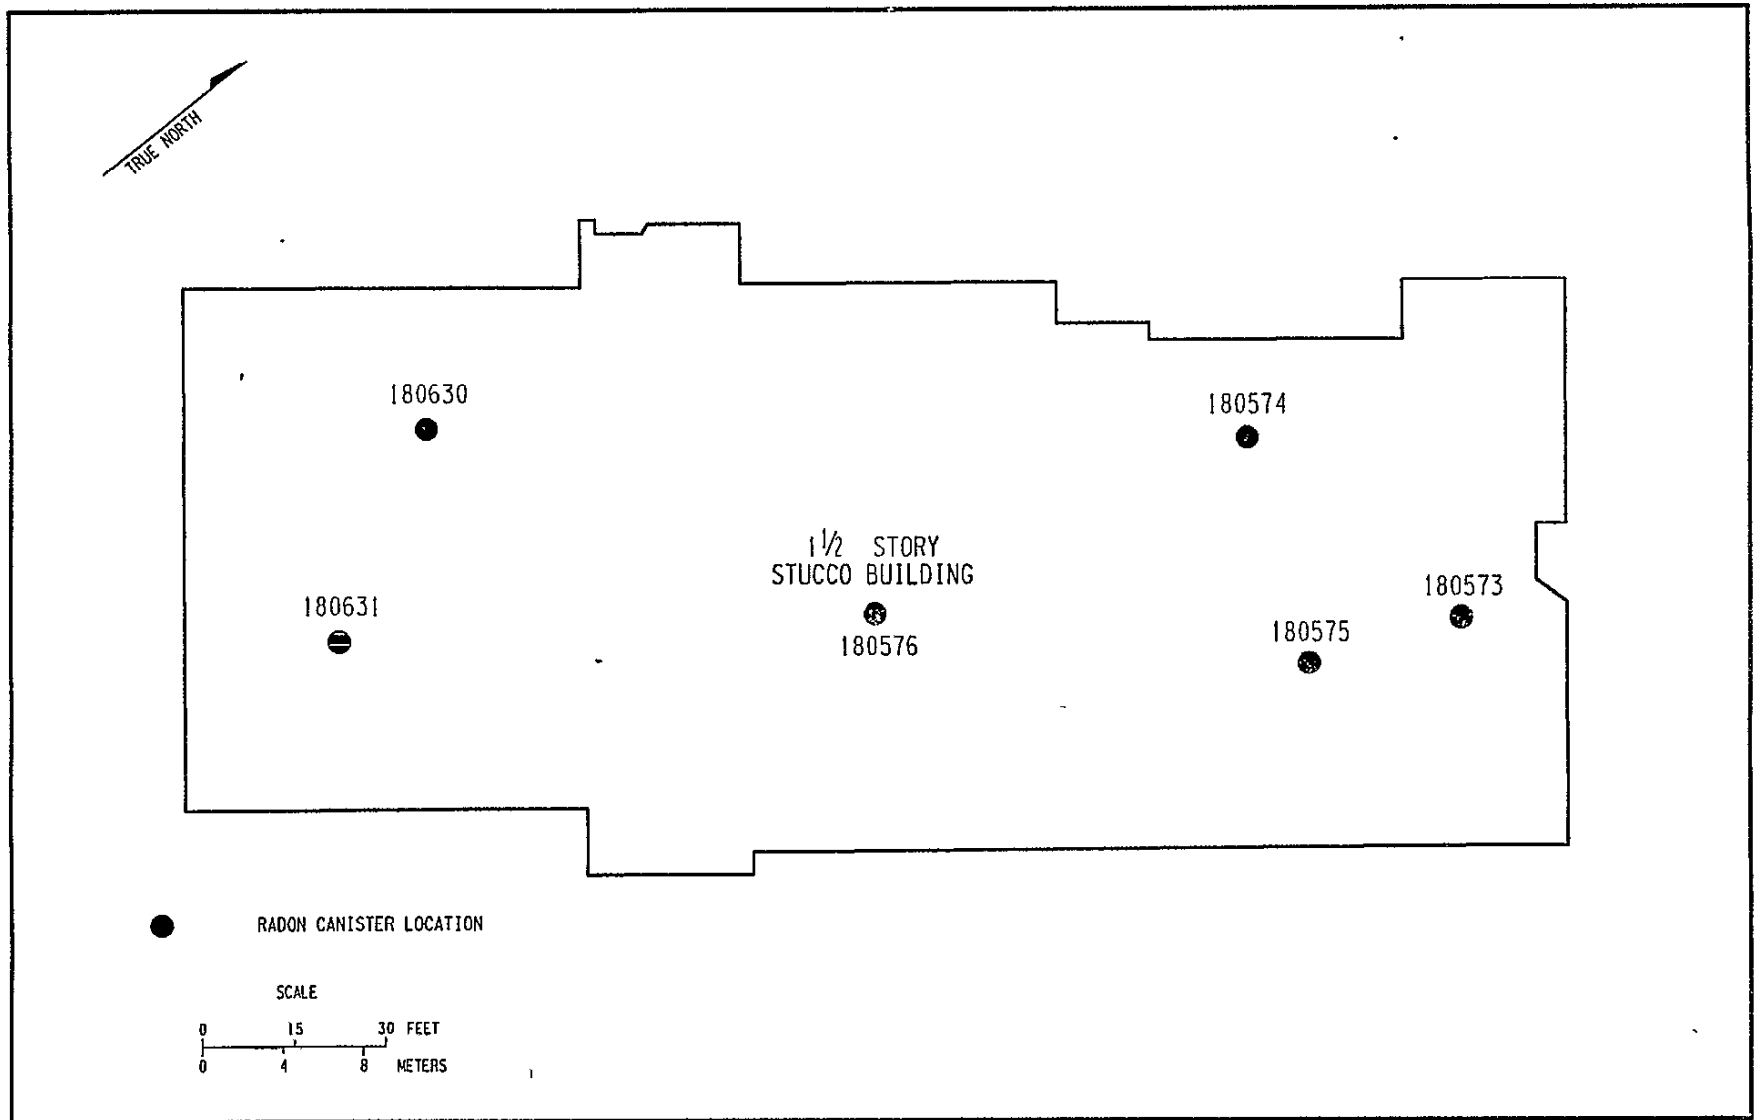
Figure 4-2
Locations of Radon Canisters at
National Community Bank 160 and 174 Essex Street

Radon concentrations were measured in six locations inside the building (see Figure 4-2) Concentrations measured ranged from less than 0.2 pCi/L to 0.3 pCi/L and

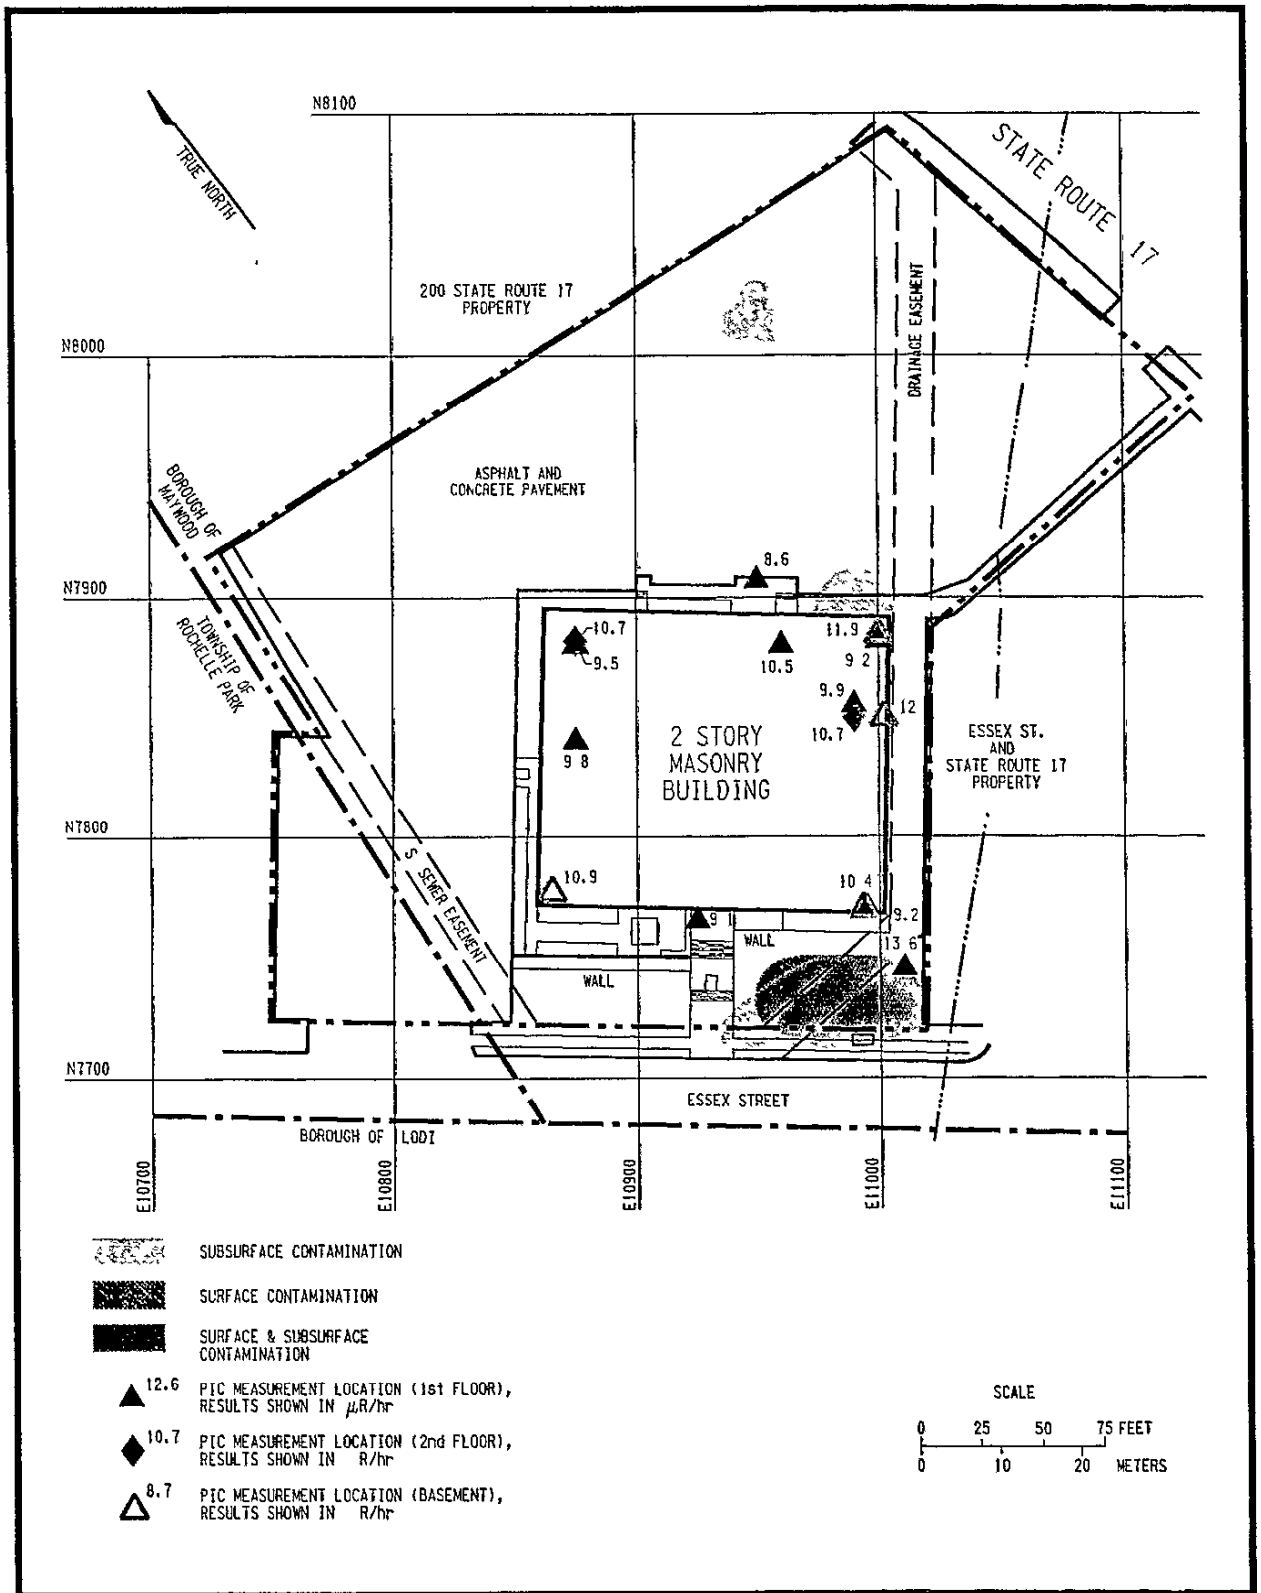
Figure 4-3
PIC Measurement Locations and Areas of Contamination at
National Community Bank 113 Essex Street

DOE guideline for habitable structures of 20 $\mu\text{R}/\text{h}$ above background. Figure 4-3 shows the locations and the data for each of these measurements.

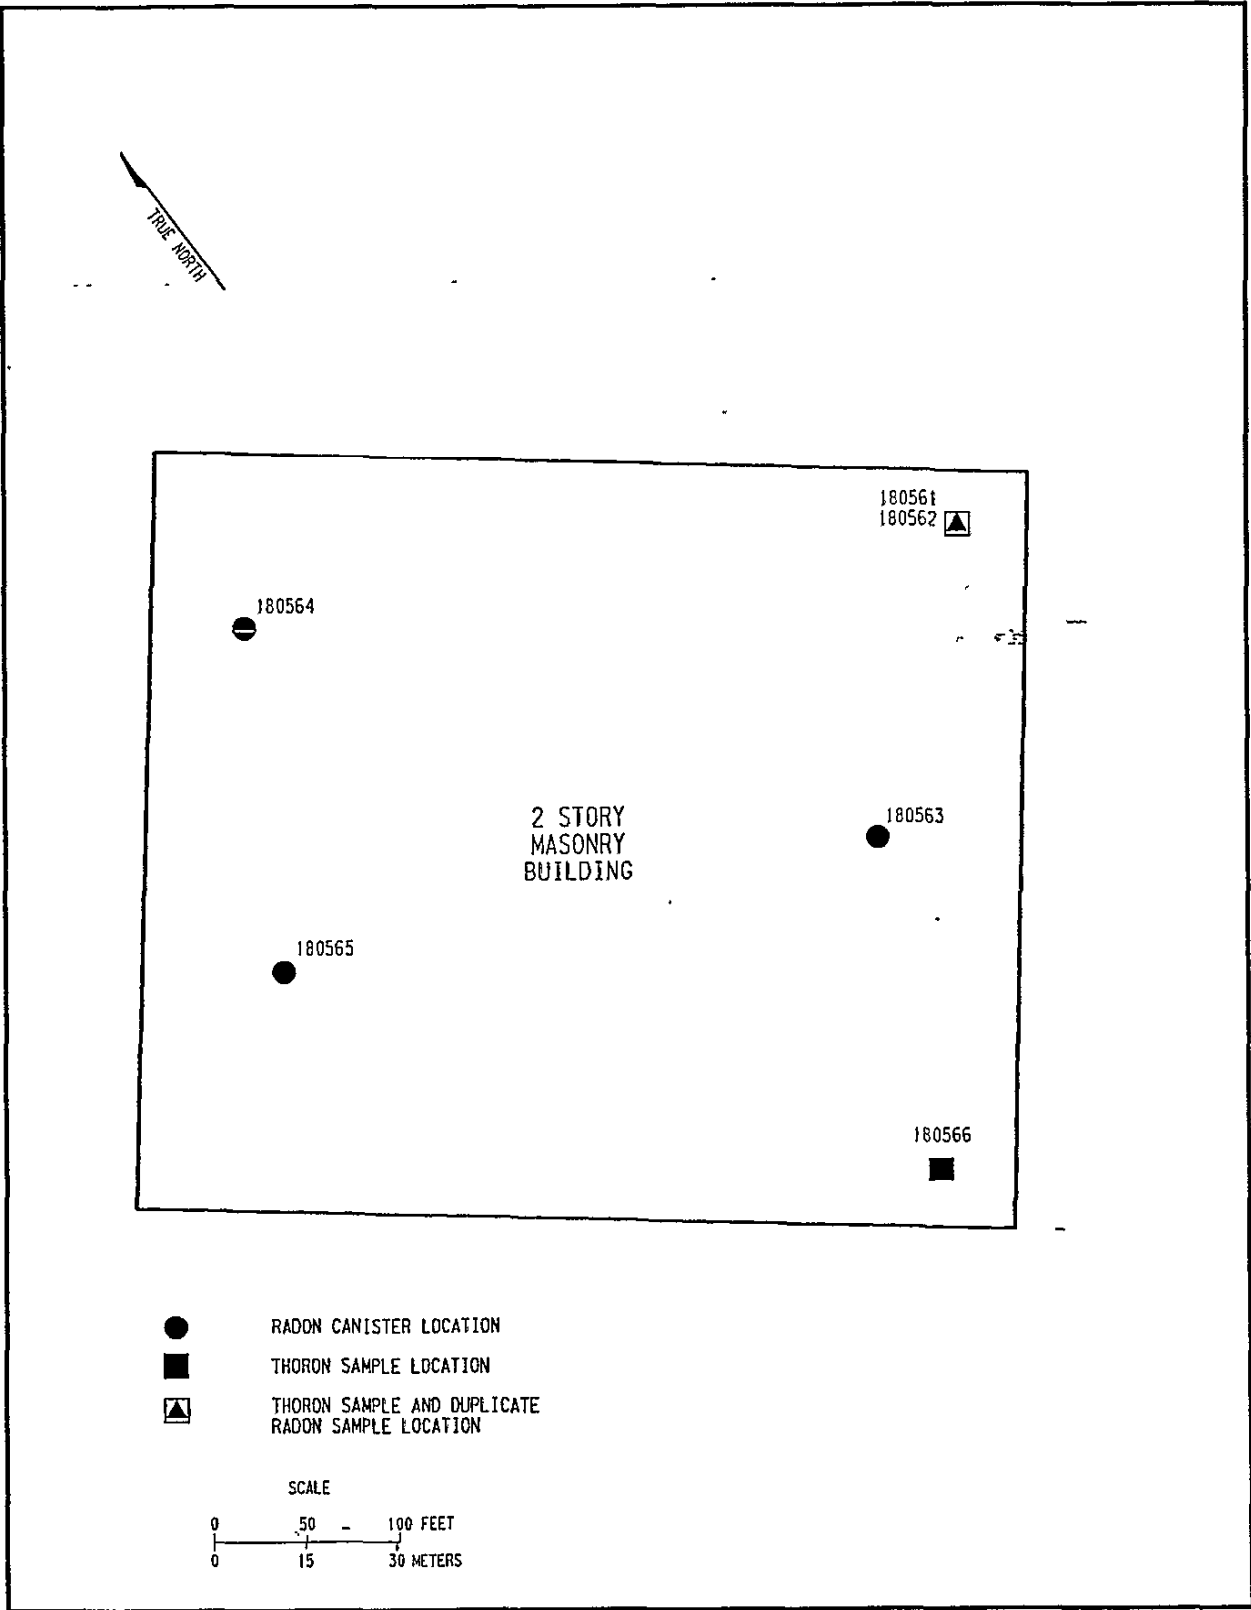
Figure 4-4
 Locations of Radon Canisters in the Basement
 at National Community Bank 113 Essex Street

Radon concentrations were measured by deploying 12 activated charcoal canisters throughout the basement and first floor of the building. Analytical results indicated concentrations ranging from less than 0.2 to 0.6 pCi/L, all within background. These concentrations are well below the DOE guideline of 3.0 pCi/L above background (background is 1.0 pCi/L for the Maywood site). Locations of the radon canisters are shown in Figures 4-4 and 4-5; data for each canister are presented in Table 4-2.

During previous characterization activities at this property (BNI 1992a), radioactively contaminated soil was identified at the rear of the building (eastern corner) and at the front of the building (southern corner). This contamination is probably the result of overbank deposition of contaminated material transported by the former channel of Lodi Brook that once flowed across this property. Because of the presence of this material, three of the canisters were analyzed for thoron concentrations. Concentrations of thoron ranged from less than 0.9 to less than 1.0 pCi/L (within background) and do not exceed the DOE guideline. DOE is reviewing the guideline for thoron at present and therefore currently applies the same guideline for thoron as for radon of 3.0 pCi/L above background. Figure 4-4 shows the location of the canisters analyzed for thoron, and Table 4-2 presents the data.

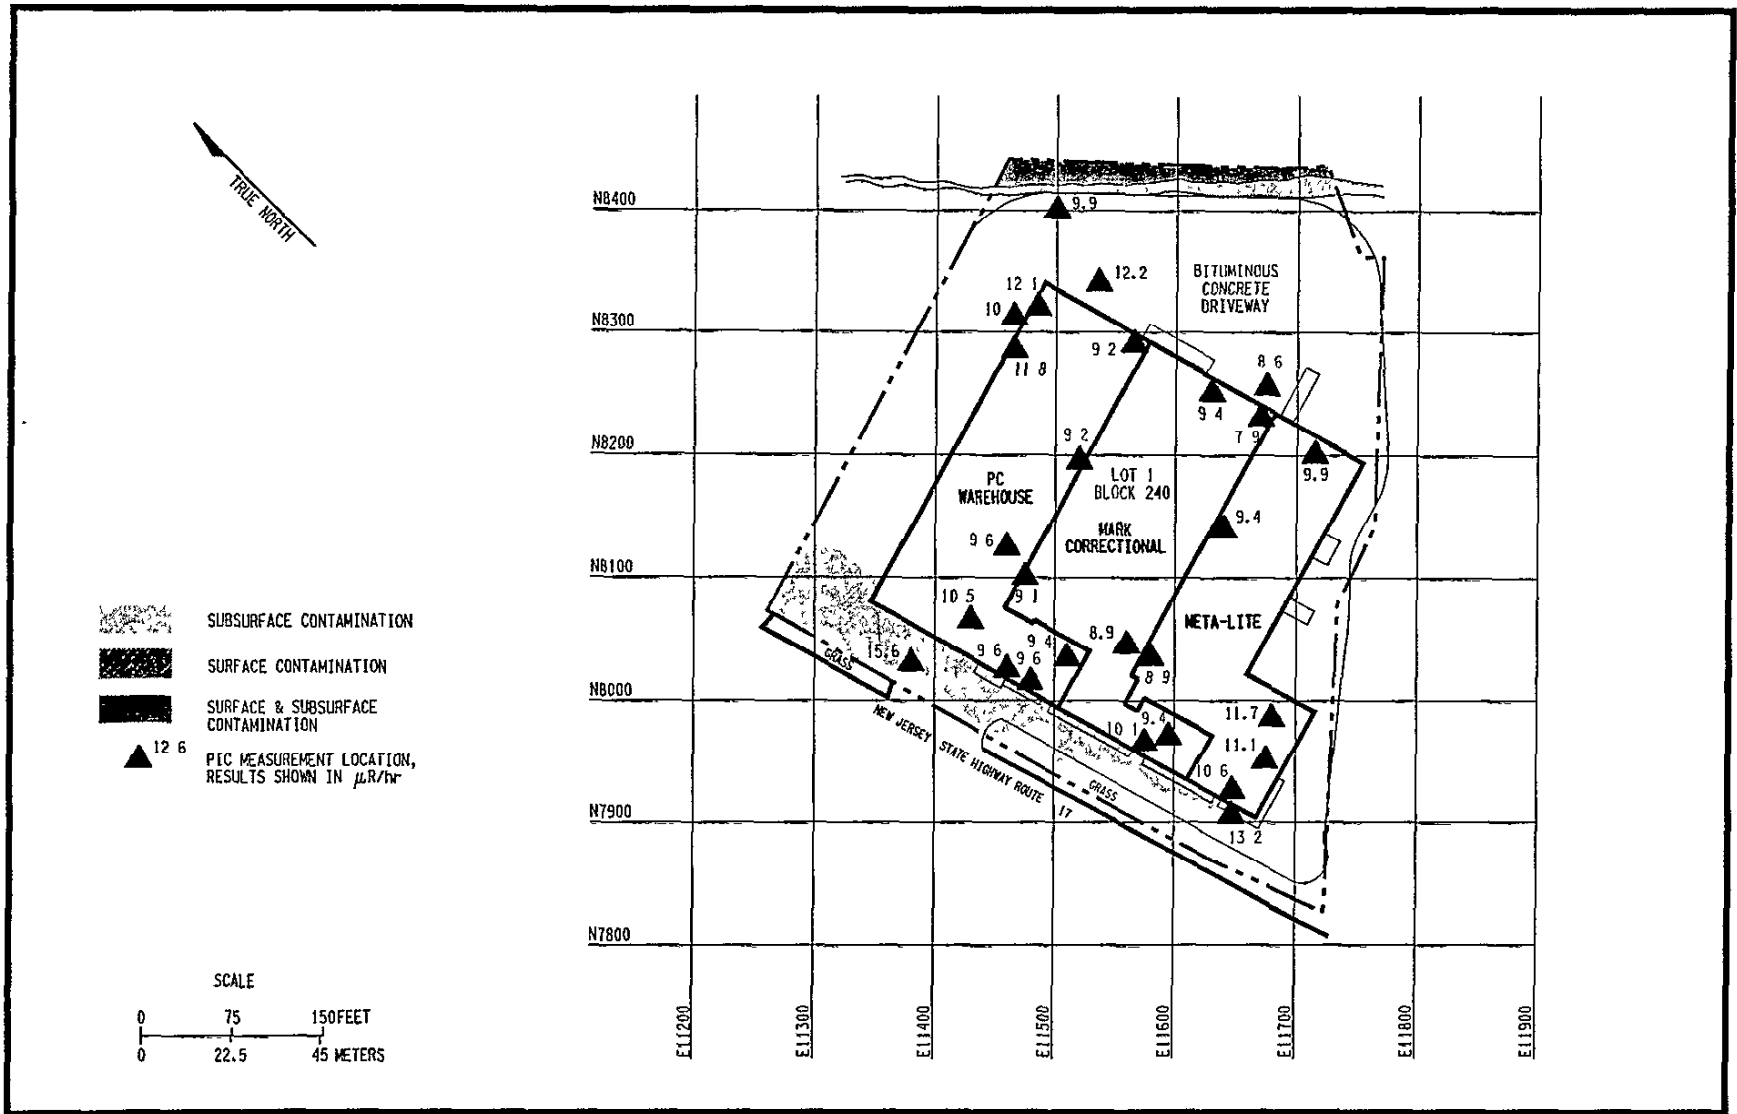
Figure 4-6
 PIC Measurement Locations and Areas of Contamination at the
 Former Hunter Douglas Property 85-99 Route 17 North

Six interior gamma exposure rate measurements were obtained at Meta-Lite. The measurements ranged from 8.9 to 11.7 $\mu\text{R}/\text{h}$, including background. The highest measurement, 11.7 $\mu\text{R}/\text{h}$, was obtained in the manufacturing area (see Figure 4-6) but does not exceed the DOE guideline of 20 $\mu\text{R}/\text{h}$ above background. The exterior gamma exposure rate measurements ranged from 8.6 to 15.6 $\mu\text{R}/\text{h}$, including background. The highest measurement, 15.6 $\mu\text{R}/\text{h}$ including background, was obtained in the parking area in front of the building and may be the result of granitic material mixed with the asphalt pavement covering the area. There is no known radioactive contamination present at this location. There are no previous external gamma radiation data for comparison with the data collected during this investigation. However, the exterior measurements at this property are consistent with the range of exterior gamma exposure rate measurements at neighboring properties.

Six interior and six exterior gamma exposure rate measurements were made at this property. The locations of these measurements and the data are shown on Figure 4-6. Interior gamma exposure measurements ranged from 7.9 to 10.1 $\mu\text{R/h}$ and were within background. Average background for the Maywood site is 9 $\mu\text{R/h}$. These measurements do not exceed the DOE guideline of 20 $\mu\text{R/h}$ above background for habitable structures. The range of exterior gamma radiation measurements was 8.6 to 15.6 $\mu\text{R/h}$, including background. The highest exterior measurement, 15.6 $\mu\text{R/h}$ including background, was obtained in the parking area at the front of the building and may be the result of granitic material mixed with the asphalt pavement covering the area. There is no known radioactive contamination at this location.

Nine interior and six exterior gamma exposure rate measurements were obtained at the PC Warehouse property. Figure 4-6 shows the location and data for each of these measurements. Interior gamma radiation measurements ranged from 9.2 to 12.1 $\mu\text{R}/\text{h}$, including background. The highest measurement, 12.1 $\mu\text{R}/\text{h}$, was recorded in northwest corner of the facility but does not exceed the DOE guideline of 20 $\mu\text{R}/\text{h}$ above background for habitable structures. The exterior gamma exposure rate measurements were the same as those for the two other tenants of the former Hunter Douglas, ranging from 8.6 to 15.6 $\mu\text{R}/\text{h}$, including background.

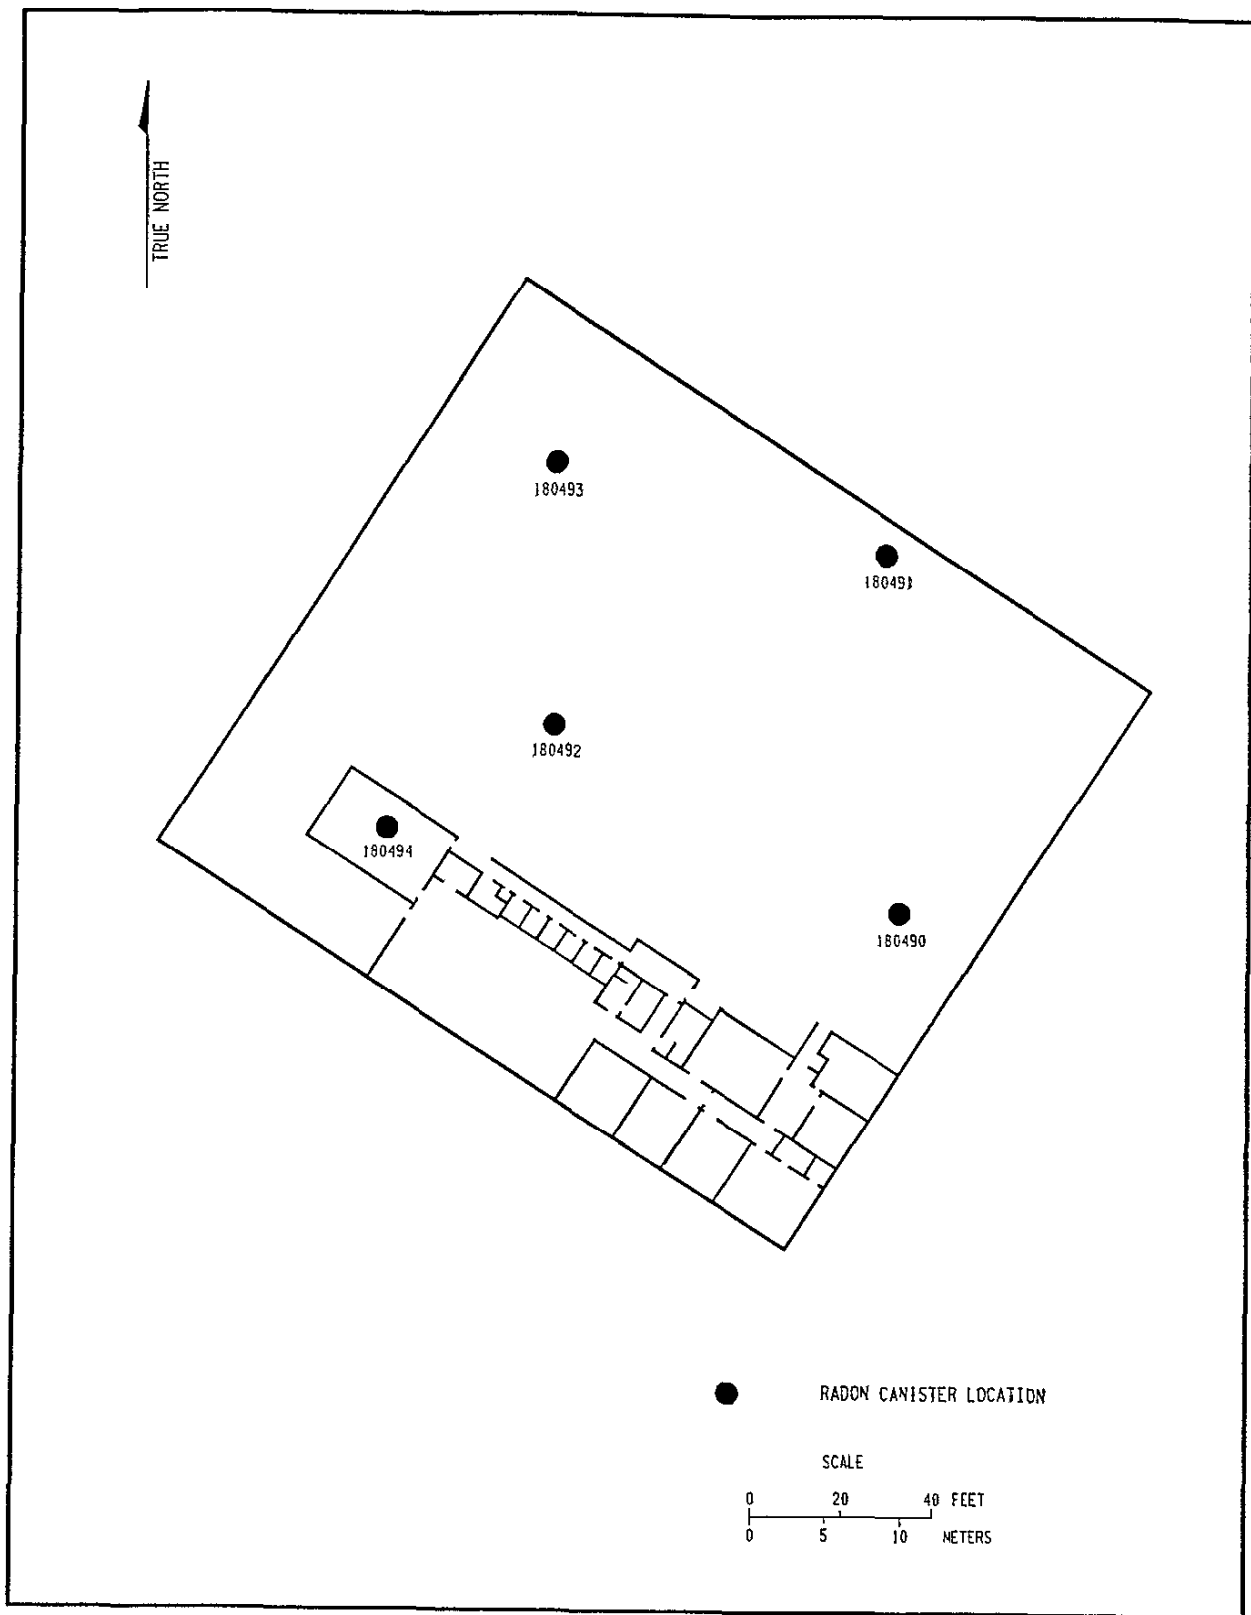
Figure 4-45
Locations of Radon Canisters at Myron Manufacturing
50 West Hunter Avenue

A total of 45 activated charcoal canisters were deployed at the Myron properties: 6 at 50 West Hunter Avenue, 5 at 61 West Hunter Avenue, and 34 at 205 Maywood Avenue. The locations of the canisters are shown in Figures 4-45 through 4-48, and the data are presented in Table 4-18. Radon concentrations ranged from less than 0.2 pCi/L to 0.5 pCi/L, all within background. Background for the Maywood area is 1.0 pCi/L. The DOE guideline for radon is 3.0 pCi/L above background. None of the measurements exceeded the DOE guideline. The radon concentrations measured were also within the EPA and NJDEP action level of 4.0 pCi/L, including background. At that level, EPA and NJDEP

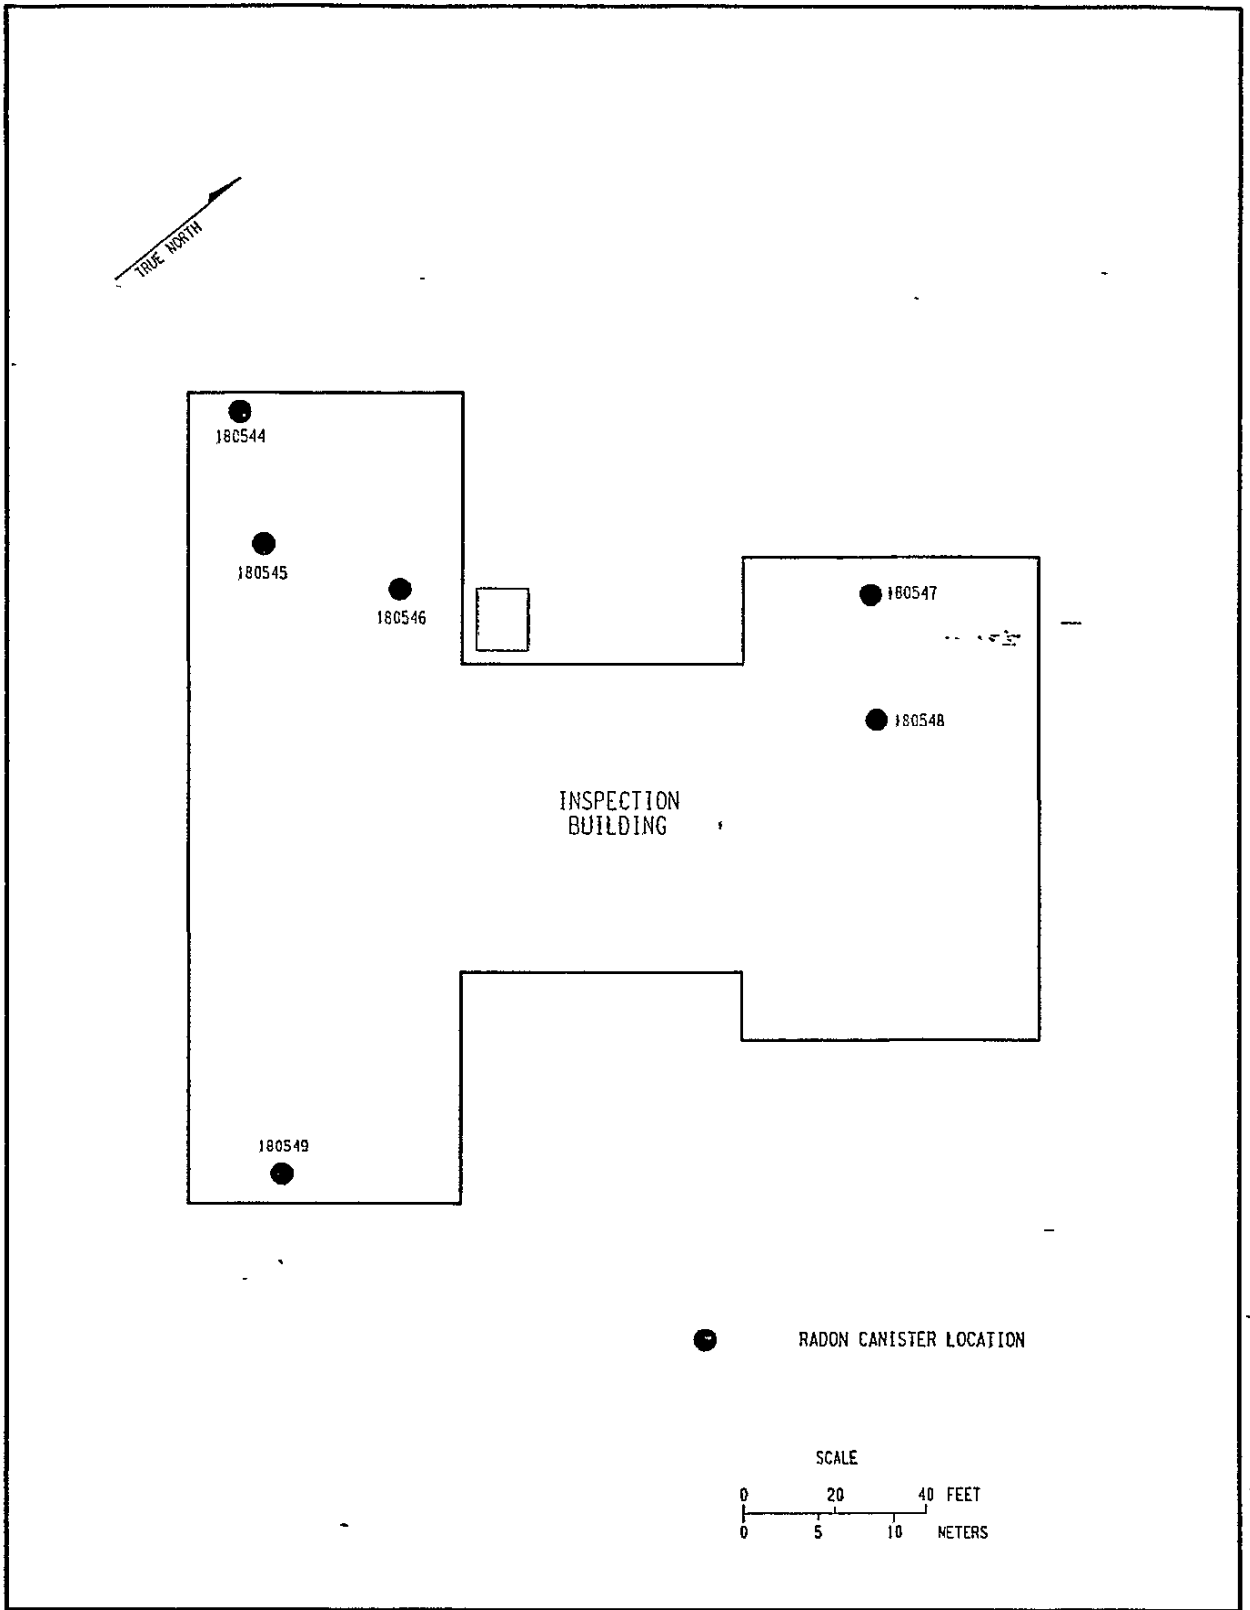
Figure 4-49
 PIC Measurement Locations and Areas of Contamination
 at the New Jersey Vehicle Inspection Station Property
 8 Mill Street

does not exceed the DOE guideline of $20 \mu\text{R/h}$ above background for habitable structures. Figure 4-49 shows the locations of the interior and exterior measurements and provides the data for each location. The data from these measurements were compared with gamma radiation measurements recorded during the 1986 radiological characterization activities (BNI 1987a). Eight exterior measurements were recorded and ranged from 4 to $5 \mu\text{R/h}$ (background has not been subtracted). These measurements are within the range of exterior measurements recorded during this investigation and show no significant changes in conditions at this property.

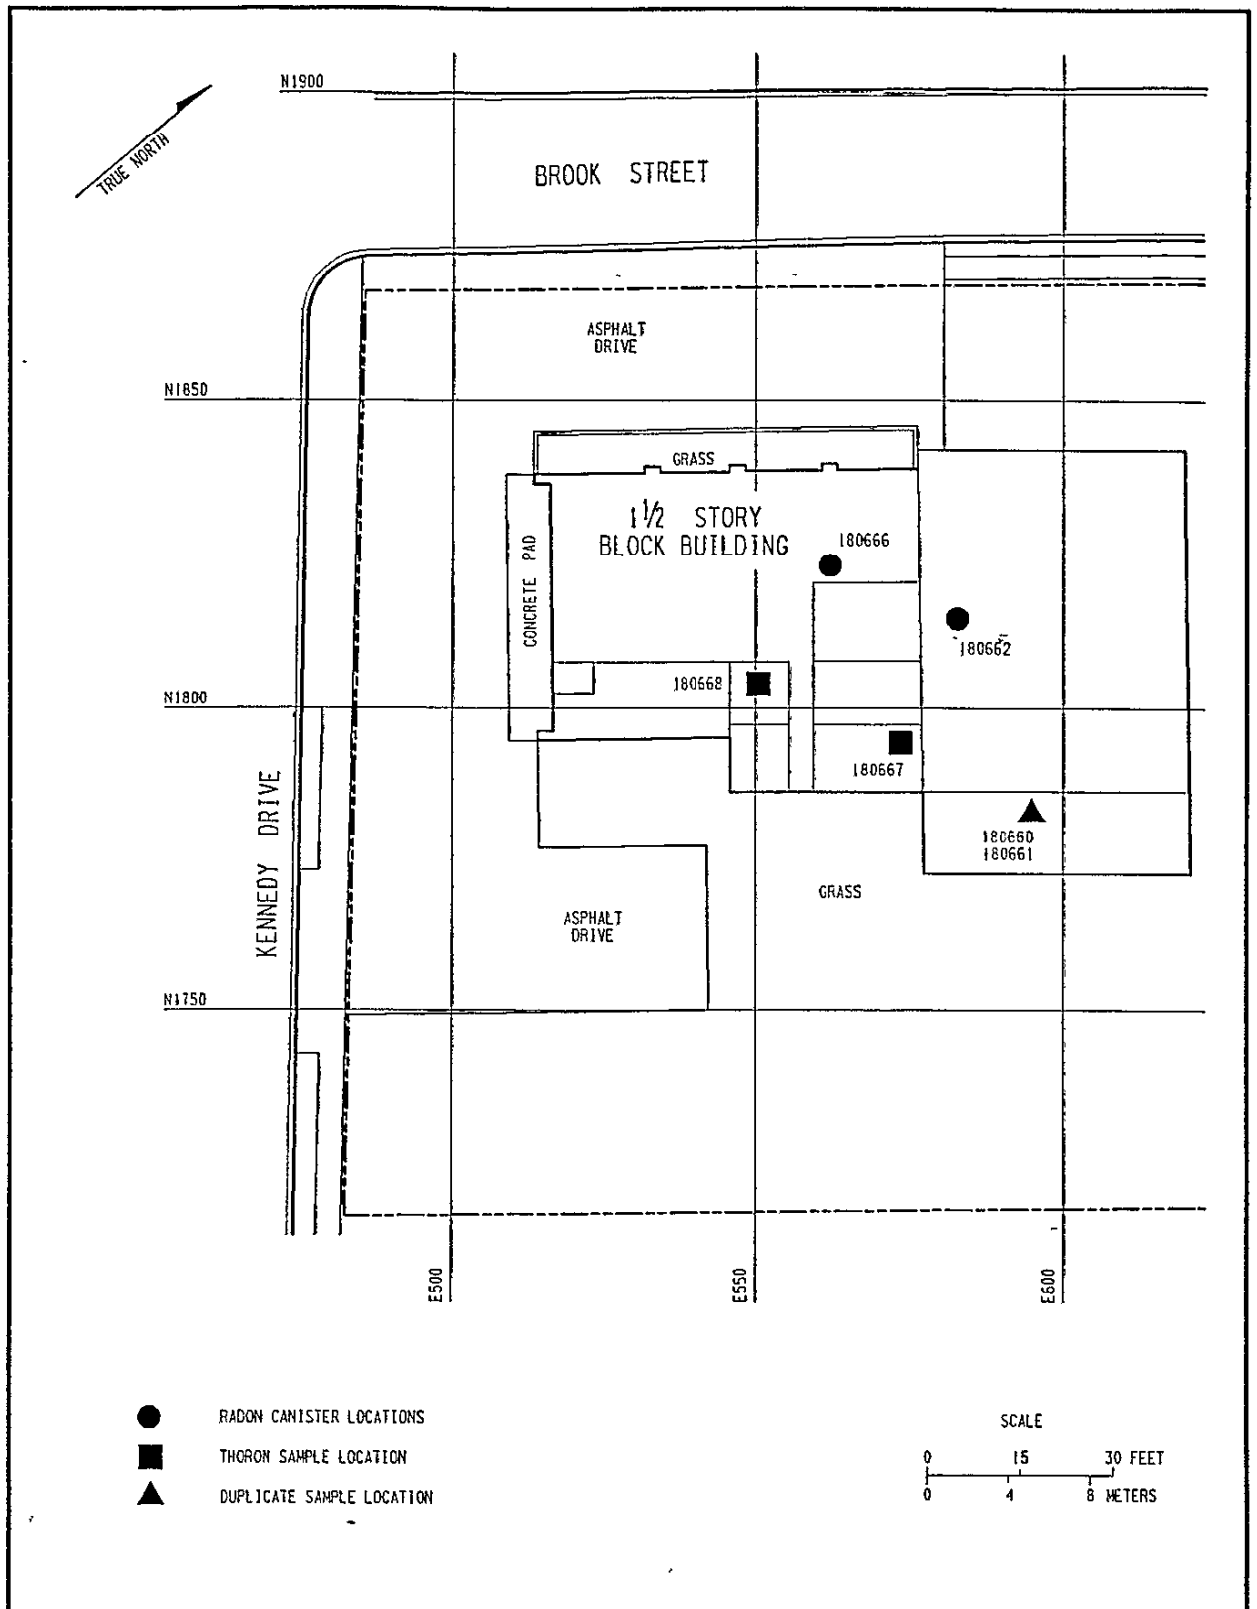
Figure 4-51
PIC Measurement Locations and Areas of Contamination at the
Fire Station No. 2 Property Kennedy Drive and Brook Street

Three interior and five exterior gamma exposure rate measurements were made at the fire station property. Figure 4-51 shows the locations of these measurements. The interior measurements ranged from 9.9 to $10.5 \mu\text{R/h}$ and were within background. The locations of the highest interior measurements, $10.5 \mu\text{R/h}$, were the women's restroom and the equipment

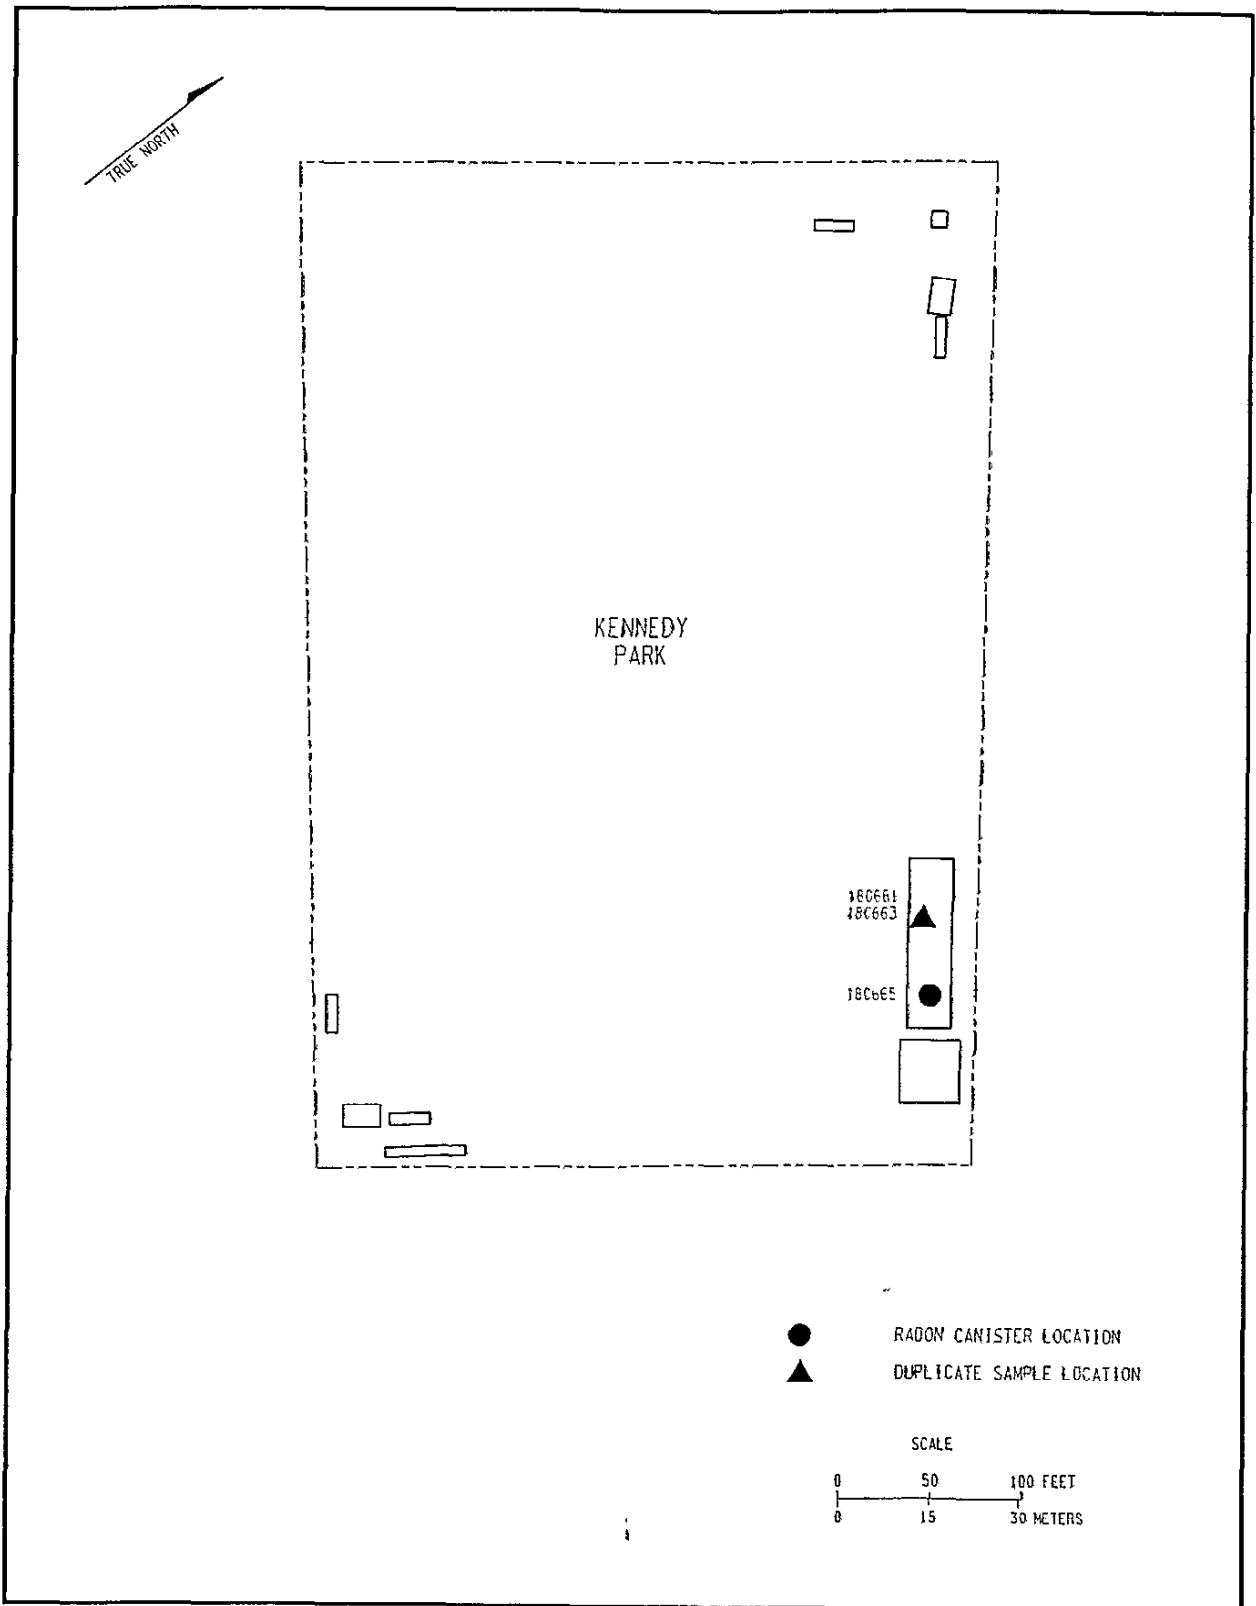
Figure 4-53
 PIC Measurement Locations and Areas of Contamination
 at John F. Kennedy Park
 Kennedy Drive and Money Street

The two interior gamma exposure rate measurements made in the park building (see Figure 4-53) were 8.6 $\mu\text{R/h}$ in the maintenance area and 9.3 $\mu\text{R/h}$ in the office area. These measurements are within the range of background, which is 8 to 12 $\mu\text{R/h}$. No radioactive contamination is known to be present beneath the building. The seven exterior gamma exposure rate measurements ranged from 8.2 to 12.3 $\mu\text{R/h}$ and were within background. Radioactively contaminated soils are known to be present at the end of the park bordered by Money Street. These soils were identified during radiological characterization of the property in 1987 (BNI 1989g), and this area is suspected to be near the original channel of Lodi Brook before it was contained in conduit during development of the area. The measurement of 12.3 $\mu\text{R/h}$, including background, was obtained in this area. The interior gamma exposure rate measurements do not exceed the DOE guidelines of 20 $\mu\text{R/h}$ above background for habitable structures. Data from these measurements were compared with data recorded during the 1987 radiological characterization of this property (BNI 1989g). Exterior gamma radiation measurements in 1987 ranged from 5 to 22 $\mu\text{R/h}$ (background has not been subtracted). Comparison of the data from this investigation indicates no significant changes at this property.
