Formerly Utilized Sites Remedial Action Program (FUSRAP)

for the Maywood Site, New Jersey

Subject: Contract DE-AC05-91OR21950
MAYWOOD - STAGE IA ARCHAEOLOGICAL STUDY AND STAGE II HISTORICAL STUDY
OF THE MAYWOOD SITE - FINAL (REVISION 1)

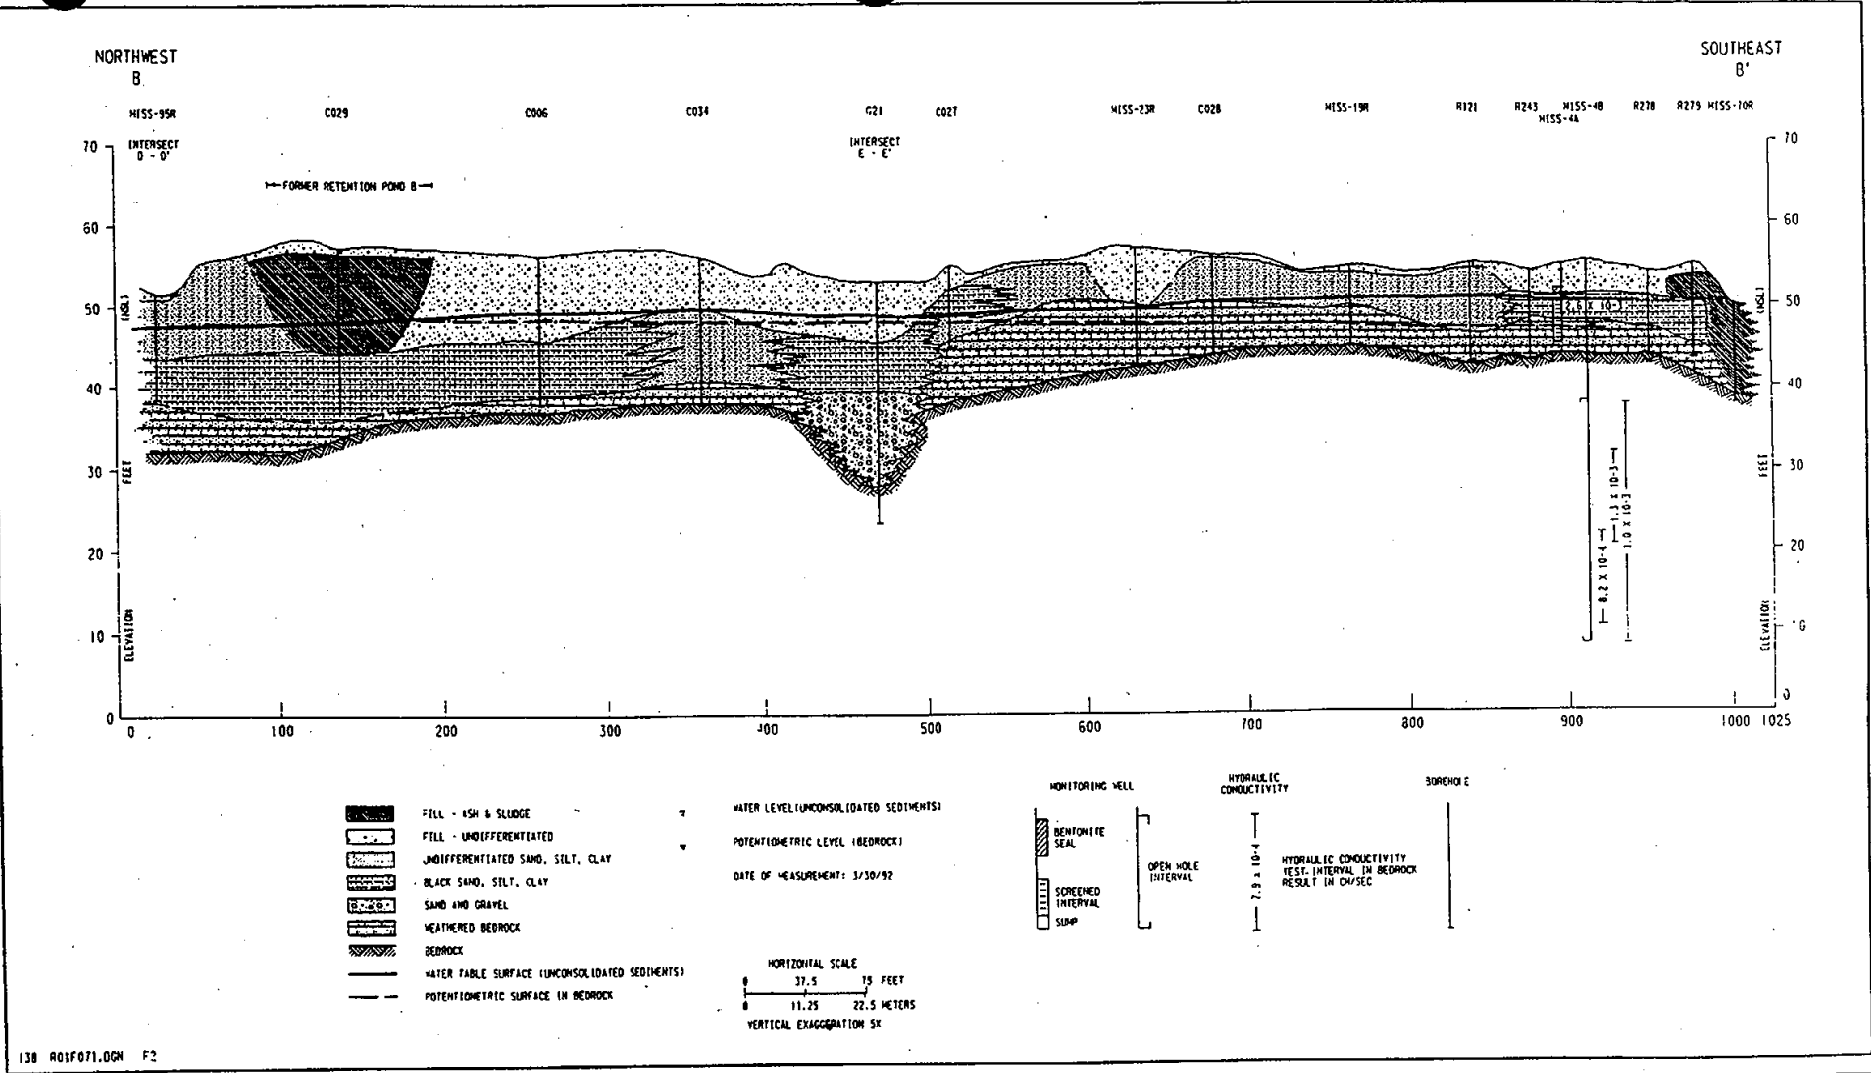
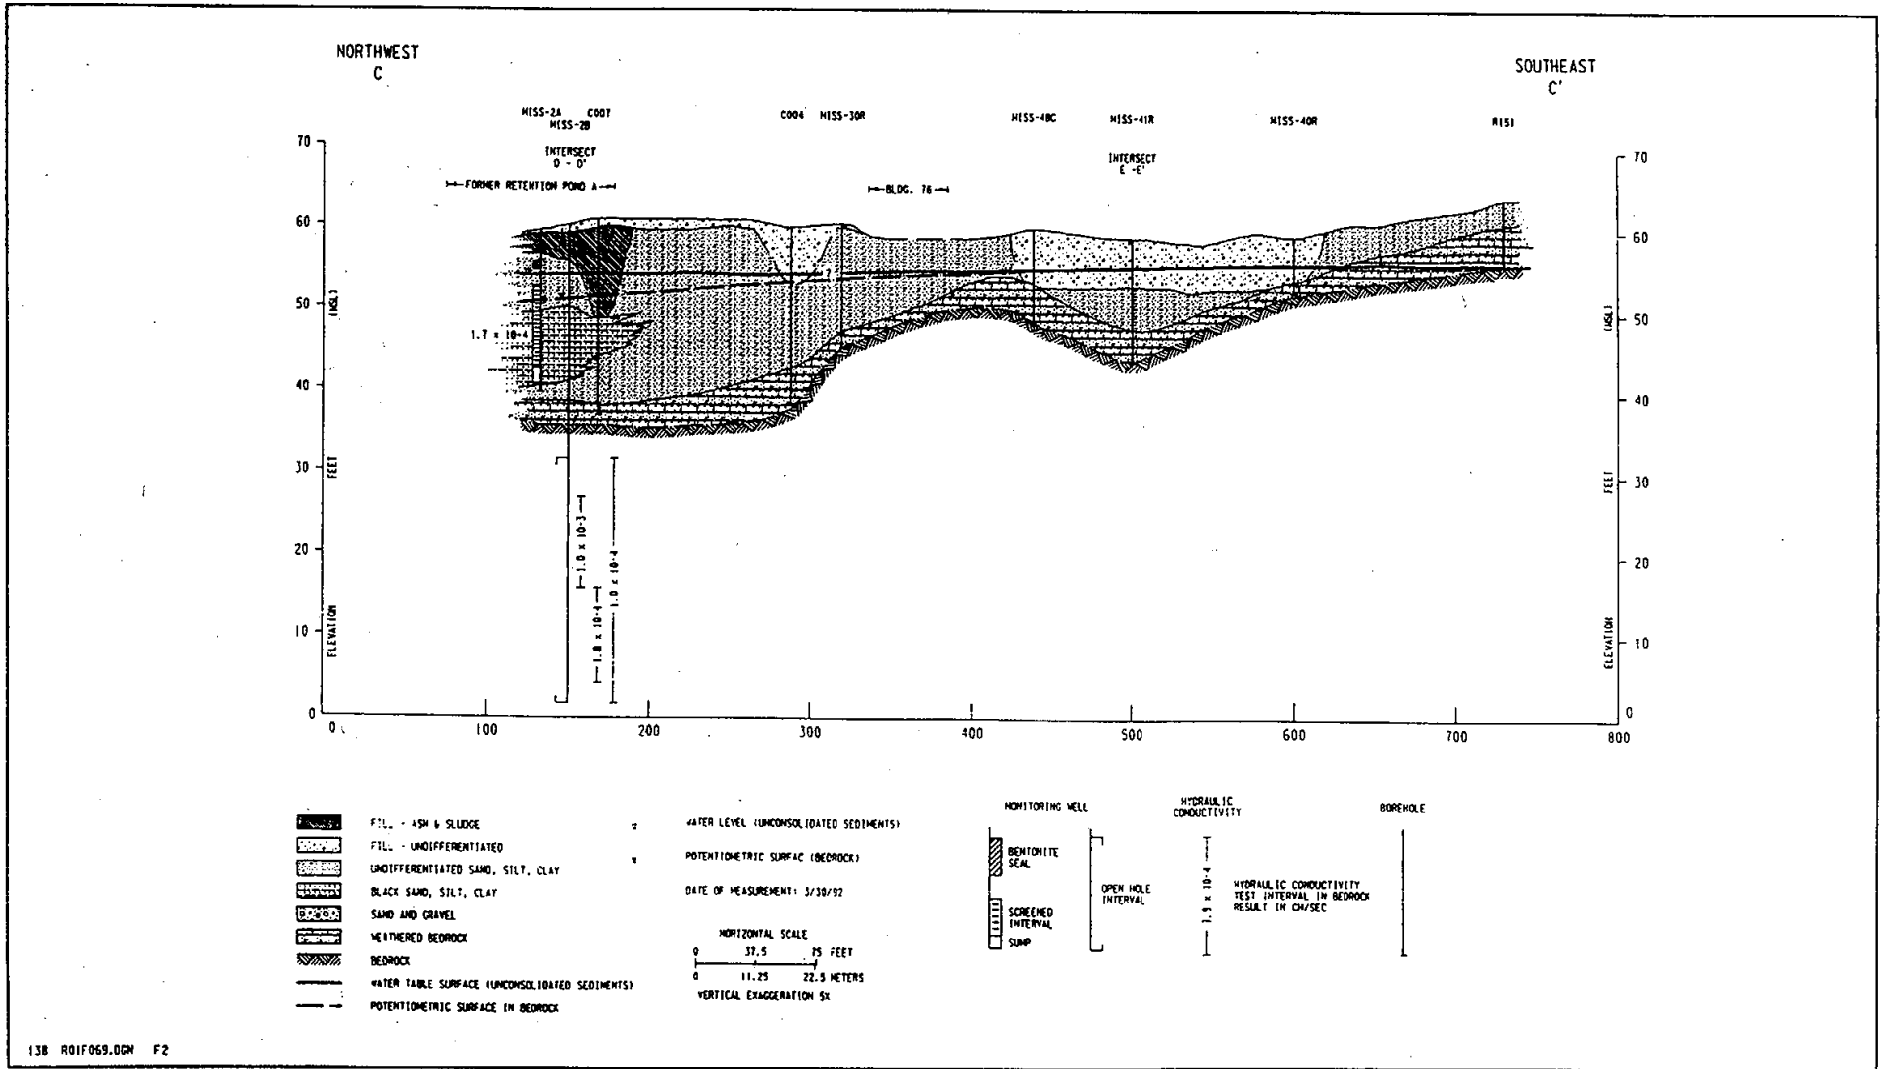
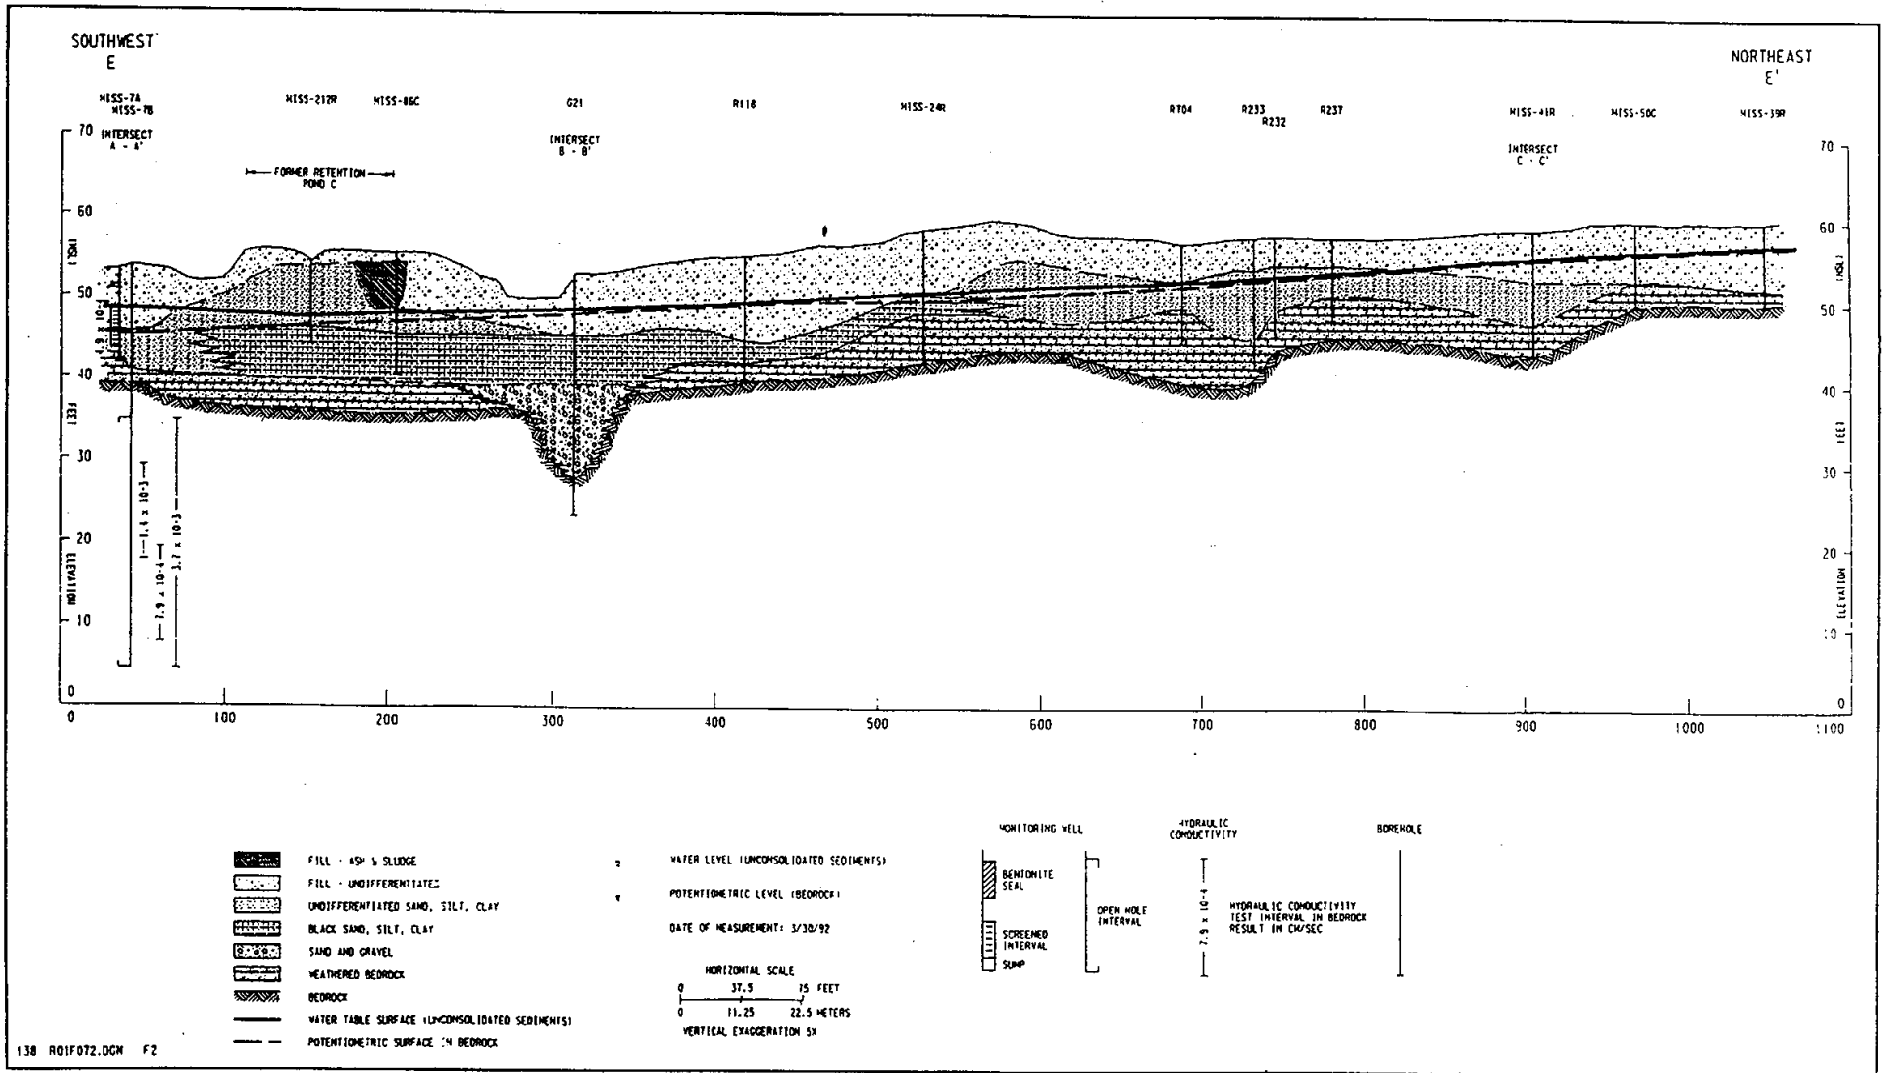
Figure 10
HYDROGEOLOGIC CROSS-SECTION
B-B' AT MISS

Figure 11
HYDROGEOLOGIC CROSS-SECTION
C-C' AT MISS

Figure 12
HYDROGEOLOGIC CROSS-SECTION
D-D' AT MISS

Figure 13
HYDROGEOLOGIC CROSS-SECTION
E-E' AT MISS

The MISS property is a large area crossed by Westerly Brook. The property has been intensively sampled for contamination and excellent geological cross-sections have been prepared (see Figures 8 through 13). The cross-sections provide a clear picture of extensive subsurface disturbance. Figure 9, for example, indicates that extensive cutting and filling associated with the construction and use of three former retention ponds has removed the original ground surface. This ground disturbance would have destroyed or severely damaged any historic remains associated with former buildings that once stood on the site (see Section 4.3). The former ponds are underlain either by weathered bedrock or by black sands, silts and clays derived from the former swampy conditions of Westerly Brook. No evidence of historic or prehistoric materials or old upper soil horizons is evident and MISS is not considered sensitive for archaeological resources.

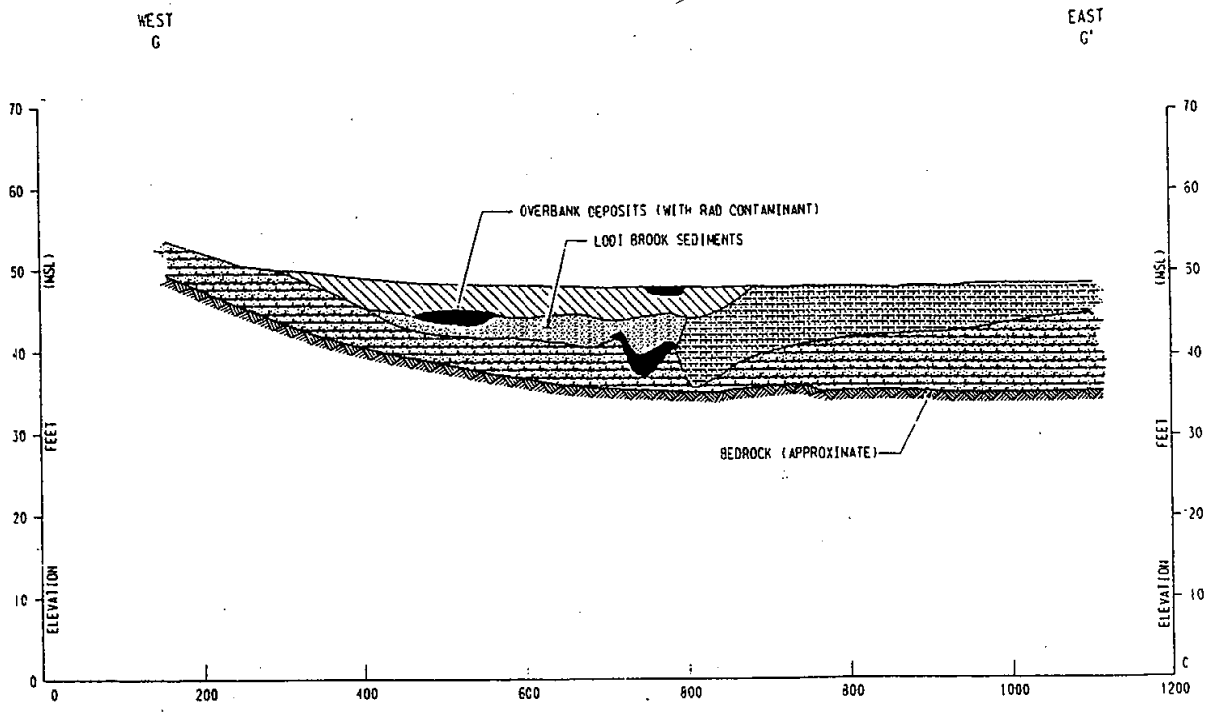
Figure 16
DIAGRAMMATIC CROSS-SECTION
SECTION G-G OF LODI STUDY AREA

- URBAN FILL
- SAND
- SILTY SAND
- SAND AND GRAVEL
- NATURAL UNDISTURBED SEDIMENTS AND WEATHERED BEDROCK
- RADIOLOGICAL CONTAMINATION
- BEDROCK

Figure 16 crosses the northernmost portion of Hancock Street. It indicates that contamination is restricted to the former channel of Lodi Brook. Given that the lowest contaminated materials would have been deposited no earlier than the 1890s when the Schaefer Alkaloid Works was established in Maywood, these deposits and those that overlie them would not have archaeological sensitivity. In addition, boring logs summarized in Table 2 indicate the absence of historic archaeological materials in this part of Hancock Street.

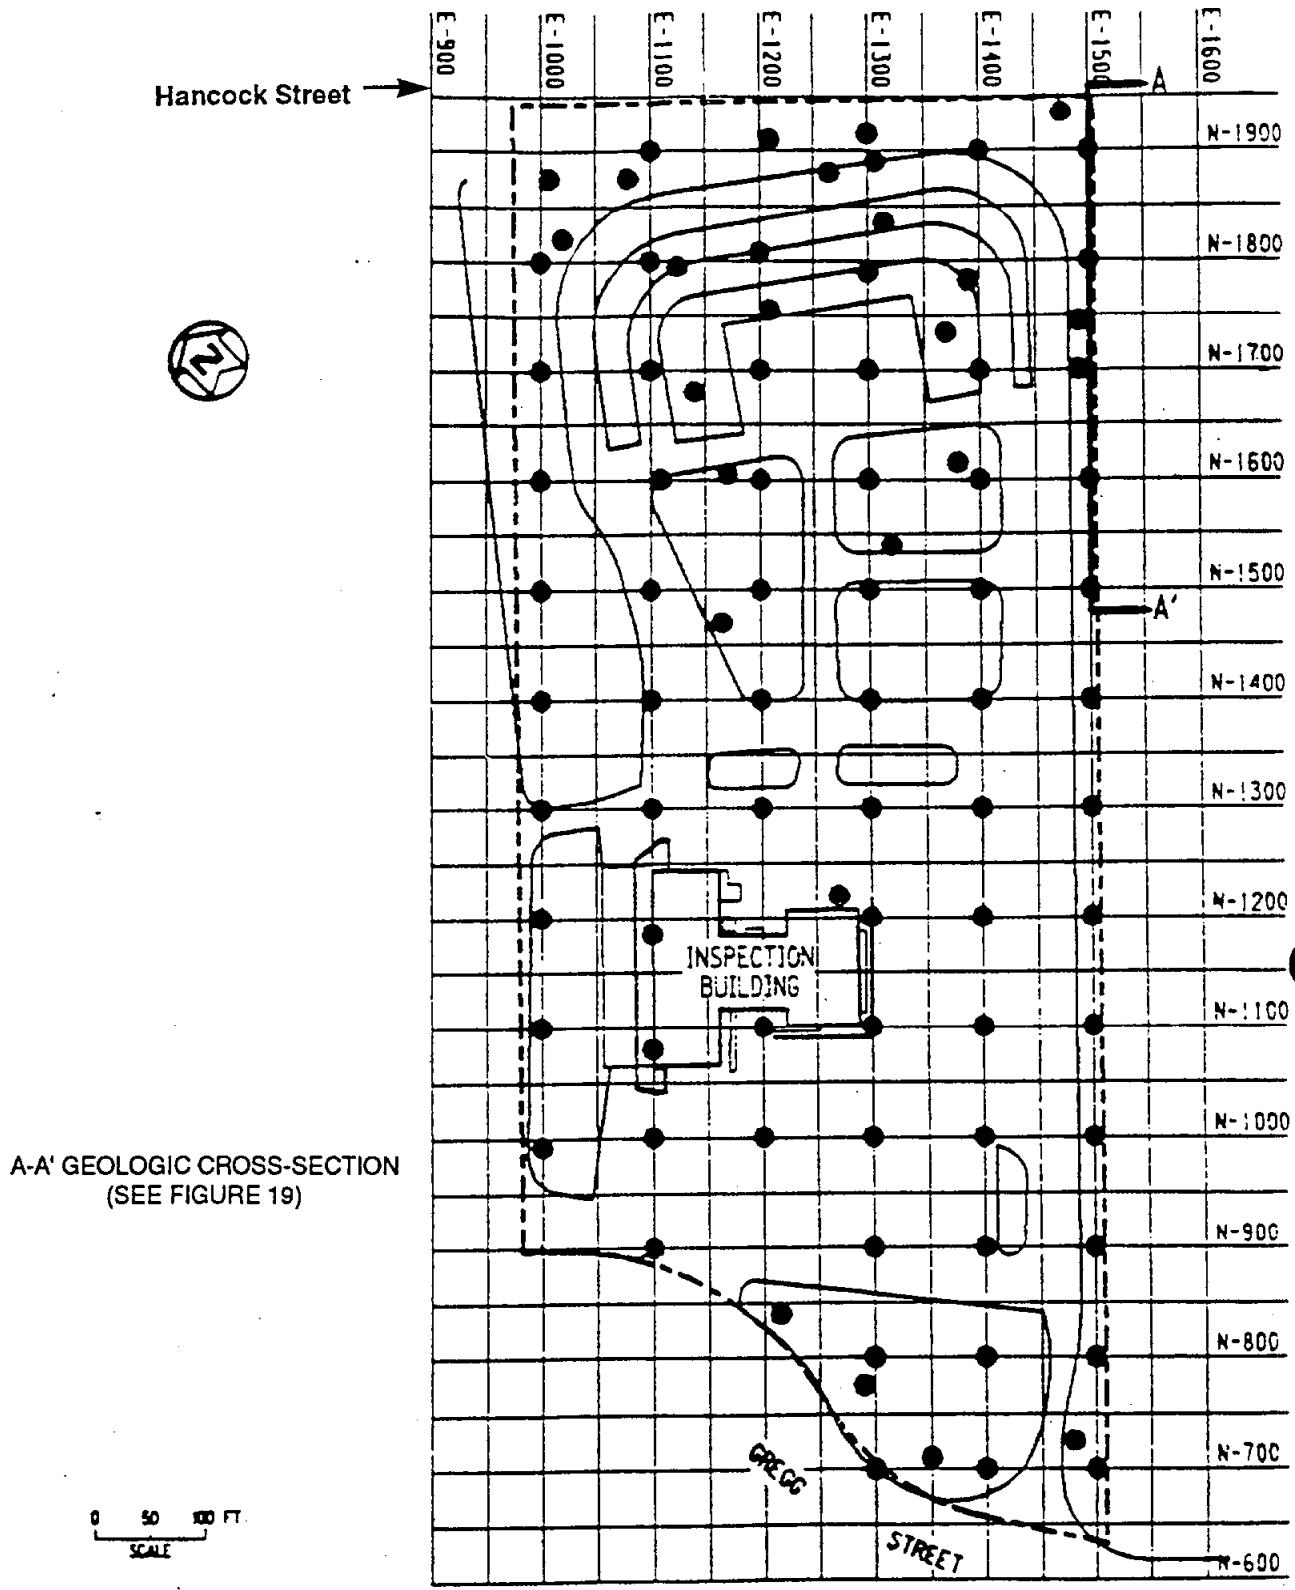
Figure 18

BOREHOLE LOCATIONS AT THE NEW JERSEY VEHICLE INSPECTION STATION PROPERTY

Figures 18 and 19 indicate the location and nature of a cross-section prepared for the New Jersey Motor Vehicle Inspection Station. The cross-section indicates that a buried upper soil horizon exists within the property. An examination of the soil boring logs indicates that borings did not locate any cultural materials.

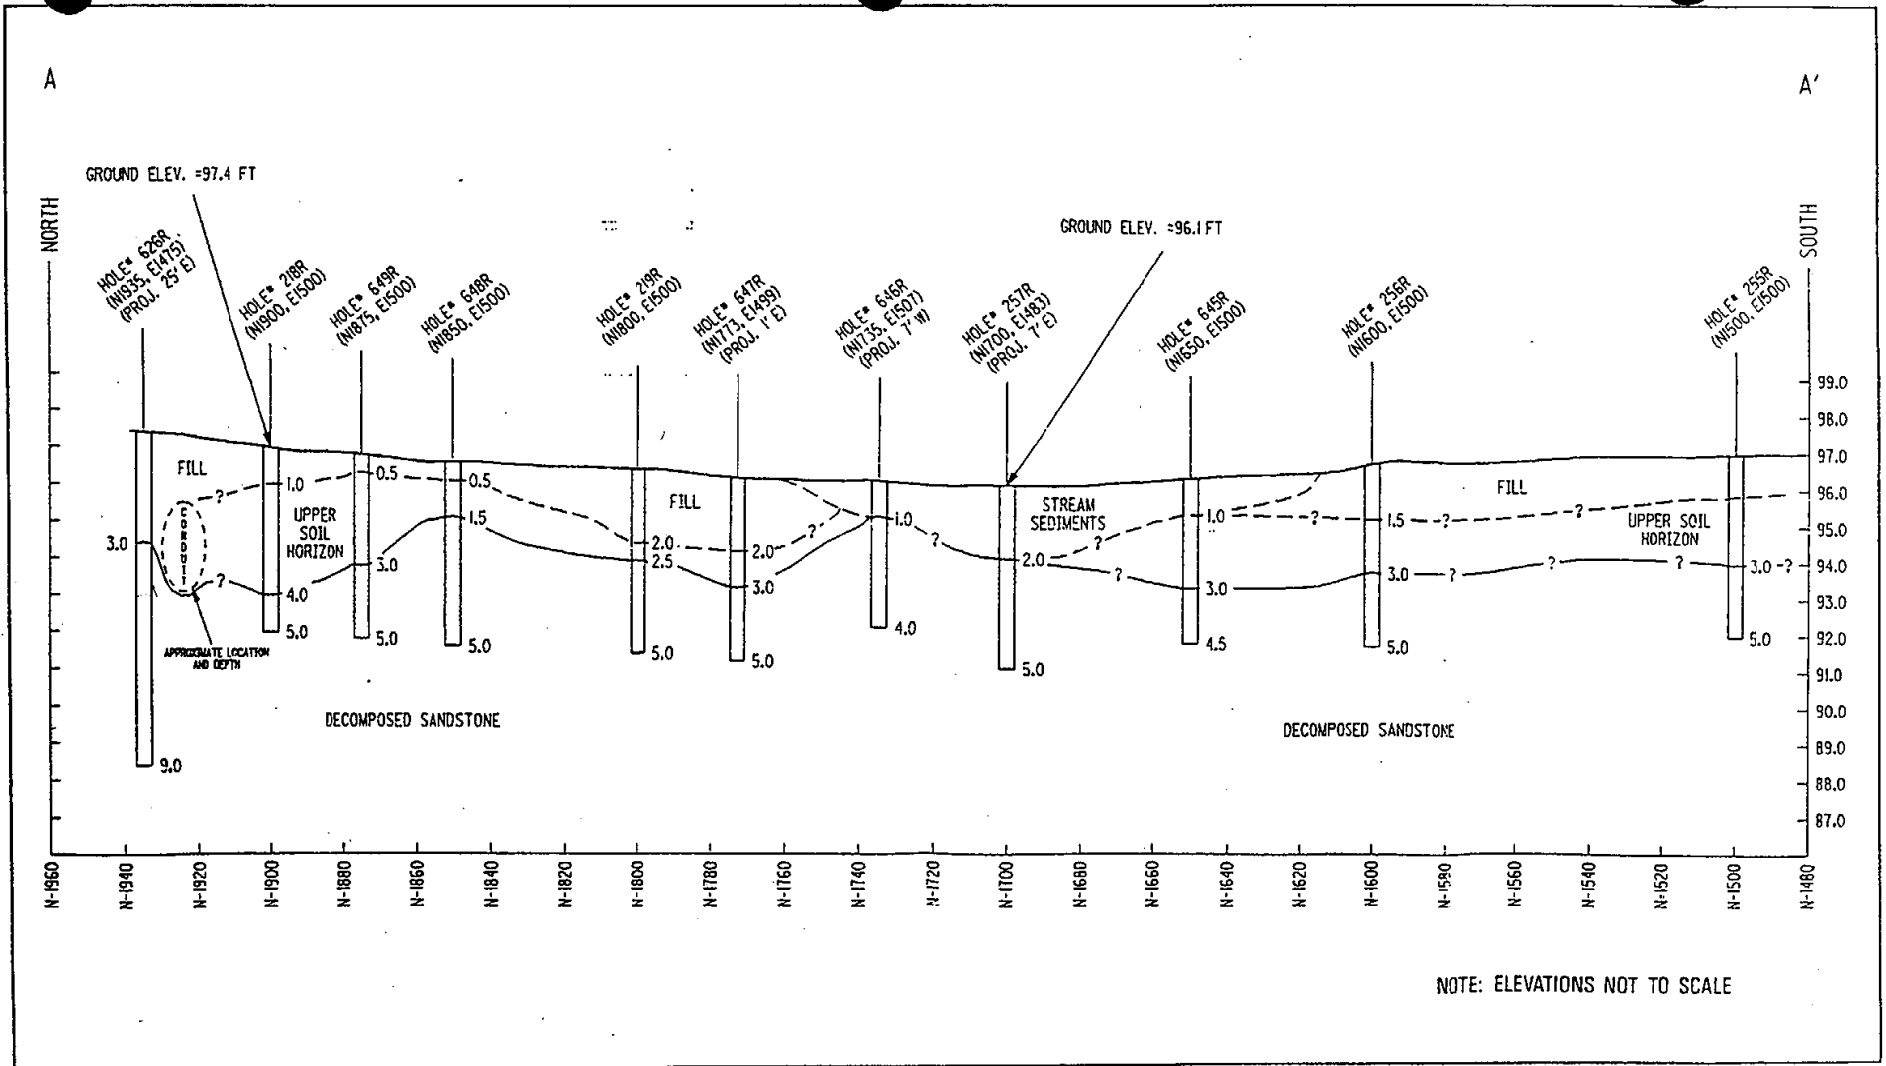
Figure 19
 GEOLOGIC CROSS-SECTION OF THE
 FORMER LODI BROOK STREAMBED

NOTE: ELEVATIONS NOT TO SCALE
