**Maywood Chemical Company Superfund Site**

**SUBJECT: Final Post-Remedial Action Report for 4 Hancock Street**

# **Final Post-Remedial Action Report for 4 Hancock Street**

**Lodi, New Jersey**

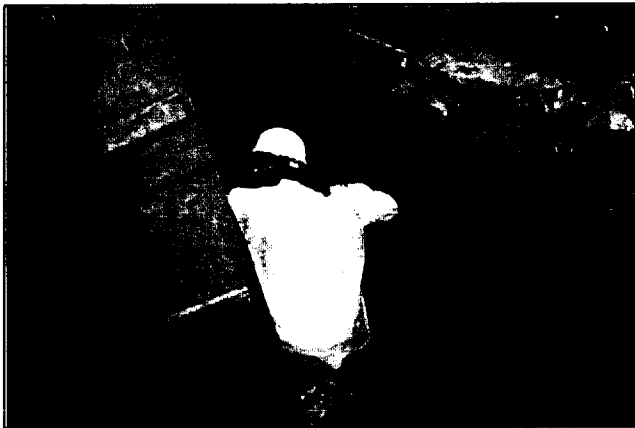
Figure 4-7  
Photographs Taken During Remediation  
(Photos 1 through 4)  
4 Hancock Street

The primary technique used in the remedial action was excavation of the contaminated materials. A jackhammer was used to break up concrete, asphalt, and debris before removal. Because of the limited working space available, small volumes of soil were removed with picks and shovels, while a backhoe was used to remove larger volumes. A vacuum truck was also used to remove larger volumes below the house. After remedial action, areas were restored to the condition agreed upon by the property owners.
