**Final Post-Remedial Action Report
for 5 Hancock Street Including the Minor
Remediation of 46 Long Valley Road**

FINAL POST-REMEDIAL ACTION REPORT

5 HANCOCK STREET

46 LONG VALLEY ROAD

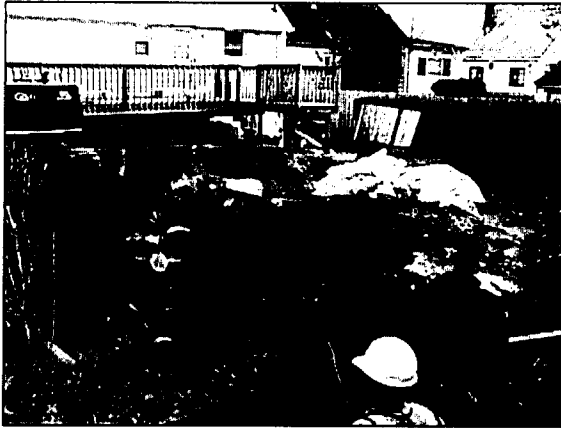
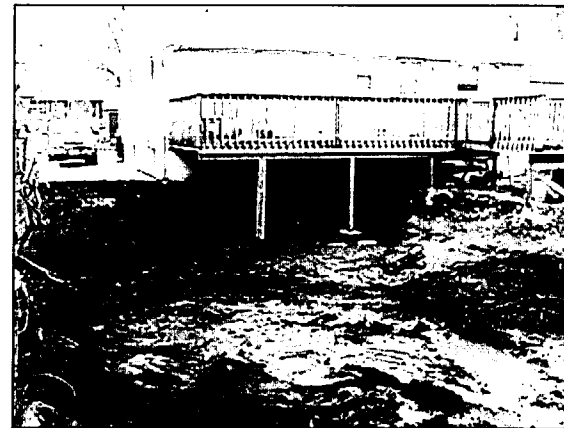
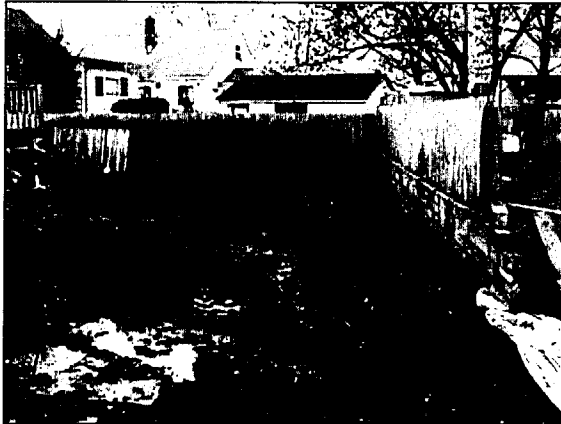
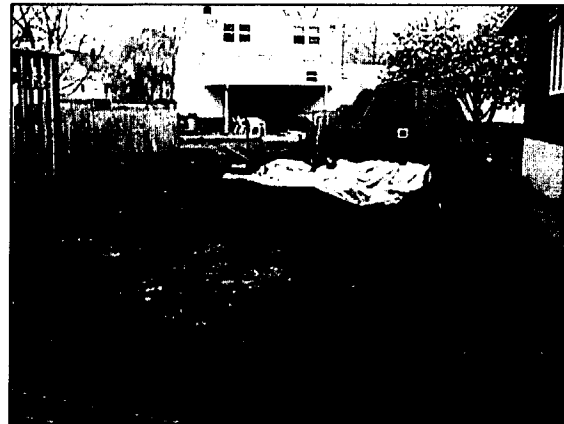
Figure 4-8
Photographs Taken During Remediation
(Photos 1 through 4)
5 Hancock Street

The primary technique used in the remedial action was excavation of the contaminated materials. A jackhammer was used to break up concrete, asphalt, and debris before removal. Because of the limited working space available, small volumes of soil were removed with picks and shovels, while a backhoe was used to remove larger volumes. After remedial action, areas were restored to the condition agreed upon by the property owners.
