ORNL/RASA-84/LJ2

RESULTS OF THE RADIOLOGICAL SURVEY AT 61 TRUDY DRIVE (LJ002), LODI, NEW JERSEY

October 1984

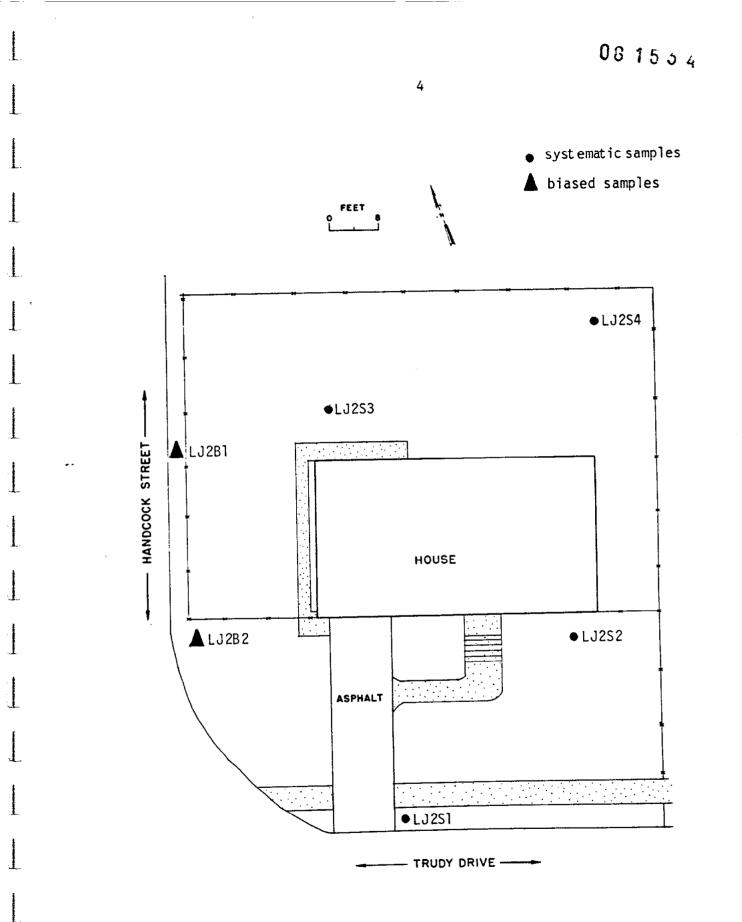
Systematic and biased soil samples were taken from various locations on the property for radionuclide analyses. Locations of the systematic (LJ2S) and biased (LJ2B) samples are shown in Fig. 1, with results of laboratory analyses provided in Table 3. Concentrations of 232 Th exceeded the background concentrations of 232 Th anticipated for northern New Jersey in the biased soil samples collected at 61 Trudy Drive (LJ2B1 and LJ2B2). These results indicate that 232 Th-bearing residues exist on this site. The amount of material present is in excess of DOE guidelines (Table 1).

^aLocations of soil samples are shown on Fig. 1.

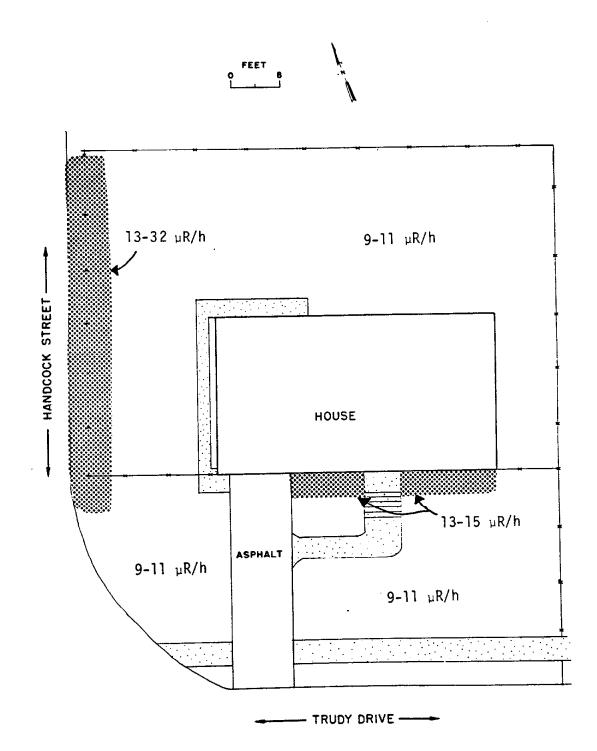
Fig. 2. Location of elevated gamma radiation levels at 61 Trudy Drive.

Results of the gamma scan of the surface of the property show areas where gamma exposure rates are in excess of background radiation levels. These locations are shown in Fig. 2, and the measurements are quantified. These locations suggest where potential 232 Th contamination exists. Gamma exposure rate levels up to 32 μ R/h exist on the ground surface at this property.

Measurements taken at 61 Trudy Drive indicate that the property contains radioactive contamination primarily from the 232 Th decay chain, and to a lesser extent from the 238 U decay chain. This material is found in the locations shown in Fig. 2. Concentrations of radionuclides were elevated significantly above background and are in excess of DOE remedial action guidelines. It is recommended that this property be designated for further evaluation. A comprehensive radiological survey will be required to fully delineate the extent of contamination prior to remedial action.
